ASBESTOS SURVEY REPORT

(Refurbishment / Demolition Survey)

**Location: Presentation Convent,
Long Range Bagenalstown, Co. Carlow**

Report No. PE23-157

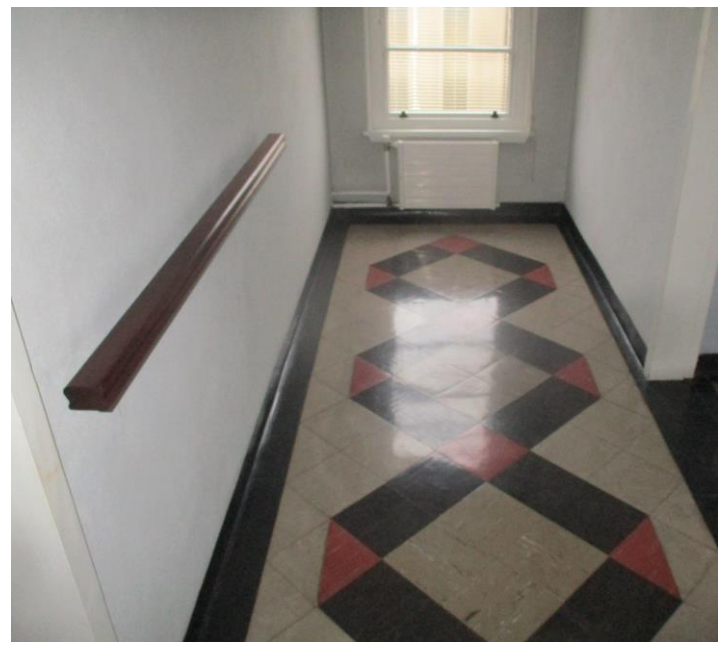
Created By	Andrew Hickey
Date	27 th January 2023
Site Details	Presentation Convent, Long Range, Bagenalstown, Co. Carlow
Client Name	Carlow Community Enterprise Centres CLG
Survey Type	R/D Asbestos Survey
Site Ref	PE 23-157
Building Ref.	Presentation convent
Location	Various locations
Extent/ Amount	560 m ² floor area approx.

MATERIAL ASSESSMENT		PRIORITY ASSESSMENT
Product type	Floor tiles & bitumen	Normal occupant activity	N/A
Extent of damage	Low	Likelihood of disturbance	N/A
Surface treatment	Composite & well bound material	Human exposure potential	N/A
Asbestos type	Chrysotile	Maintenance activity	N/A
	Material assessment score: N/A	TOTAL SCORE: N/A	Priority assessment score: N/A

The floor tiles & bitumen identified on the floor in various areas throughout the convent contain Chrysotile (white) asbestos fibres. Thermoplastic floor tiles can contain up to 25% asbestos fibres. Bitumen adhesives contain a small quantity of asbestos fibres

The floor tiles & bitumen adhesive may be left in situ and managed in place, However, if the forthcoming refurbishment works are likely to disturb the floors, The floor tile & bitumen should be removed by an asbestos removal contactor and disposed of as asbestos waste before the refurbishment/demolition works commence

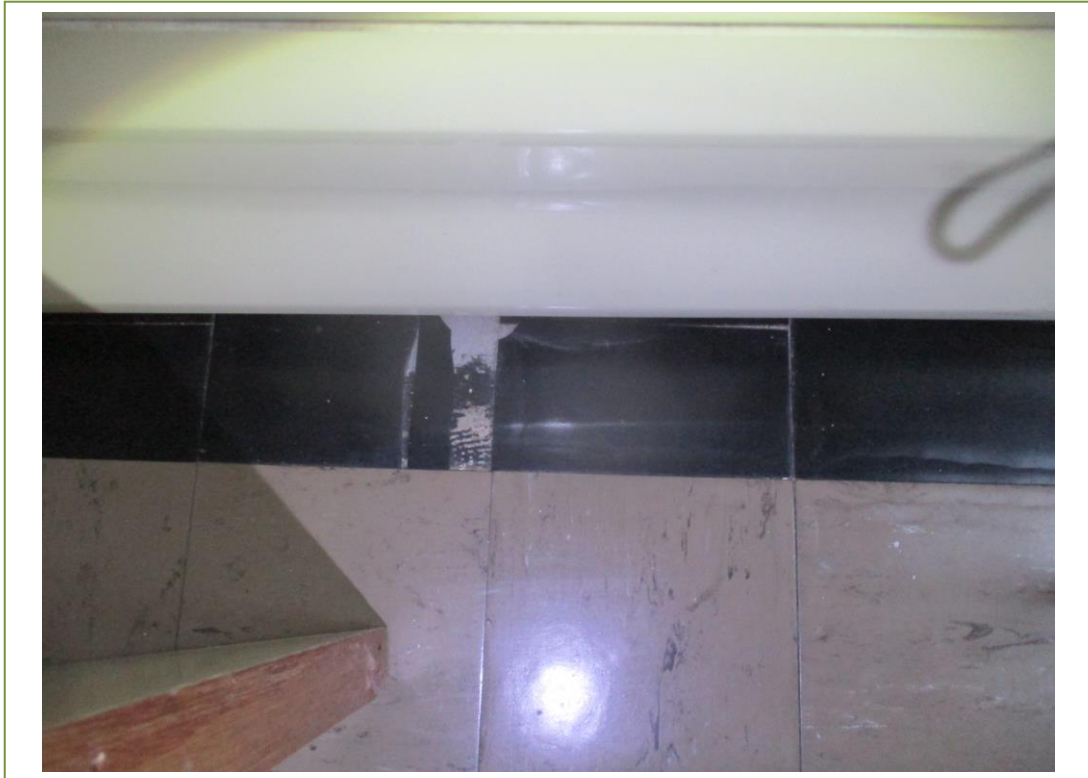
View of the asbestos containing floor tiles and bitumen adhesive in the toilet on the 1st floor

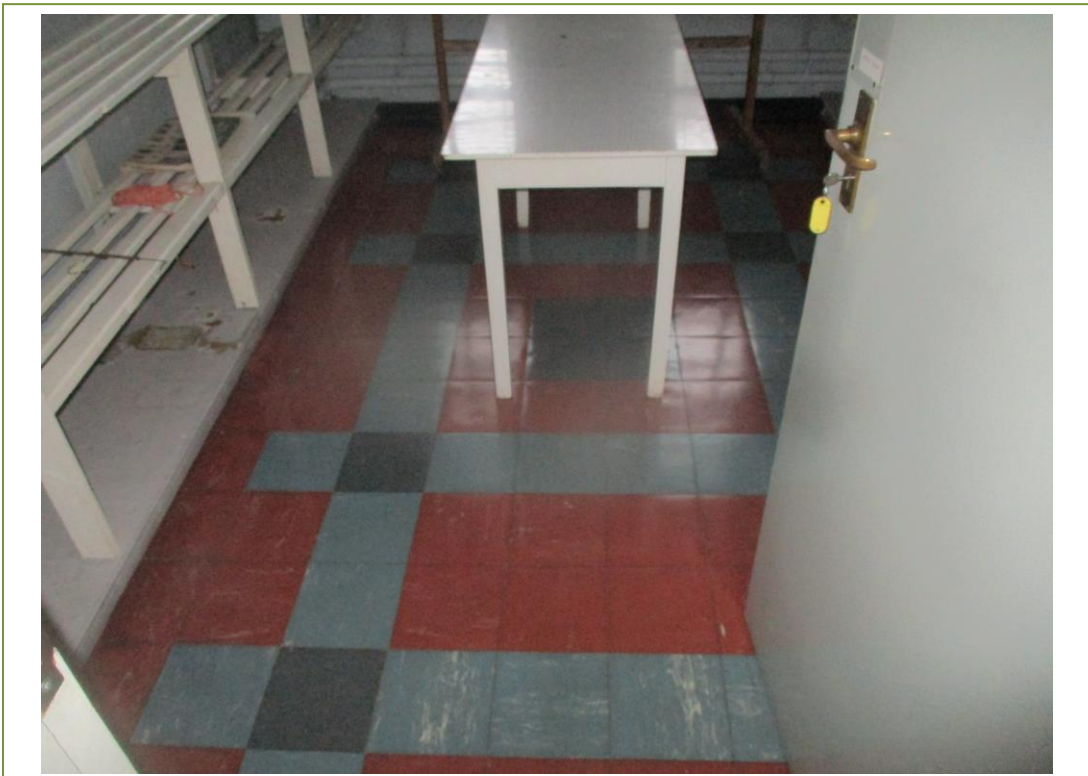
Asbestos containing floor tiles and bitumen adhesive in the ground floor drying room

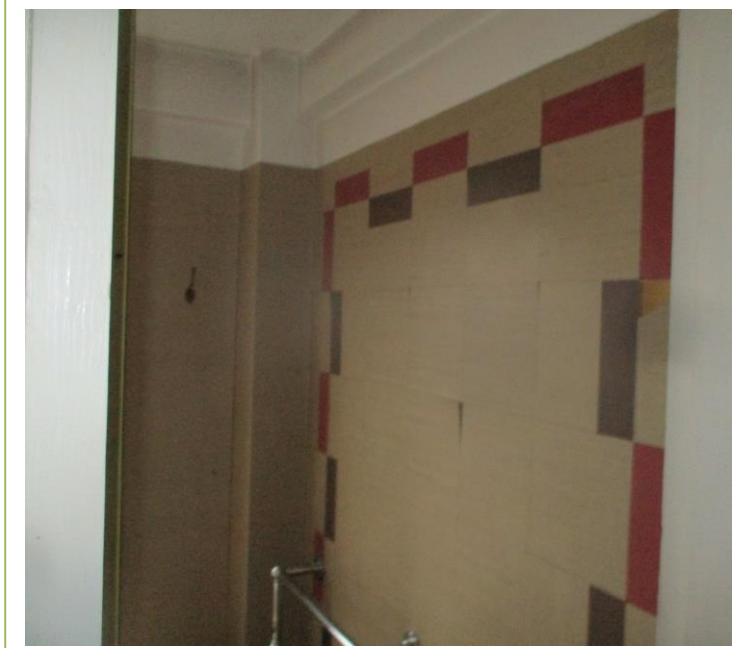
Created By	Andrew Hickey
Date	27 th January 2023
Site Details	Presentation Convent, Long Range, Bagenalstown, Co. Carlow
Client Name	Carlow Community Enterprise Centres CLG
Survey Type	R/D Asbestos Survey
Site Ref	PE 23-157
Building Ref.	Presentation convent
Location	Bathroom areas
Extent/ Amount	100 m ² floor area approx.

MATERIAL ASSESSMENT		PRIORITY ASSESSMENT
Product type	Floor tile	Normal occupant activity	N/A
Extent of damage	Low	Likelihood of disturbance	N/A
Surface treatment	Composite material	Human exposure potential	N/A
Asbestos type	Chrysotile	Maintenance activity	N/A
	Material assessment score: N/A	TOTAL SCORE: N/A	Priority assessment score: N/A

The floor tiles identified on the walls in bathroom areas throughout the convent contain Chrysotile (white) asbestos fibres. Thermoplastic floor tiles can contain up to 25% asbestos fibres.

The floor tiles may be left in situ and managed in place, However, if the forthcoming refurbishment works are likely to disturb the wall areas, The floor tiles should be removed by an asbestos removal contractor and disposed of as asbestos waste before the refurbishment/demolition works commence.

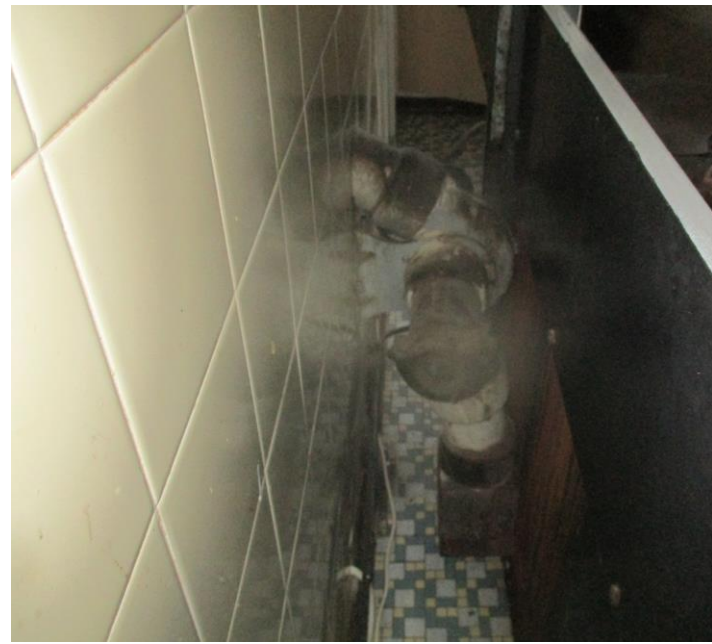
Created By	Andrew Hickey
Date	27 th January 2023
Site Details	Presentation Convent, Long Range, Bagenalstown, Co. Carlow
Client Name	Carlow Community Enterprise Centres CLG
Survey Type	R/D Asbestos Survey
Site Ref	PE 23-157
Building Ref.	Presentation convent
Location	Kitchen
Extent/ Amount	1 liner meter approx.

MATERIAL ASSESSMENT		PRIORITY ASSESSMENT
Product type	Cement	Normal occupant activity	N/A
Extent of damage	Low	Likelihood of disturbance	N/A
Surface treatment	None	Human exposure potential	N/A
Asbestos type	Chrysotile	Maintenance activity	N/A
	Material assessment score: N/A	TOTAL SCORE: N/A	Priority assessment score: N/A

The cement pipe identified in the kitchen at the rear of the cooker contains Chrysotile (white) asbestos fibres. Asbestos cement products usually contain between 10-15% asbestos fibres, found in Portland cement.

The asbestos cement pipe may be left in situ and managed in place, However, if the forthcoming refurbishment works are likely to disturb the cement pipe, The cement pipe should be removed by an asbestos removal contractor and disposed of as asbestos waste before the refurbishment/demolition works commence.

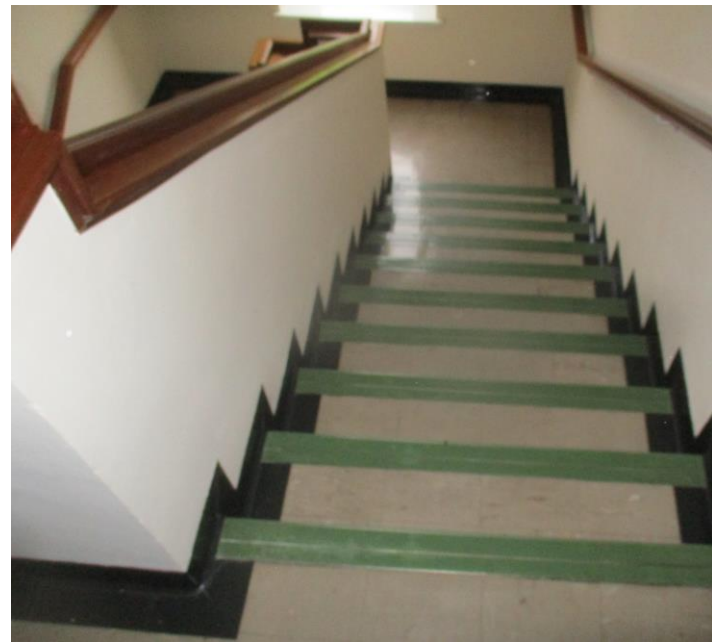
Created By	Andrew Hickey
Date	27 th January 2023
Site Details	Presentation Convent, Long Range, Bagenalstown, Co. Carlow
Client Name	Carlow Community Enterprise Centres CLG
Survey Type	R/D Asbestos Survey
Site Ref	PE 23-157
Building Ref.	Presentation convent
Location	Stairs
Extent/ Amount	2 per step

MATERIAL ASSESSMENT		PRIORITY ASSESSMENT
Product type	Resin step nosing	Normal occupant activity	N/A
Extent of damage	Low	Likelihood of disturbance	N/A
Surface treatment	Composite material	Human exposure potential	N/A
Asbestos type	Chrysotile	Maintenance activity	N/A
	Material assessment score: N/A	TOTAL SCORE: N/A	Priority assessment score: N/A

The resin step nosing identified on the steps on both stairwells contain Chrysotile (white) asbestos fibres. Resins may contain between 20 & 50% asbestos fibres.

The resin step nosing's may be left in situ and managed in place, However, if the forthcoming refurbishment works are likely to disturb the floors of the stairs, The resin step nosing's should be removed by an asbestos removal contractor and disposed of as asbestos waste before the refurbishment/demolition works commence.

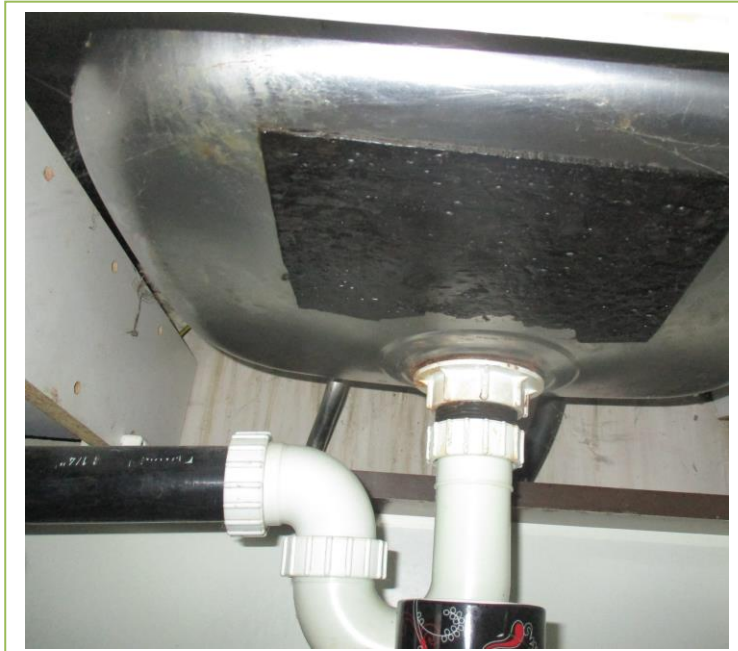
Created By	Andrew Hickey
Date	27 th January 2023
Site Details	Presentation Convent, Long Range, Bagenalstown, Co. Carlow
Client Name	Carlow Community Enterprise Centres CLG
Survey Type	R/D Asbestos Survey
Site Ref	PE 23-157
Building Ref.	Presentation convent
Location	Kitchen - sink
Extent/ Amount	Small amount

MATERIAL ASSESSMENT		PRIORITY ASSESSMENT
Product type	Felt pad	Normal occupant activity	N/A
Extent of damage	Low	Likelihood of disturbance	N/A
Surface treatment	Well bound material	Human exposure potential	N/A
Asbestos type	Chrysotile	Maintenance activity	N/A
	Material assessment score: N/A	TOTAL SCORE: N/A	Priority assessment score: N/A

The felt pads identified on the underside of the sink unit in the kitchen contains Chrysotile (white) asbestos fibres. Felt products usually contain a small quantity of asbestos fibres mixed into a product matrix.

The felt pads may be left in situ and managed in place, However, if the forthcoming refurbishment works are likely to disturb the felt pads, The felt pads should be removed by an asbestos removal contractor and disposed of as asbestos waste before the refurbishment/demolition works commence.

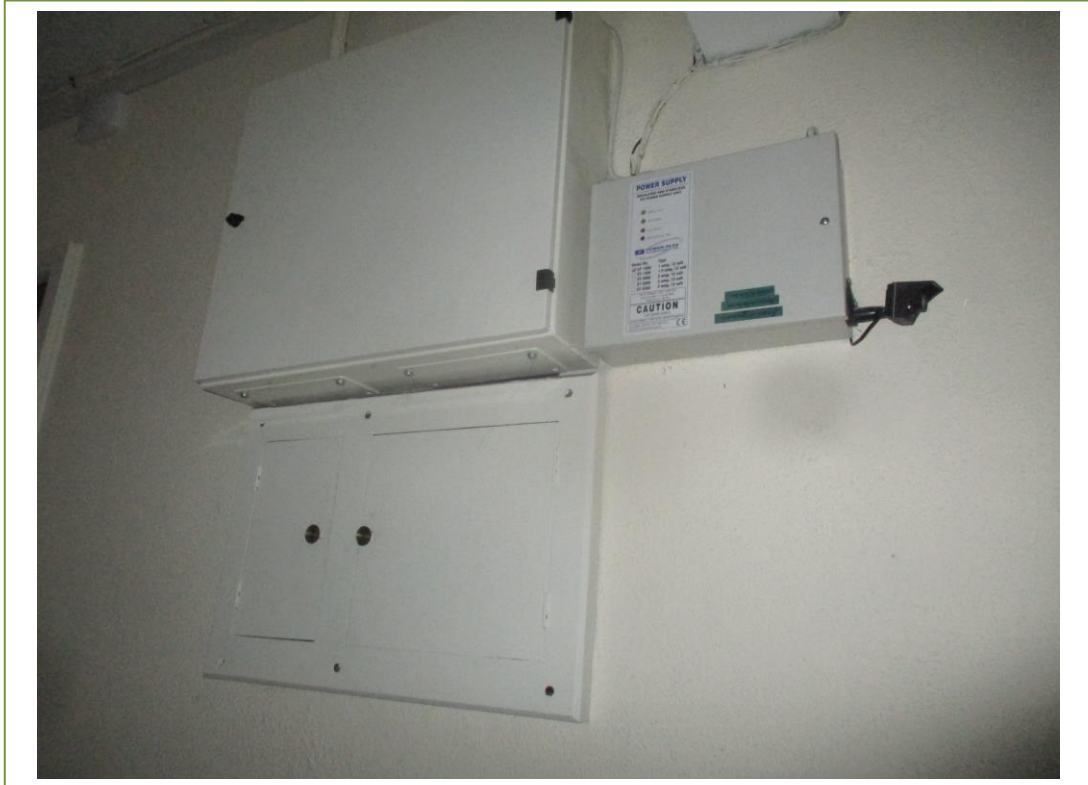
Modern Electrical unit

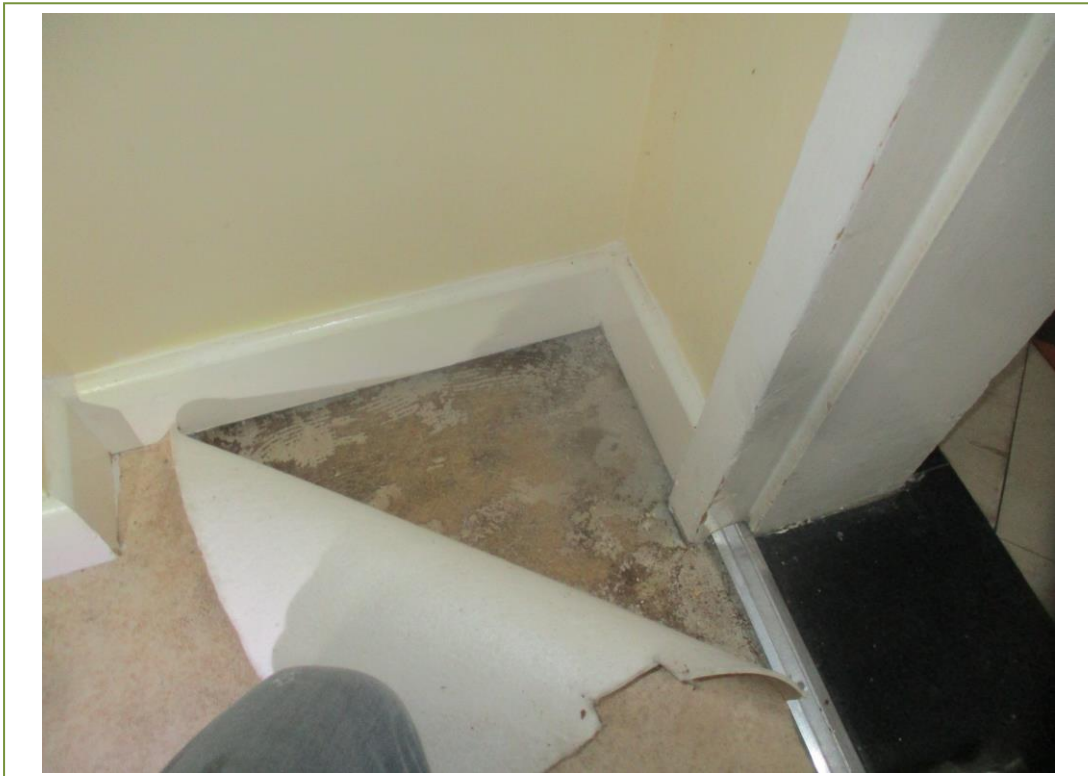
Concrete floors under lino in bedrooms

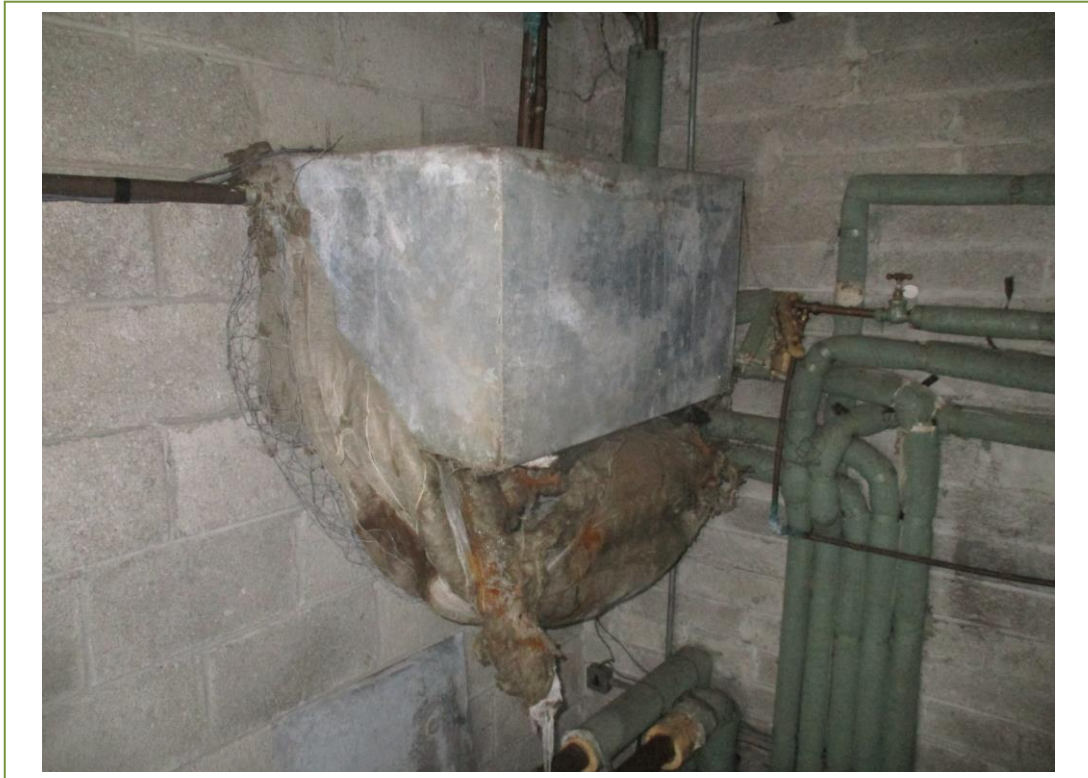
Steel water tank

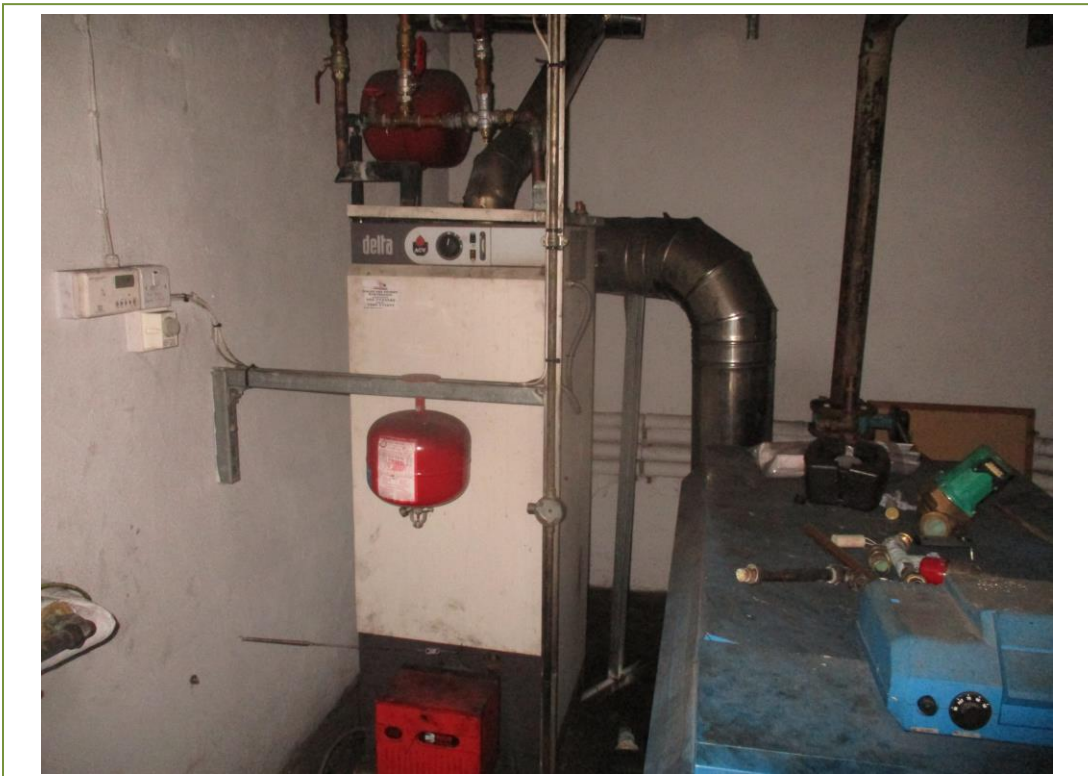
Boiler unit

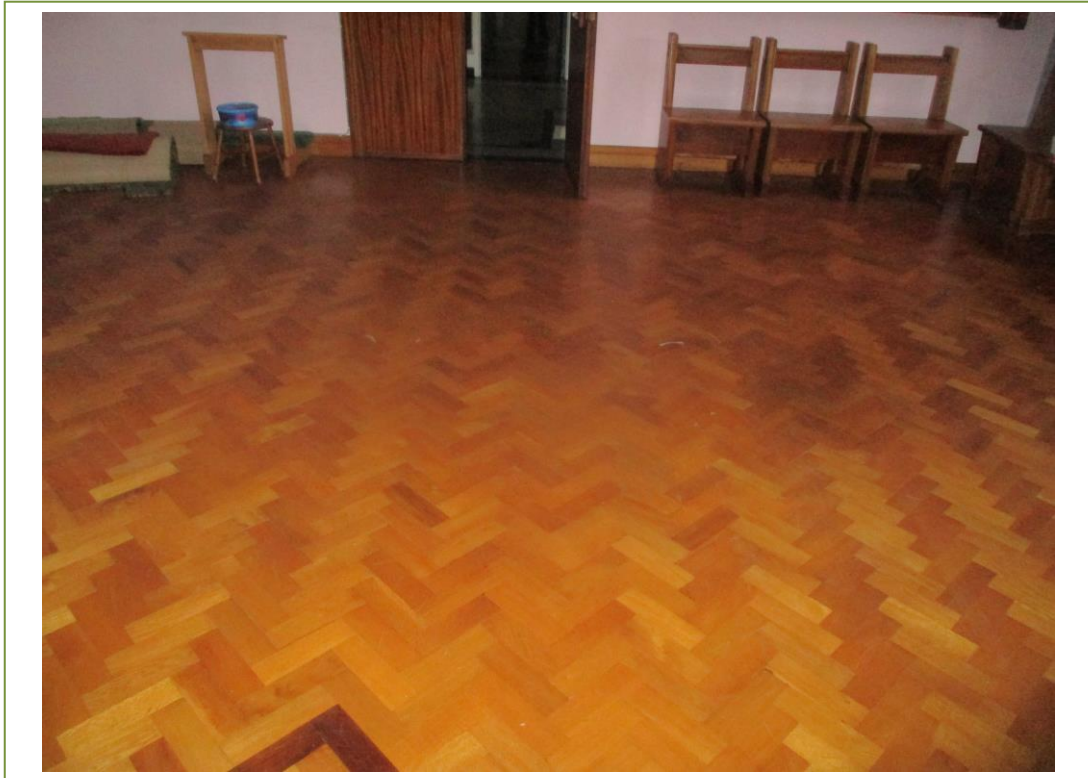
Original Timber floors

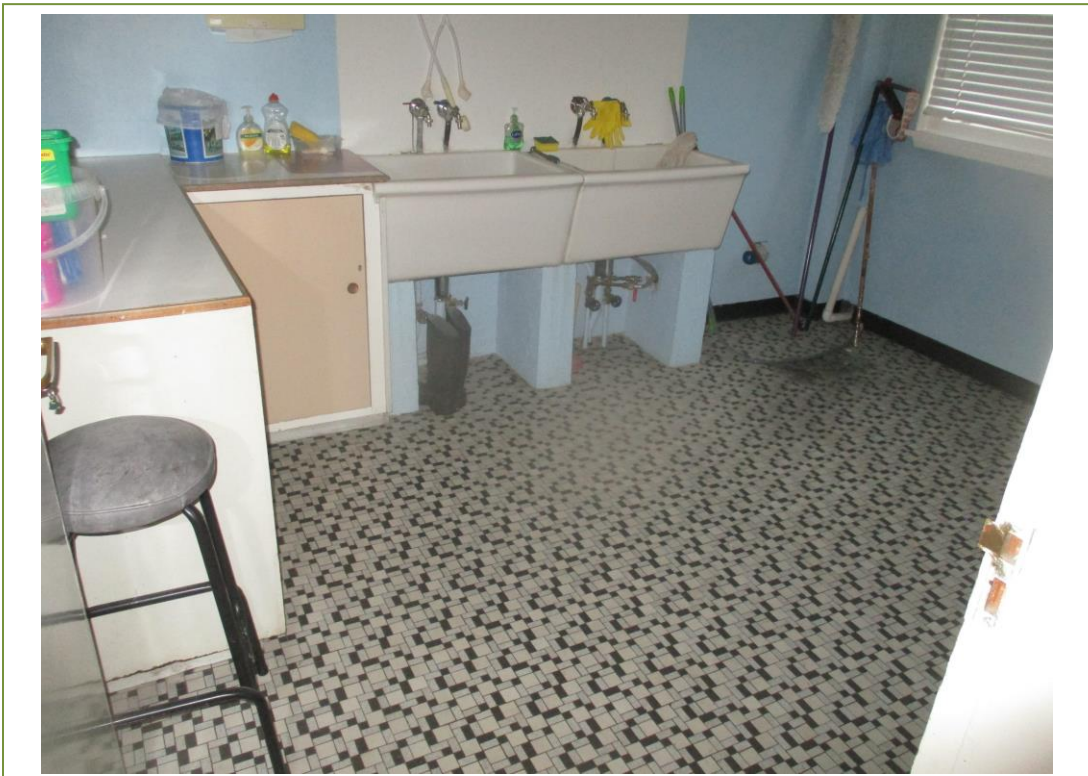
Original Ceramic tiles

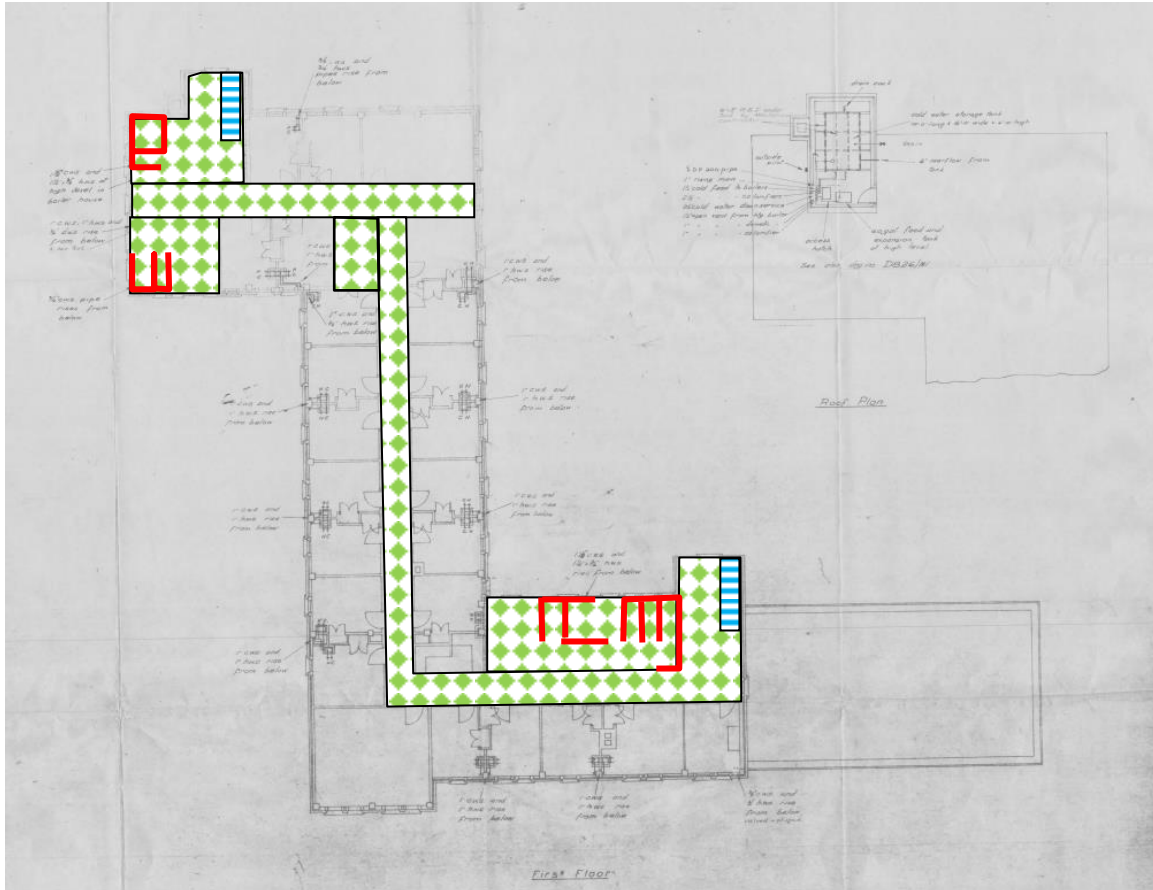
1ST FLOOR PLAN

Area where asbestos containing floor tiles and bitumen adhesive were identified

Area where asbestos containing tiles were identified on the walls in the bathroom areas

Area where asbestos containing step nosings were identified on stairs

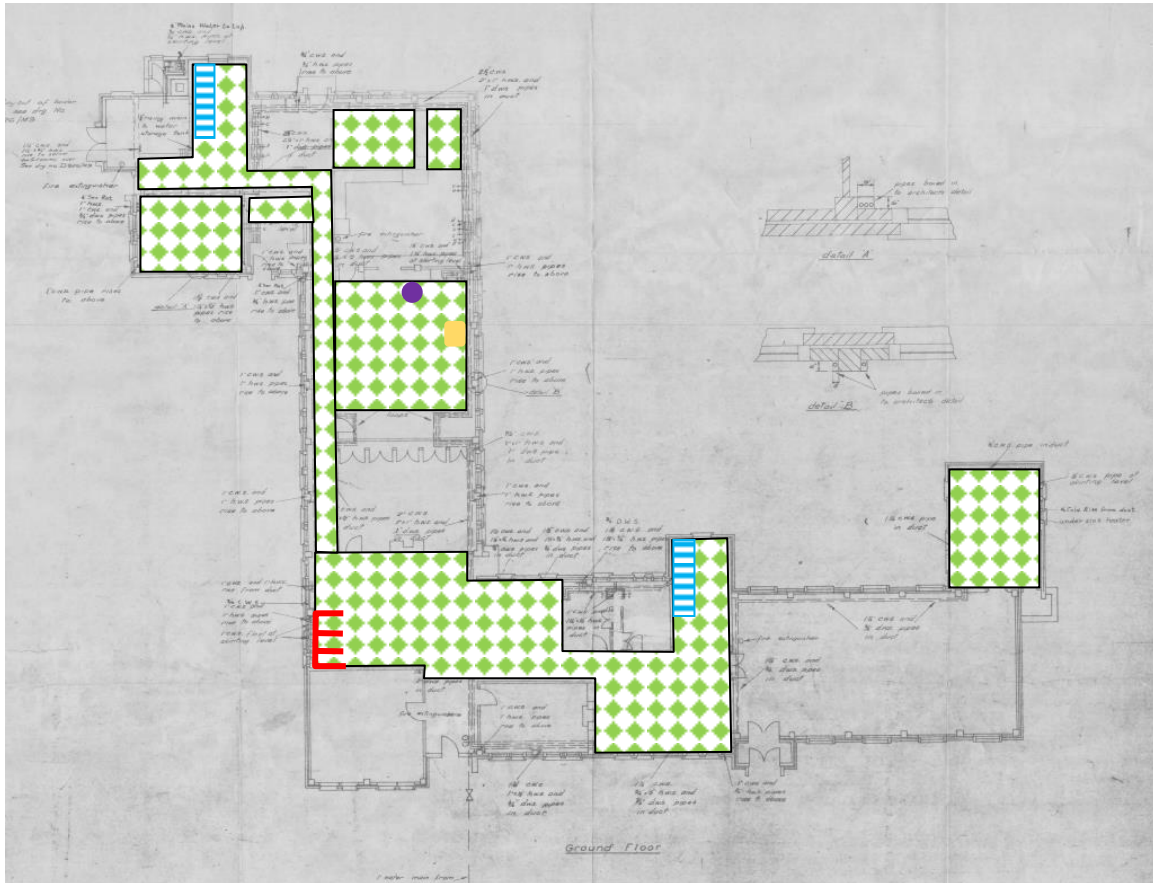
GROUND FLOOR PLAN

Area where asbestos containing floor tile and bitumen adhesive were identified

Area where asbestos containing tile was identified on walls.

Area where asbestos containing cement pipe was identified.

Area where asbestos containing felts pad were identified underneath the sink

Area where asbestos containing resin step nosing were identified on stairway
