# **Asbestos Refurbishment & Demolition Survey (including Sampling and Analysis)**

## ***Carlow County Council***

**Former Bank Premises,  
Court Place,  
Co. Carlow**

Project N <sup>o</sup> and Revision N <sup>o</sup>	Report Status	Surveyor	Report Author	Approved by	Issue Date
A-02110 (Revision 1)	Issued	Daragh Gogarty	Daragh Gogarty

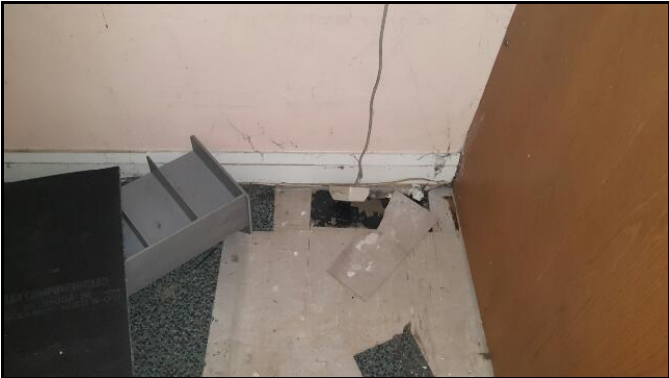
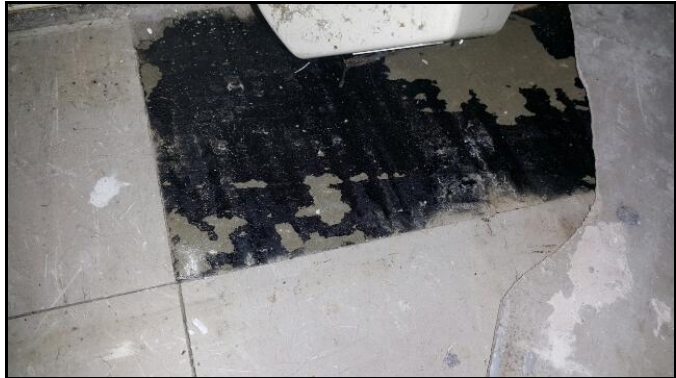
FLOOR:	Ground Floor			SURVEY DATES:	22/02/2021		
ROOM NAME / NO.:	0-002			SAMPLE REF NO.:	S2

PRODUCT TYPE:	Vinyl Floor Tile and Bitumen			ACCESSIBILITY:	Easy		
FOUND IN:	Floor						
LOCATION:	Main Room			EXTENT / QUANTITY:	50 m <sup>2</sup>		
ASBESTOS TYPE	NON ASBESTOS	0		EXTENT OF DAMAGE / DETERIORATION	GOOD CONDITION	0	
	CHRYSTOLE	1	✓		LOW DAMAGE	1	
	AMOSITE	2			MEDIUM DAMAGE	2	
	CROCIDOLITE	3			HIGH DAMAGE	3	✓
	OTHER (ACTINOLITE/TREMOLITE/ANTHOPHYLLITE)	2			LOOSE ASBESTOS	3	
SURFACE TREATMENT	COMPOSITE MATERIAL	0	✓	FIBRE RELEASE POTENTIAL	HIGH RISK	10-12	
	ENCLOSED SPRAY / LAGGING, PAINTED / ENCAPSULATED AIB, ASBESTOS CEMENT SHEETS	1			MEDIUM RISK	7-9	
	UNSEALED AIB OR ENCAPSULATED LAGGING AND SPRAYS	2			LOW RISK	5-6	✓
	UNSEALED LAGGING / SPRAY COATING	3			VERY LOW RISK	1-4	
PRODUCT TYPE	ASBESTOS REINFORCED COMPOSITES	1	✓	RECOMMENDED ACTION	REMOVE		✓
	ASBESTOS INSULATING BOARD, TEXTILES, GASKETS, ROPE, PAPER, FELT	2			REPAIR / SEAL ENCAPSULATE

THERMAL INSULATION, SPRAYED ASBESTOS, LOOSE ASBESTOS	3			LABEL AND MANAGE		
OTHER RELEVANT INFORMATION:							
White tiles and bitumen. Bitumen continues throughout room. Tiles present in various locations. Inspection limited due to furniture.							
All work with asbestos materials must be carried out in accordance with SI No 386 of the Safety, Health & Welfare at Work (Exposure to Asbestos) Regulations 2006 & amended version 2010 & Guidelines issued by the Health & Safety Authority in Ireland. 14 days notification may be required to the HSA. Ensure valid asbestos insurance & evidence of current training & competency is obtained from your selected approved asbestos removal contractor prior to works commencing.

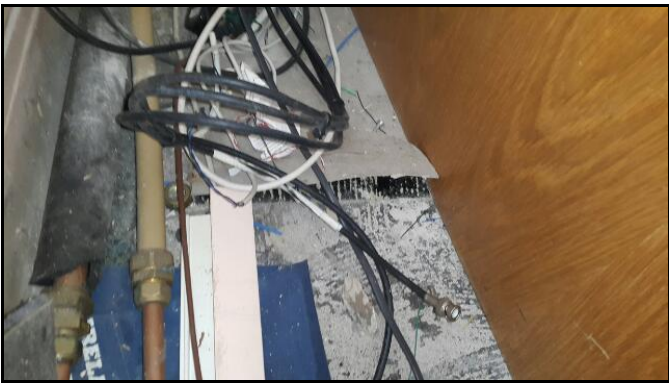
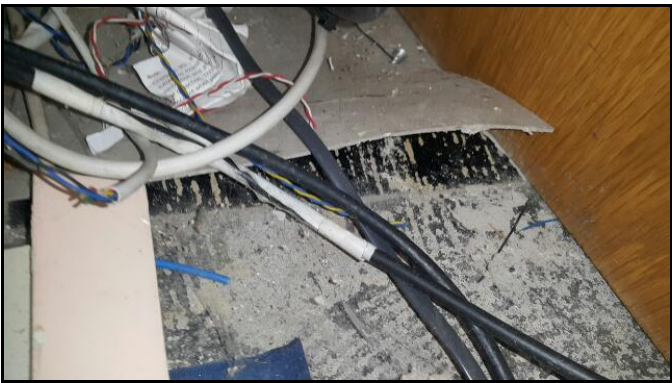
FLOOR:	Ground Floor			SURVEY DATES:	22/02/2021		
ROOM NAME / NO.:	0-003			SAMPLE REF NO.:	Same As S2

PRODUCT TYPE:	Vinyl Floor Tile and Bitumen			ACCESSIBILITY:	Easy		
FOUND IN:	Floor						
LOCATION:	Front Office 1			EXTENT / QUANTITY:	5 m <sup>2</sup>		
ASBESTOS TYPE	NON ASBESTOS	0		EXTENT OF DAMAGE / DETERIORATION	GOOD CONDITION	0	
	CHRYSTOLE	1	✓		LOW DAMAGE	1	
	AMOSITE	2			MEDIUM DAMAGE	2	
	CROCIDOLITE	3			HIGH DAMAGE	3	✓
	OTHER (ACTINOLITE/TREMOLITE/ANTHOPHYLLITE)	2			LOOSE ASBESTOS	3	
SURFACE TREATMENT	COMPOSITE MATERIAL	0	✓	FIBRE RELEASE POTENTIAL	HIGH RISK	10-12	
	ENCLOSED SPRAY / LAGGING, PAINTED / ENCAPSULATED AIB, ASBESTOS CEMENT SHEETS	1			MEDIUM RISK	7-9	
	UNSEALED AIB OR ENCAPSULATED LAGGING AND SPRAYS	2			LOW RISK	5-6	✓
	UNSEALED LAGGING / SPRAY COATING	3			VERY LOW RISK	1-4	
PRODUCT TYPE	ASBESTOS REINFORCED COMPOSITES	1	✓	RECOMMENDED ACTION	REMOVE		✓
	ASBESTOS INSULATING BOARD, TEXTILES, GASKETS, ROPE, PAPER, FELT	2			REPAIR / SEAL ENCAPSULATE

THERMAL INSULATION, SPRAYED ASBESTOS, LOOSE ASBESTOS	3			LABEL AND MANAGE		
<b>OTHER RELEVANT INFORMATION:</b>							
White tiles and bitumen. Bitumen continues throughout room. Tiles present in various locations. Inspection limited due to furniture.							
All work with asbestos materials must be carried out in accordance with SI No 386 of the Safety, Health & Welfare at Work (Exposure to Asbestos) Regulations 2006 & amended version 2010 & Guidelines issued by the Health & Safety Authority in Ireland. 14 days notification may be required to the HSA. Ensure valid asbestos insurance & evidence of current training & competency is obtained from your selected approved asbestos removal contractor prior to works commencing.

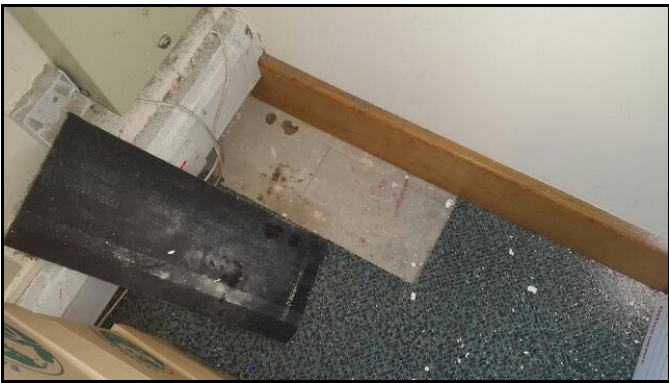
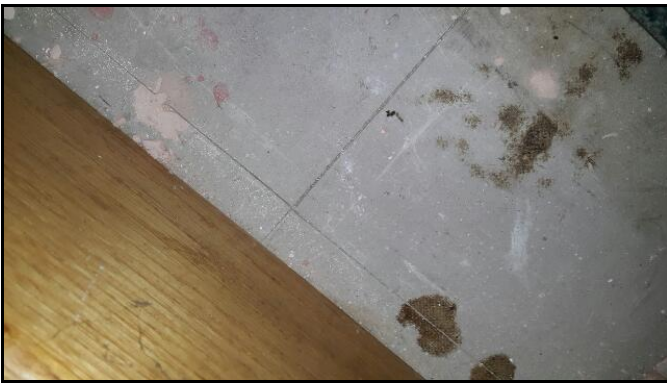
<b>FLOOR:</b>	Ground Floor	<b>SURVEY DATES:</b>	22/02/2021
<b>ROOM NAME / NO.:</b>	0-004	<b>SAMPLE REF NO.:</b>	Same As S2

<b>PRODUCT TYPE:</b>	Vinyl Floor Tile and Bitumen	<b>ACCESSIBILITY:</b>	Easy
<b>FOUND IN:</b>	Floor		
<b>LOCATION:</b>	Office 2	<b>EXTENT / QUANTITY:</b>	8 m <sup>2</sup>
<b>ASBESTOS TYPE</b>	NON ASBESTOS	0	✓
	CHRYSOTILE	1	✓
	AMOSITE	2	
	CROCIDOLITE	3	
	OTHER (ACTINOLITE/TREMOLITE/ANTHOPHYLLITE)	2	
<b>SURFACE TREATMENT</b>	COMPOSITE MATERIAL	0	✓
	ENCLOSED SPRAY / LAGGING, PAINTED / ENCAPSULATED AIB, ASBESTOS CEMENT SHEETS	1	
	UNSEALED AIB OR ENCAPSULATED LAGGING AND SPRAYS	2	
	UNSEALED LAGGING / SPRAY COATING	3	
<b>FIBRE RELEASE POTENTIAL</b>	GOOD CONDITION	0	
	LOW DAMAGE	1	
	MEDIUM DAMAGE	2	
	HIGH DAMAGE	3	✓
<b>RECOMMENDED ACTION</b>	LOOSE ASBESTOS	3	
	HIGH RISK	10-12	
	MEDIUM RISK	7-9	
	LOW RISK	5-6	✓
<b>PRODUCT TYPE</b>	ASBESTOS REINFORCED COMPOSITES	1	✓
	ASBESTOS INSULATING BOARD, TEXTILES, GASKETS, ROPE, PAPER, FELT	2

THERMAL INSULATION, SPRAYED ASBESTOS, LOOSE ASBESTOS	3	
<b>OTHER RELEVANT INFORMATION:</b>			
White tiles and bitumen. Bitumen continues throughout room. Tiles present in various locations. Inspection limited due to furniture.			
All work with asbestos materials must be carried out in accordance with SI No 386 of the Safety, Health & Welfare at Work (Exposure to Asbestos) Regulations 2006 & amended version 2010 & Guidelines issued by the Health & Safety Authority in Ireland. 14 days notification may be required to the HSA. Ensure valid asbestos insurance & evidence of current training & competency is obtained from your selected approved asbestos removal contractor prior to works commencing.

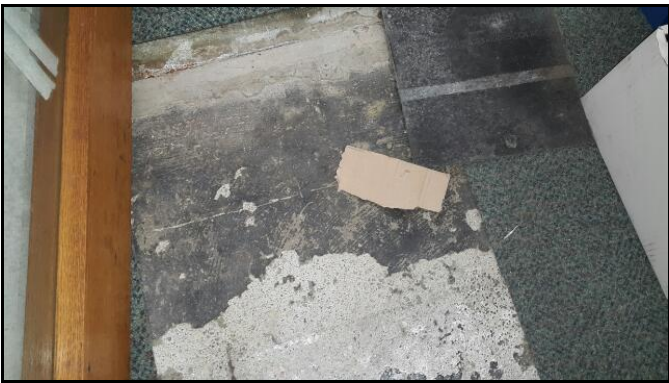
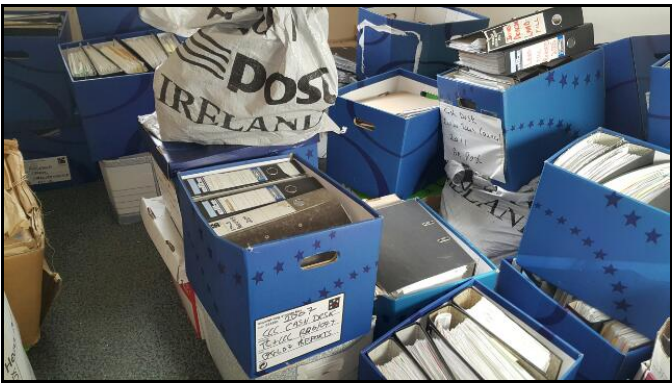
FLOOR:		Ground Floor		SURVEY DATES:		22/02/2021							
ROOM NAME / NO.:		005		SAMPLE REF NO.:		Same As S2

PRODUCT TYPE:		Vinyl Floor Tile and Bitumen		ACCESSIBILITY:		Easy							
FOUND IN:		Floor											
LOCATION:		Office 3		EXTENT / QUANTITY:		8 m <sup>2</sup>							
ASBESTOS TYPE		NON ASBESTOS		0		GOOD CONDITION		0					
		CHRYSOTILE		1		✓		LOW DAMAGE		1			
		AMOSITE		2				MEDIUM DAMAGE		2			
		CROCIDOLITE		3				HIGH DAMAGE		3		✓	
		OTHER (ACTINOLITE/TREMOLITE/ANTHOPHYLLITE)		2				LOOSE ASBESTOS		3			
SURFACE TREATMENT		COMPOSITE MATERIAL		0		✓		HIGH RISK		10-12			
		ENCLOSED SPRAY / LAGGING, PAINTED / ENCAPSULATED AIB, ASBESTOS CEMENT SHEETS		1				MEDIUM RISK		7-9			
		UNSEALED AIB OR ENCAPSULATED LAGGING AND SPRAYS		2				LOW RISK		5-6		✓	
		UNSEALED LAGGING / SPRAY COATING		3				VERY LOW RISK		1-4			
PRODUCT TYPE		ASBESTOS REINFORCED COMPOSITES		1		✓		REMOVE				✓	
		ASBESTOS INSULATING BOARD, TEXTILES, GASKETS, ROPE, PAPER, FELT		2				REPAIR / SEAL ENCAPSULATE

THERMAL INSULATION, SPRAYED ASBESTOS, LOOSE ASBESTOS		3				LABEL AND MANAGE					
OTHER RELEVANT INFORMATION:													
<p>White tiles and bitumen. Bitumen continues throughout room. Tiles present in various locations. Inspection limited due to furniture.</p> <p>All work with asbestos materials must be carried out in accordance with SI No 386 of the Safety, Health &amp; Welfare at Work (Exposure to Asbestos) Regulations 2006 &amp; amended version 2010 &amp; Guidelines issued by the Health &amp; Safety Authority in Ireland. 14 days notification may be required to the HSA. Ensure valid asbestos insurance &amp; evidence of current training &amp; competency is obtained from your selected approved asbestos removal contractor prior to works commencing.</p>

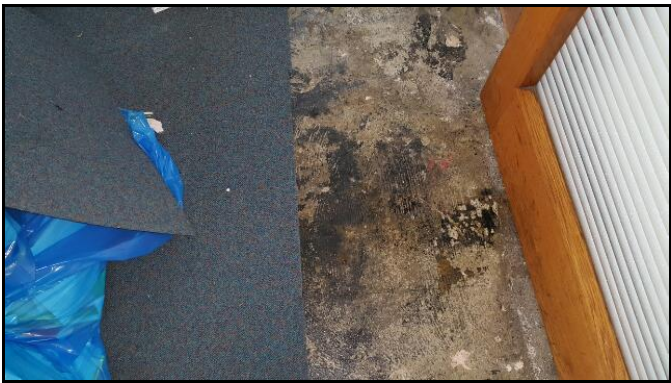
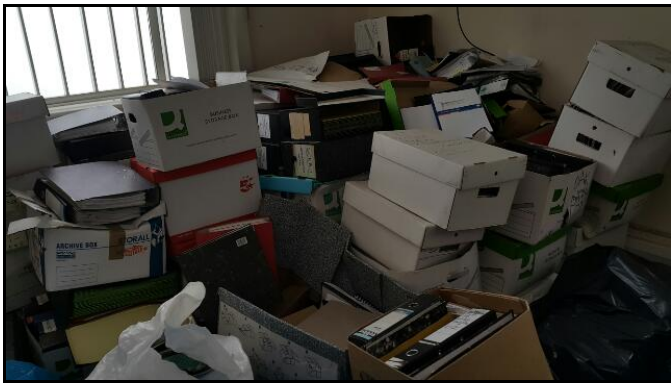
FLOOR:		Ground Floor		SURVEY DATES:		22/02/2021							
ROOM NAME / NO.:		0-007		SAMPLE REF NO.:		Same As S2

PRODUCT TYPE:		Vinyl Floor Tile and Bitumen		ACCESSIBILITY:		Easy							
FOUND IN:		Floor											
LOCATION:		Corner Office 5		EXTENT / QUANTITY:		8 m <sup>2</sup>							
ASBESTOS TYPE		NON ASBESTOS		0		GOOD CONDITION		0					
		CHRYSOTILE		1		✓		LOW DAMAGE		1			
		AMOSITE		2				MEDIUM DAMAGE		2			
		CROCIDOLITE		3				HIGH DAMAGE		3		✓	
		OTHER (ACTINOLITE/TREMOLITE/ANTHOPHYLLITE)		2				LOOSE ASBESTOS		3			
SURFACE TREATMENT		COMPOSITE MATERIAL		0		✓		HIGH RISK		10-12			
		ENCLOSED SPRAY / LAGGING, PAINTED / ENCAPSULATED AIB, ASBESTOS CEMENT SHEETS		1				MEDIUM RISK		7-9			
		UNSEALED AIB OR ENCAPSULATED LAGGING AND SPRAYS		2				LOW RISK		5-6		✓	
		UNSEALED LAGGING / SPRAY COATING		3				VERY LOW RISK		1-4			
PRODUCT TYPE		ASBESTOS REINFORCED COMPOSITES		1		✓		REMOVE				✓

ASBESTOS INSULATING BOARD, TEXTILES, GASKETS, ROPE, PAPER, FELT		2				REPAIR / SEAL ENCAPSULATE					
		THERMAL INSULATION, SPRAYED ASBESTOS, LOOSE ASBESTOS		3				LABEL AND MANAGE					
OTHER RELEVANT INFORMATION:													
<p>White tiles and bitumen. Bitumen continues throughout room. Tiles present in various locations. Inspection limited due to furniture.</p> <p>All work with asbestos materials must be carried out in accordance with SI No 386 of the Safety, Health &amp; Welfare at Work (Exposure to Asbestos) Regulations 2006 &amp; amended version 2010 &amp; Guidelines issued by the Health &amp; Safety Authority in Ireland. 14 days notification may be required to the HSA. Ensure valid asbestos insurance &amp; evidence of current training &amp; competency is obtained from your selected approved asbestos removal contractor prior to works commencing.</p>

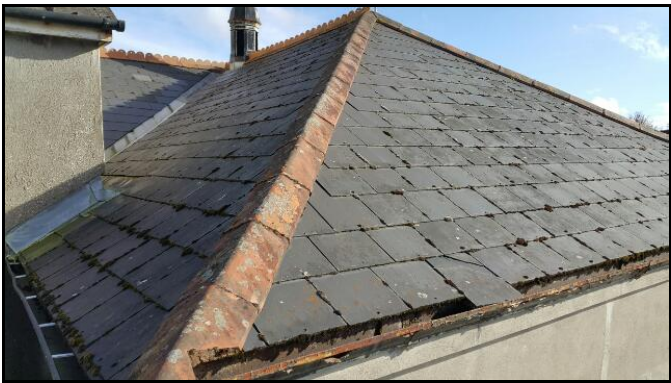
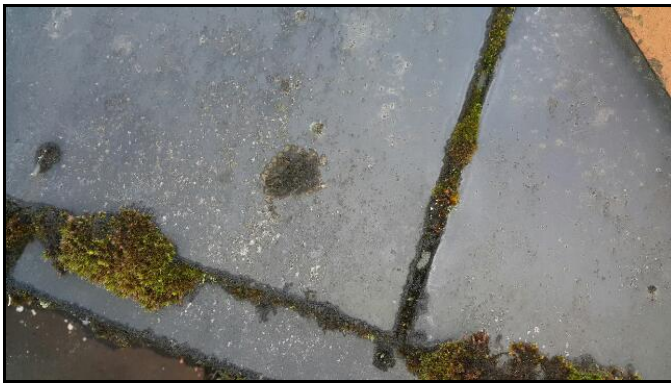
FLOOR:	External	SURVEY DATES:	22/02/2021				
ROOM NAME / NO.:	99-001	SAMPLE REF NO.:	S4

PRODUCT TYPE:	Cement Slate	ACCESSIBILITY:	Difficult				
FOUND IN:	Roof						
LOCATION:	Roof	EXTENT / QUANTITY:	100 m <sup>2</sup>				
ASBESTOS TYPE	NON ASBESTOS	0		EXTENT OF DAMAGE / DETERIORATION	GOOD CONDITION	0	
	CHRYSOTILE	1	✓		LOW DAMAGE	1	
	AMOSITE	2			MEDIUM DAMAGE	2	✓
	CROCIDOLITE	3			HIGH DAMAGE	3	
	OTHER (ACTINOLITE/TREMOLITE/ANTHOPHYLLITE)	2			LOOSE ASBESTOS	3	
SURFACE TREATMENT	COMPOSITE MATERIAL	0		FIBRE RELEASE POTENTIAL	HIGH RISK	10-12	
	ENCLOSED SPRAY / LAGGING, PAINTED / ENCAPSULATED AIB, ASBESTOS CEMENT SHEETS	1	✓		MEDIUM RISK	7-9	
	UNSEALED AIB OR ENCAPSULATED LAGGING AND SPRAYS	2			LOW RISK	5-6	✓
	UNSEALED LAGGING / SPRAY COATING	3			VERY LOW RISK	1-4	
PRODUCT TYPE	ASBESTOS REINFORCED COMPOSITES	1	✓	RECOMMENDED ACTION	REMOVE		✓
	ASBESTOS INSULATING BOARD, TEXTILES, GASKETS, ROPE, PAPER, FELT	2			REPAIR / SEAL ENCAPSULATE

THERMAL INSULATION, SPRAYED ASBESTOS, LOOSE ASBESTOS	3			LABEL AND MANAGE		
<b>OTHER RELEVANT INFORMATION:</b>							
Slates to original roofs.							
All work with asbestos materials must be carried out in accordance with SI No 386 of the Safety, Health & Welfare at Work (Exposure to Asbestos) Regulations 2006 & amended version 2010 & Guidelines issued by the Health & Safety Authority in Ireland. 14 days notification may be required to the HSA. Ensure valid asbestos insurance & evidence of current training & competency is obtained from your selected approved asbestos removal contractor prior to works commencing.

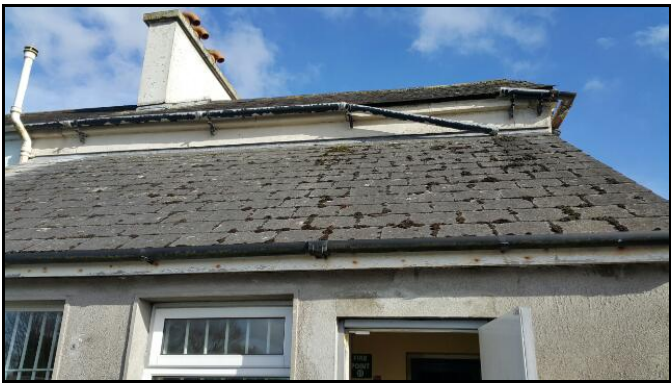
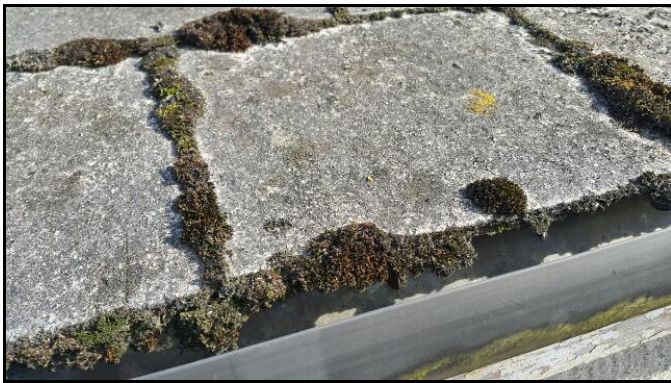
FLOOR:	External	SURVEY DATES:	22/02/2021				
ROOM NAME / NO.:	99-001	SAMPLE REF NO.:	S5

PRODUCT TYPE:	Cement Slate	ACCESSIBILITY:	Difficult				
FOUND IN:	Roof						
LOCATION:	Roof	EXTENT / QUANTITY:	30 m <sup>2</sup>				
ASBESTOS TYPE	NON ASBESTOS	0		EXTENT OF DAMAGE / DETERIORATION	GOOD CONDITION	0	
	CHRYSOTILE	1	✓		LOW DAMAGE	1	
	AMOSITE	2			MEDIUM DAMAGE	2	✓
	CROCIDOLITE	3			HIGH DAMAGE	3	
	OTHER (ACTINOLITE/TREMOLITE/ANTHOPHYLLITE)	2			LOOSE ASBESTOS	3	
SURFACE TREATMENT	COMPOSITE MATERIAL	0		FIBRE RELEASE POTENTIAL	HIGH RISK	10-12	
	ENCLOSED SPRAY / LAGGING, PAINTED / ENCAPSULATED AIB, ASBESTOS CEMENT SHEETS	1	✓		MEDIUM RISK	7-9	
	UNSEALED AIB OR ENCAPSULATED LAGGING AND SPRAYS	2			LOW RISK	5-6	✓
	UNSEALED LAGGING / SPRAY COATING	3			VERY LOW RISK	1-4	
PRODUCT TYPE	ASBESTOS REINFORCED COMPOSITES	1	✓	RECOMMENDED ACTION	REMOVE		✓
	ASBESTOS INSULATING BOARD, TEXTILES, GASKETS, ROPE, PAPER, FELT	2			REPAIR / SEAL ENCAPSULATE

THERMAL INSULATION, SPRAYED ASBESTOS, LOOSE ASBESTOS	3			LABEL AND MANAGE		
OTHER RELEVANT INFORMATION:							
Slates to Kitchen roof.							
All work with asbestos materials must be carried out in accordance with SI No 386 of the Safety, Health & Welfare at Work (Exposure to Asbestos) Regulations 2006 & amended version 2010 & Guidelines issued by the Health & Safety Authority in Ireland. 14 days notification may be required to the HSA. Ensure valid asbestos insurance & evidence of current training & competency is obtained from your selected approved asbestos removal contractor prior to works commencing.

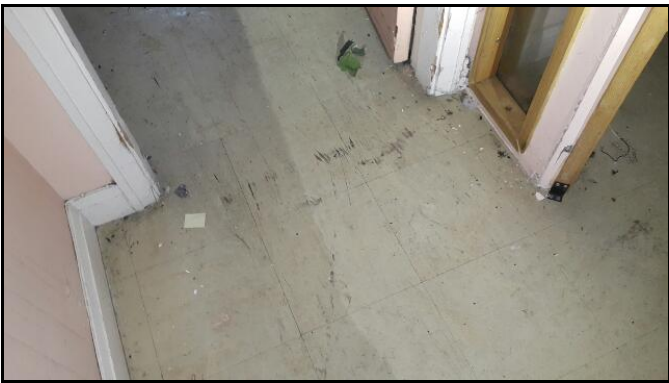
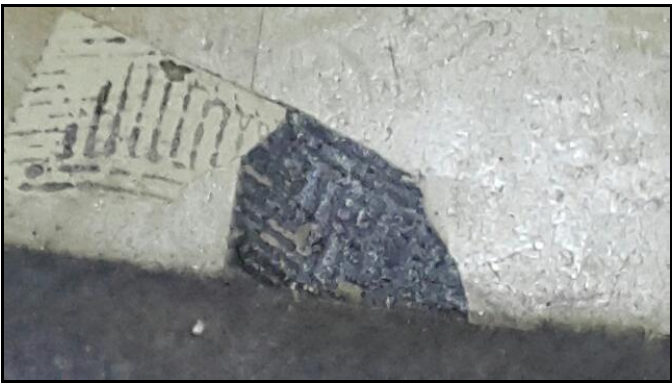
FLOOR:	Ground Floor			SURVEY DATES:	22/02/2021		
ROOM NAME / NO.:	0-016			SAMPLE REF NO.:	S7

PRODUCT TYPE:	Vinyl Floor Tile and Bitumen			ACCESSIBILITY:	Easy		
FOUND IN:	Floor						
LOCATION:	Side Entrance & Linked Corridors			EXTENT / QUANTITY:	10 m <sup>2</sup>		
ASBESTOS TYPE	NON ASBESTOS	0		EXTENT OF DAMAGE / DETERIORATION	GOOD CONDITION	0	
	CHRYSOTILE	1	✓		LOW DAMAGE	1	
	AMOSITE	2			MEDIUM DAMAGE	2	
	CROCIDOLITE	3			HIGH DAMAGE	3	✓
	OTHER (ACTINOLITE/TREMOLITE/ANTHOPHYLLITE)	2			LOOSE ASBESTOS	3	
SURFACE TREATMENT	COMPOSITE MATERIAL	0	✓	FIBRE RELEASE POTENTIAL	HIGH RISK	10-12	
	ENCLOSED SPRAY / LAGGING, PAINTED / ENCAPSULATED AIB, ASBESTOS CEMENT SHEETS	1			MEDIUM RISK	7-9	
	UNSEALED AIB OR ENCAPSULATED LAGGING AND SPRAYS	2			LOW RISK	5-6	✓
	UNSEALED LAGGING / SPRAY COATING	3			VERY LOW RISK	1-4	
PRODUCT TYPE	ASBESTOS REINFORCED COMPOSITES	1	✓	RECOMMENDED ACTION	REMOVE		✓
	ASBESTOS INSULATING BOARD, TEXTILES, GASKETS, ROPE, PAPER, FELT	2			REPAIR / SEAL ENCAPSULATE

THERMAL INSULATION, SPRAYED ASBESTOS, LOOSE ASBESTOS	3			LABEL AND MANAGE		
<b>OTHER RELEVANT INFORMATION:</b>							
Cream vinyl floor tiles and bitumen adhesive.							
All work with asbestos materials must be carried out in accordance with SI No 386 of the Safety, Health & Welfare at Work (Exposure to Asbestos) Regulations 2006 & amended version 2010 & Guidelines issued by the Health & Safety Authority in Ireland. 14 days notification may be required to the HSA. Ensure valid asbestos insurance & evidence of current training & competency is obtained from your selected approved asbestos removal contractor prior to works commencing.

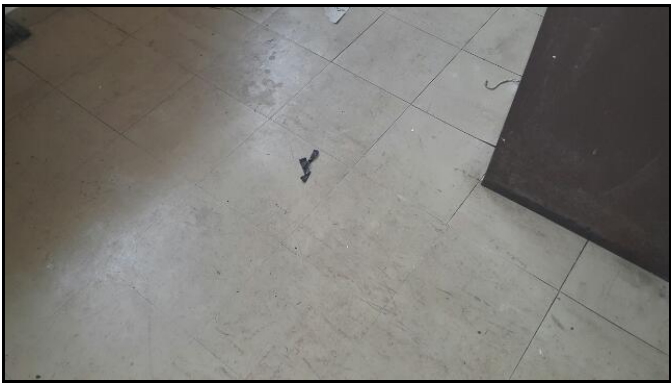
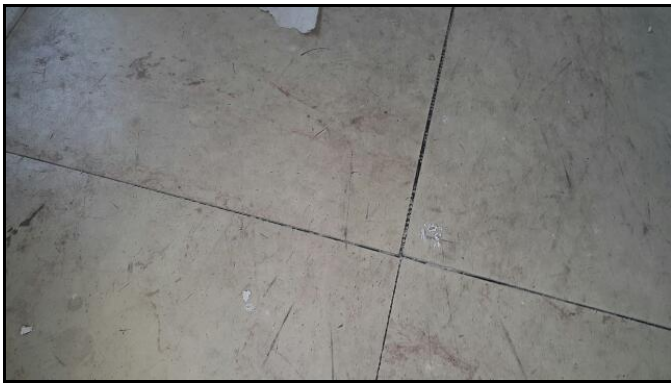
FLOOR:	Ground Floor			SURVEY DATES:	22/02/2021		
ROOM NAME / NO.:	0-018			SAMPLE REF NO.:	Same As S7

PRODUCT TYPE:	Vinyl Floor Tile and Bitumen			ACCESSIBILITY:	Easy		
FOUND IN:	Floor						
LOCATION:	Toilet			EXTENT / QUANTITY:	8 m <sup>2</sup>		
ASBESTOS TYPE	NON ASBESTOS	0		EXTENT OF DAMAGE / DETERIORATION	GOOD CONDITION	0	
	CHRYSOTILE	1	✓		LOW DAMAGE	1	
	AMOSITE	2			MEDIUM DAMAGE	2	
	CROCIDOLITE	3			HIGH DAMAGE	3	✓
	OTHER (ACTINOLITE/TREMOLITE/ANTHOPHYLLITE)	2			LOOSE ASBESTOS	3	
SURFACE TREATMENT	COMPOSITE MATERIAL	0	✓	FIBRE RELEASE POTENTIAL	HIGH RISK	10-12	
	ENCLOSED SPRAY / LAGGING, PAINTED / ENCAPSULATED AIB, ASBESTOS CEMENT SHEETS	1			MEDIUM RISK	7-9	
	UNSEALED AIB OR ENCAPSULATED LAGGING AND SPRAYS	2			LOW RISK	5-6	✓
	UNSEALED LAGGING / SPRAY COATING	3			VERY LOW RISK	1-4	
PRODUCT TYPE	ASBESTOS REINFORCED COMPOSITES	1	✓	RECOMMENDED ACTION	REMOVE		✓
	ASBESTOS INSULATING BOARD, TEXTILES, GASKETS, ROPE, PAPER, FELT	2			REPAIR / SEAL ENCAPSULATE

THERMAL INSULATION, SPRAYED ASBESTOS, LOOSE ASBESTOS	3			LABEL AND MANAGE		
<b>OTHER RELEVANT INFORMATION:</b>							
Cream vinyl floor tiles and bitumen adhesive.							
All work with asbestos materials must be carried out in accordance with SI No 386 of the Safety, Health & Welfare at Work (Exposure to Asbestos) Regulations 2006 & amended version 2010 & Guidelines issued by the Health & Safety Authority in Ireland. 14 days notification may be required to the HSA. Ensure valid asbestos insurance & evidence of current training & competency is obtained from your selected approved asbestos removal contractor prior to works commencing.

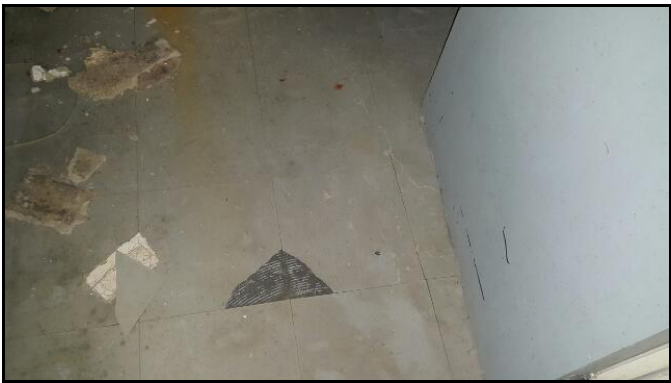
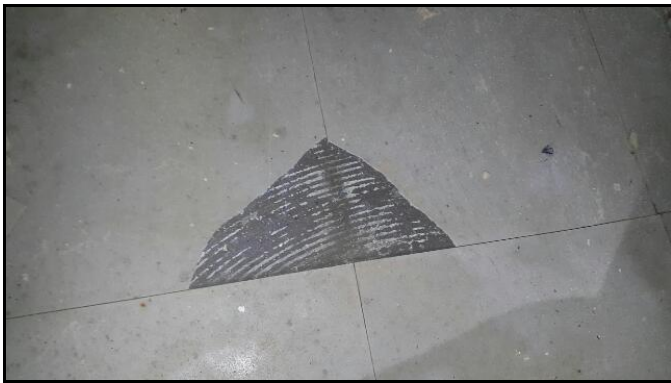
FLOOR:	Ground Floor			SURVEY DATES:	22/02/2021		
ROOM NAME / NO.:	0-022			SAMPLE REF NO.:	Same As S7

PRODUCT TYPE:	Vinyl Floor Tile and Bitumen			ACCESSIBILITY:	Easy		
FOUND IN:	Floor						
LOCATION:	Store			EXTENT / QUANTITY:	5 m <sup>2</sup>		
ASBESTOS TYPE	NON ASBESTOS	0		EXTENT OF DAMAGE / DETERIORATION	GOOD CONDITION	0	
	CHRYSOTILE	1	✓		LOW DAMAGE	1	
	AMOSITE	2			MEDIUM DAMAGE	2	
	CROCIDOLITE	3			HIGH DAMAGE	3	✓
	OTHER (ACTINOLITE/TREMOLITE/ANTHOPHYLLITE)	2			LOOSE ASBESTOS	3	
SURFACE TREATMENT	COMPOSITE MATERIAL	0	✓	FIBRE RELEASE POTENTIAL	HIGH RISK	10-12	
	ENCLOSED SPRAY / LAGGING, PAINTED / ENCAPSULATED AIB, ASBESTOS CEMENT SHEETS	1			MEDIUM RISK	7-9	
	UNSEALED AIB OR ENCAPSULATED LAGGING AND SPRAYS	2			LOW RISK	5-6	✓
	UNSEALED LAGGING / SPRAY COATING	3			VERY LOW RISK	1-4	
PRODUCT TYPE	ASBESTOS REINFORCED COMPOSITES	1	✓	RECOMMENDED ACTION	REMOVE		✓
	ASBESTOS INSULATING BOARD, TEXTILES, GASKETS, ROPE, PAPER, FELT	2			REPAIR / SEAL ENCAPSULATE

THERMAL INSULATION, SPRAYED ASBESTOS, LOOSE ASBESTOS	3			LABEL AND MANAGE		
OTHER RELEVANT INFORMATION:							
Cream vinyl floor tiles and bitumen adhesive.							
All work with asbestos materials must be carried out in accordance with SI No 386 of the Safety, Health & Welfare at Work (Exposure to Asbestos) Regulations 2006 & amended version 2010 & Guidelines issued by the Health & Safety Authority in Ireland. 14 days notification may be required to the HSA. Ensure valid asbestos insurance & evidence of current training & competency is obtained from your selected approved asbestos removal contractor prior to works commencing.

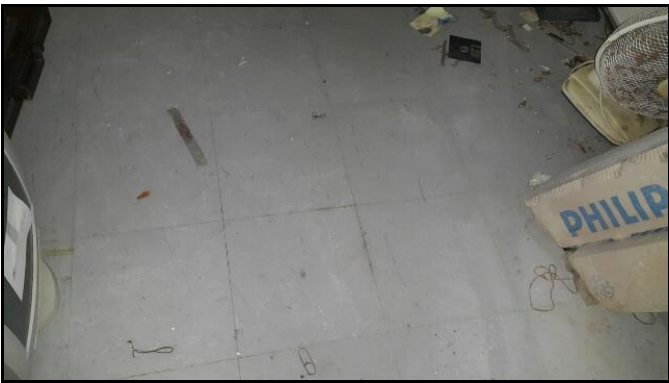
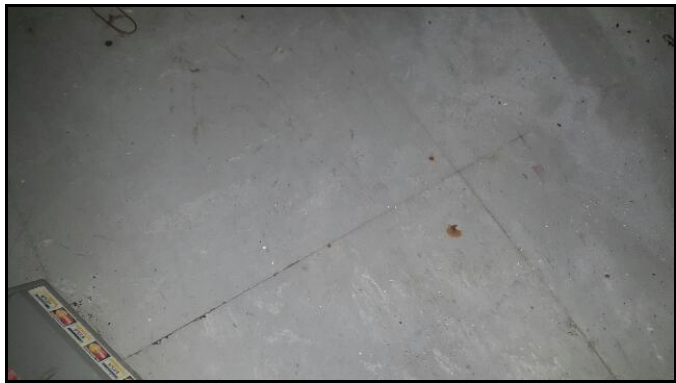
<b>FLOOR:</b>	Ground Floor	<b>SURVEY DATES:</b>	22/02/2021		
<b>ROOM NAME / NO.:</b>	0-027	<b>SAMPLE REF NO.:</b>	Same As S7

<b>PRODUCT TYPE:</b>	Vinyl Floor Tile and Bitumen		<b>ACCESSIBILITY:</b>	Easy	
<b>FOUND IN:</b>	Floor				
<b>LOCATION:</b>	Store		<b>EXTENT / QUANTITY:</b>	5 m <sup>2</sup>	
<b>ASBESTOS TYPE</b>	NON ASBESTOS	0	<b>EXTENT OF DAMAGE / DETERIORATION</b>	GOOD CONDITION	0
	CHRYSOTILE	1		LOW DAMAGE	1
	AMOSITE	2		MEDIUM DAMAGE	2
	CROCIDOLITE	3		HIGH DAMAGE	3
	OTHER (ACTINOLITE/TREMOLITE/ANTHOPHYLLITE)	2		LOOSE ASBESTOS	3
<b>SURFACE TREATMENT</b>	COMPOSITE MATERIAL	0	<b>FIBRE RELEASE POTENTIAL</b>	HIGH RISK	10-12
	ENCLOSED SPRAY / LAGGING, PAINTED / ENCAPSULATED AIB, ASBESTOS CEMENT SHEETS	1		MEDIUM RISK	7-9
	UNSEALED AIB OR ENCAPSULATED LAGGING AND SPRAYS	2		LOW RISK	5-6
	UNSEALED LAGGING / SPRAY COATING	3		VERY LOW RISK	1-4
<b>PRODUCT TYPE</b>	ASBESTOS REINFORCED COMPOSITES	1	<b>RECOMMENDED ACTION</b>	REMOVE	✓

ASBESTOS INSULATING BOARD, TEXTILES, GASKETS, ROPE, PAPER, FELT	2		REPAIR / SEAL ENCAPSULATE	
	THERMAL INSULATION, SPRAYED ASBESTOS, LOOSE ASBESTOS	3		LABEL AND MANAGE	
<b>OTHER RELEVANT INFORMATION:</b>					
Cream vinyl floor tiles and bitumen adhesive.					
All work with asbestos materials must be carried out in accordance with SI No 386 of the Safety, Health & Welfare at Work (Exposure to Asbestos) Regulations 2006 & amended version 2010 & Guidelines issued by the Health & Safety Authority in Ireland. 14 days notification may be required to the HSA. Ensure valid asbestos insurance & evidence of current training & competency is obtained from your selected approved asbestos removal contractor prior to works commencing.

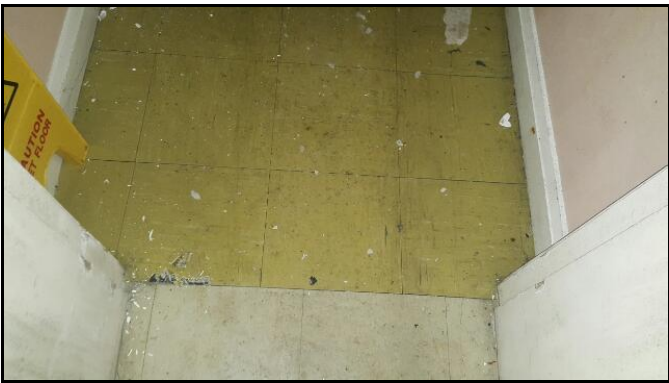
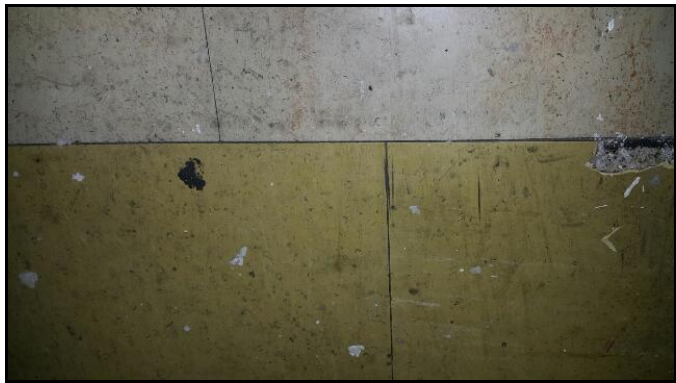
<b>FLOOR:</b>	Ground Floor	<b>SURVEY DATES:</b>	22/02/2021			
<b>ROOM NAME / NO.:</b>	0-016	<b>SAMPLE REF NO.:</b>	S9

<b>PRODUCT TYPE:</b>	Vinyl Floor Tile and Bitumen		<b>ACCESSIBILITY:</b>	Easy		
<b>FOUND IN:</b>	Floor					
<b>LOCATION:</b>	Side Entrance & Linked Corridors		<b>EXTENT / QUANTITY:</b>	5 m <sup>2</sup>		
<b>ASBESTOS TYPE</b>	NON ASBESTOS	0		GOOD CONDITION	0	
	CHRYSOTILE	1	✓	LOW DAMAGE	1	
	AMOSITE	2		MEDIUM DAMAGE	2	
	CROCIDOLITE	3		HIGH DAMAGE	3	✓
	OTHER (ACTINOLITE/TREMOLITE/ANTHOPHYLLITE)	2		LOOSE ASBESTOS	3	
<b>SURFACE TREATMENT</b>	COMPOSITE MATERIAL	0	✓	HIGH RISK	10-12	
	ENCLOSED SPRAY / LAGGING, PAINTED / ENCAPSULATED AIB, ASBESTOS CEMENT SHEETS	1		MEDIUM RISK	7-9	
	UNSEALED AIB OR ENCAPSULATED LAGGING AND SPRAYS	2		LOW RISK	5-6	✓
	UNSEALED LAGGING / SPRAY COATING	3		VERY LOW RISK	1-4	
<b>PRODUCT TYPE</b>	ASBESTOS REINFORCED COMPOSITES	1	✓	REMOVE		✓
	ASBESTOS INSULATING BOARD, TEXTILES, GASKETS, ROPE, PAPER, FELT	2		REPAIR / SEAL ENCAPSULATE

THERMAL INSULATION, SPRAYED ASBESTOS, LOOSE ASBESTOS	3		LABEL AND MANAGE		
<b>OTHER RELEVANT INFORMATION:</b>						
Brown vinyl floor tiles and bitumen adhesive.						
All work with asbestos materials must be carried out in accordance with SI No 386 of the Safety, Health & Welfare at Work (Exposure to Asbestos) Regulations 2006 & amended version 2010 & Guidelines issued by the Health & Safety Authority in Ireland. 14 days notification may be required to the HSA. Ensure valid asbestos insurance & evidence of current training & competency is obtained from your selected approved asbestos removal contractor prior to works commencing.

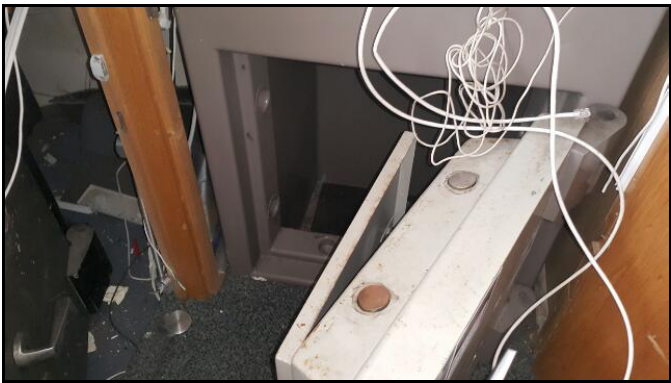
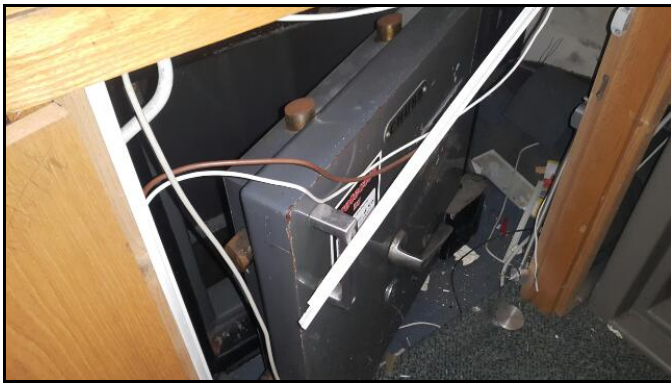
FLOOR:	Ground Floor			SURVEY DATES:	22/02/2021		
ROOM NAME / NO.:	0-002			SAMPLE REF NO.:	Presumed

PRODUCT TYPE:	Board			ACCESSIBILITY:	Difficult		
FOUND IN:	Safe						
LOCATION:	Main Room			EXTENT / QUANTITY:	2 no		
ASBESTOS TYPE	NON ASBESTOS	0		EXTENT OF DAMAGE / DETERIORATION	GOOD CONDITION	0	
	CHRYSOTILE	1	✓		LOW DAMAGE	1	✓
	AMOSITE	2	✓		MEDIUM DAMAGE	2	
	CROCIDOLITE	3			HIGH DAMAGE	3	
	OTHER (ACTINOLITE/TREMOLITE/ANTHOPHYLLITE)	2			LOOSE ASBESTOS	3	
SURFACE TREATMENT	COMPOSITE MATERIAL	0		FIBRE RELEASE POTENTIAL	HIGH RISK	10-12	
	ENCLOSED SPRAY / LAGGING, PAINTED / ENCAPSULATED AIB, ASBESTOS CEMENT SHEETS	1	✓		MEDIUM RISK	7-9	
	UNSEALED AIB OR ENCAPSULATED LAGGING AND SPRAYS	2			LOW RISK	5-6	✓
	UNSEALED LAGGING / SPRAY COATING	3			VERY LOW RISK	1-4	
PRODUCT TYPE	ASBESTOS REINFORCED COMPOSITES	1		RECOMMENDED ACTION	REMOVE if affected by refurbishment works		✓
	ASBESTOS INSULATING BOARD, TEXTILES, GASKETS, ROPE, PAPER, FELT	2	✓		LABEL AND MANAGE		✓

THERMAL INSULATION, SPRAYED ASBESTOS, LOOSE ASBESTOS	3			Investigate further		✓
<b>OTHER RELEVANT INFORMATION:</b>							
No access to doors of safe, presumed to contain insulation board.							
All work with asbestos materials must be carried out in accordance with SI No 386 of the Safety, Health & Welfare at Work (Exposure to Asbestos) Regulations 2006 & amended version 2010 & Guidelines issued by the Health & Safety Authority in Ireland. 14 days notification may be required to the HSA. Ensure valid asbestos insurance & evidence of current training & competency is obtained from your selected approved asbestos removal contractor prior to works commencing.

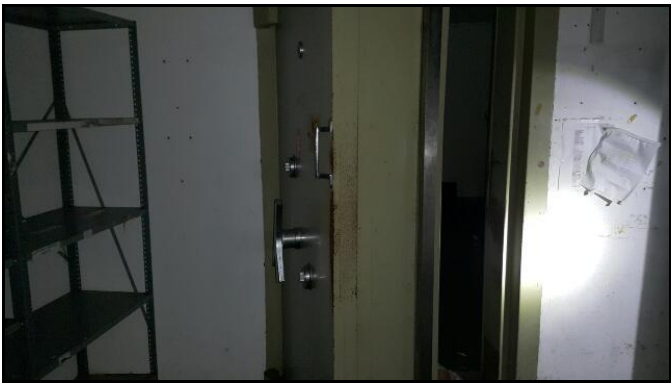
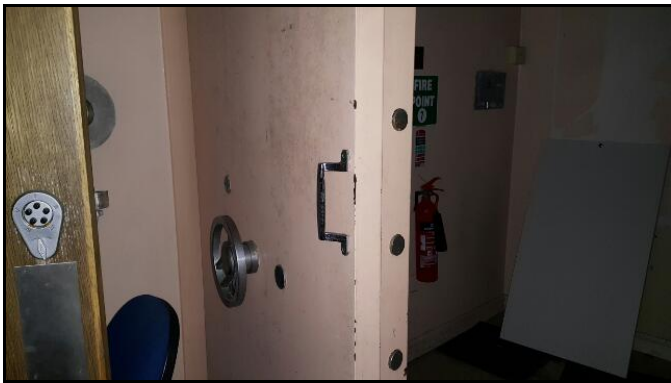
FLOOR:		Ground Floor		SURVEY DATES:		22/02/2021							
ROOM NAME / NO.:		0-017		SAMPLE REF NO.:		Presumed

PRODUCT TYPE:		Board		ACCESSIBILITY:		Difficult							
FOUND IN:		Doors											
LOCATION:		Safe Rooms		EXTENT / QUANTITY:		2							
ASBESTOS TYPE		NON ASBESTOS		0		GOOD CONDITION		0					
		CHRYSOTILE		1		✓		LOW DAMAGE		1		✓	
		AMOSITE		2		✓		MEDIUM DAMAGE		2			
		CROCIDOLITE		3				HIGH DAMAGE		3			
		OTHER (ACTINOLITE/TREMOLITE/ANTHOPHYLLITE)		2				LOOSE ASBESTOS		3			
SURFACE TREATMENT		COMPOSITE MATERIAL		0				HIGH RISK		10-12			
		ENCLOSED SPRAY / LAGGING, PAINTED / ENCAPSULATED AIB, ASBESTOS CEMENT SHEETS		1		✓		MEDIUM RISK		7-9			
		UNSEALED AIB OR ENCAPSULATED LAGGING AND SPRAYS		2				LOW RISK		5-6		✓	
		UNSEALED LAGGING / SPRAY COATING		3				VERY LOW RISK		1-4			
PRODUCT TYPE		ASBESTOS REINFORCED COMPOSITES		1				REMOVE if affected by refurbishment works				✓	
		ASBESTOS INSULATING BOARD, TEXTILES, GASKETS, ROPE, PAPER, FELT		2		✓		LABEL AND MANAGE				✓

THERMAL INSULATION, SPRAYED ASBESTOS, LOOSE ASBESTOS		3				Investigate further				✓	
OTHER RELEVANT INFORMATION:													
No access to internal of door, presumed to contain insulating board.													
All work with asbestos materials must be carried out in accordance with SI No 386 of the Safety, Health & Welfare at Work (Exposure to Asbestos) Regulations 2006 & amended version 2010 & Guidelines issued by the Health & Safety Authority in Ireland. 14 days notification may be required to the HSA. Ensure valid asbestos insurance & evidence of current training & competency is obtained from your selected approved asbestos removal contractor prior to works commencing.

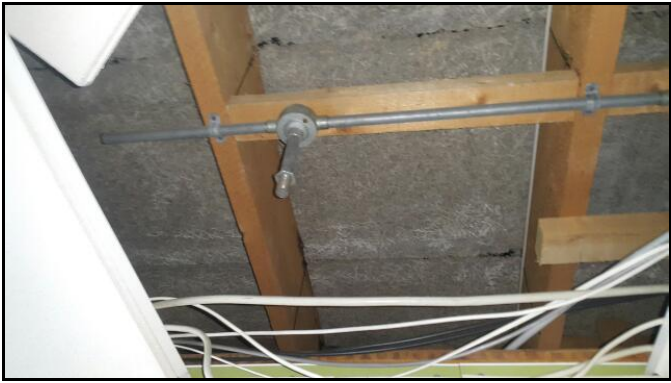
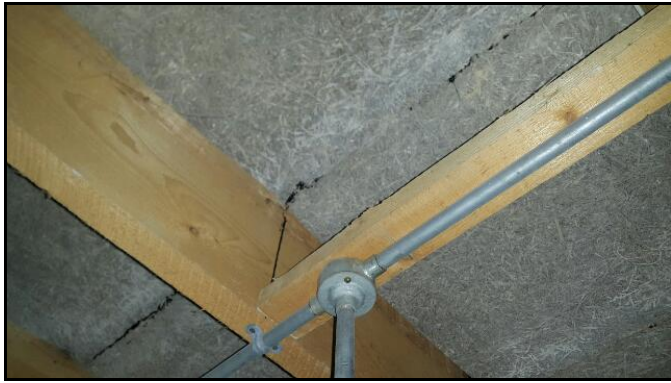
<b>FLOOR:</b>	Ground Floor	<b>SURVEY DATES:</b>	22/02/2021
<b>ROOM NAME / NO.:</b>	0-002	<b>SAMPLE REF NO.:</b>	S11

<b>PRODUCT TYPE:</b>	Bituminous Product	<b>ACCESSIBILITY:</b>	Difficult
<b>FOUND IN:</b>	Ceiling		
<b>LOCATION:</b>	Main Room	<b>EXTENT / QUANTITY:</b>	80 m <sup>2</sup>
Comments: <b>NO ASBESTOS DETECTED IN ORIGINAL SAMPLE</b>

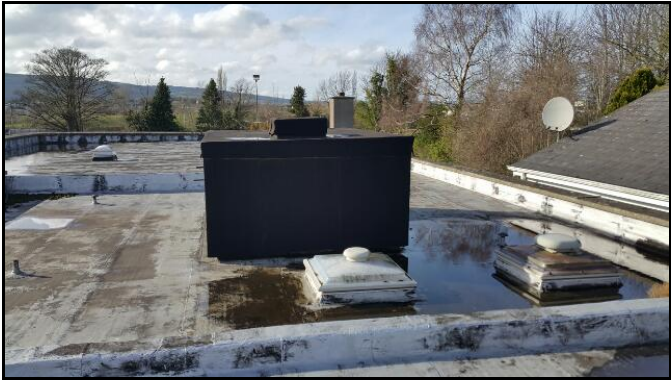
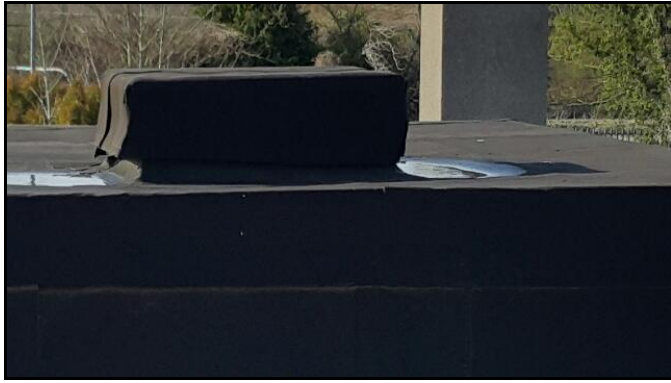
<b>FLOOR:</b>	External	<b>SURVEY DATES:</b>	22/02/2021
<b>ROOM NAME / NO.:</b>	99-001	<b>SAMPLE REF NO.:</b>	S6

<b>PRODUCT TYPE:</b>	Bituminous Product	<b>ACCESSIBILITY:</b>	Difficult
<b>FOUND IN:</b>	Roof		
<b>LOCATION:</b>	Roof	<b>EXTENT / QUANTITY:</b>	30 m <sup>2</sup>
Comments: <b>NO ASBESTOS DETECTED IN ORIGINAL SAMPLE</b>
