CARLOW CENTRAL LIBRARY, TULLOW STREET, CARLOW

Part 8 Submission Architectural Heritage and Conservation Report

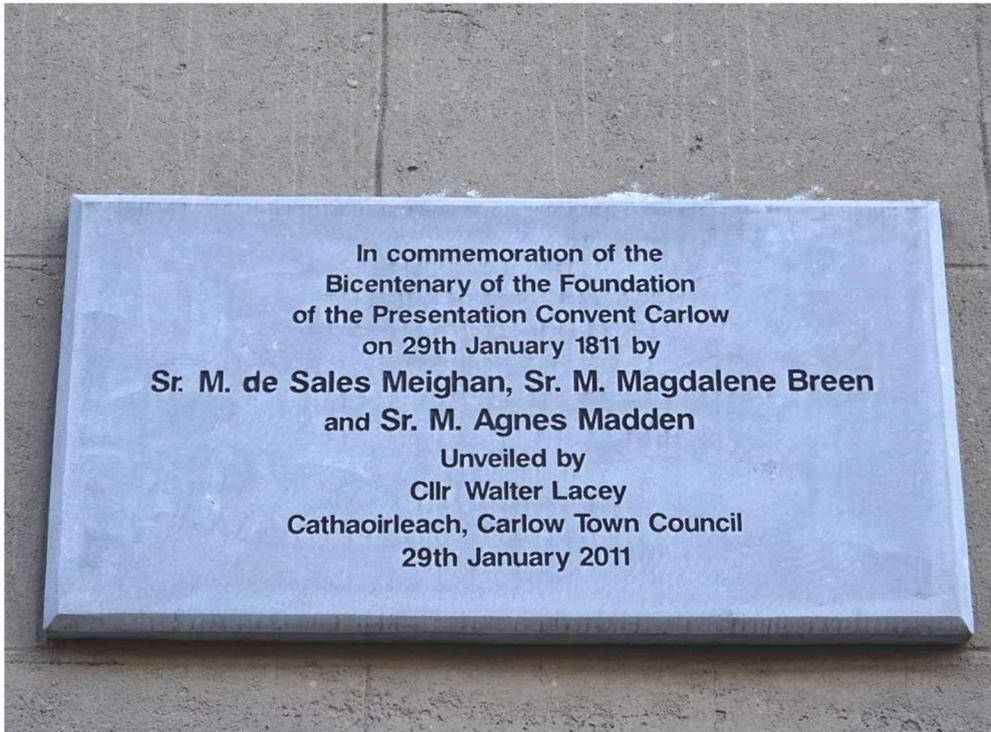
Wall-mounted limestone plaque to the front elevation of the former Presentation Convent commemorating the arrival of the Presentation Sisters to Carlow in 1811. The Presentation Sisters occupied the site until 1989. In 1998, the convent building was converted for use as the Carlow Library and Archive.

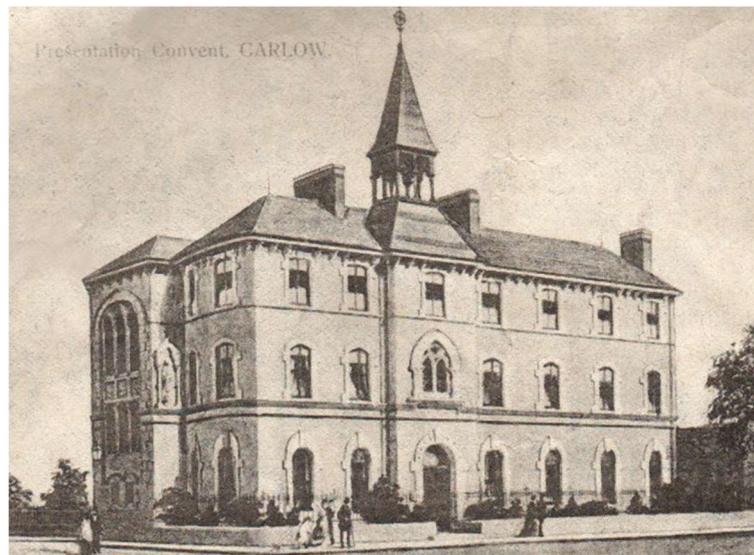
Fig.1: Early postcard showing the Presentation Convent building with its central belfry. The historic black and white image shows the building and roof in their original form.

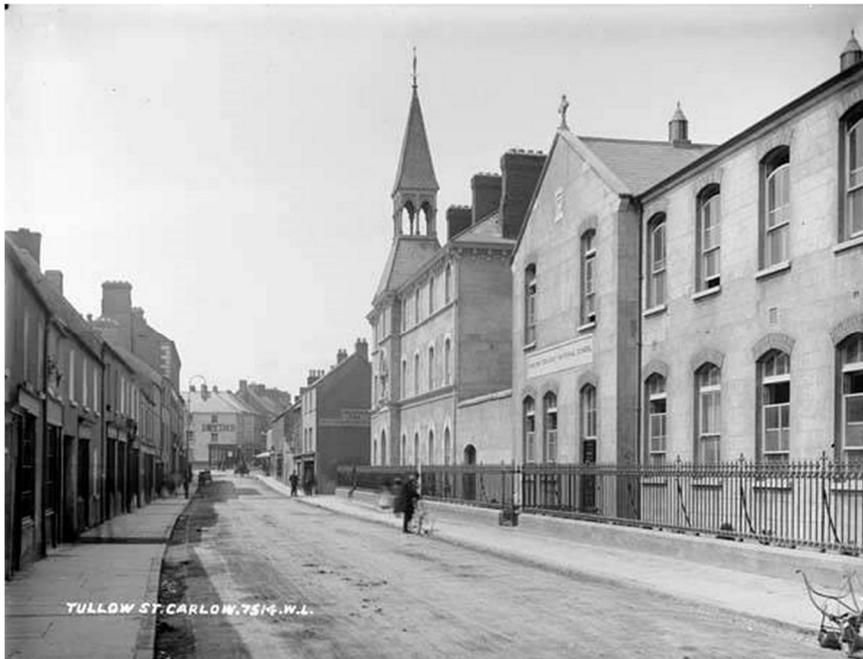
Fig.2: Tullow Street, Carlow by Robert French taken 1899-1906, Lawrence Collection, courtesy of the National Library of Ireland.

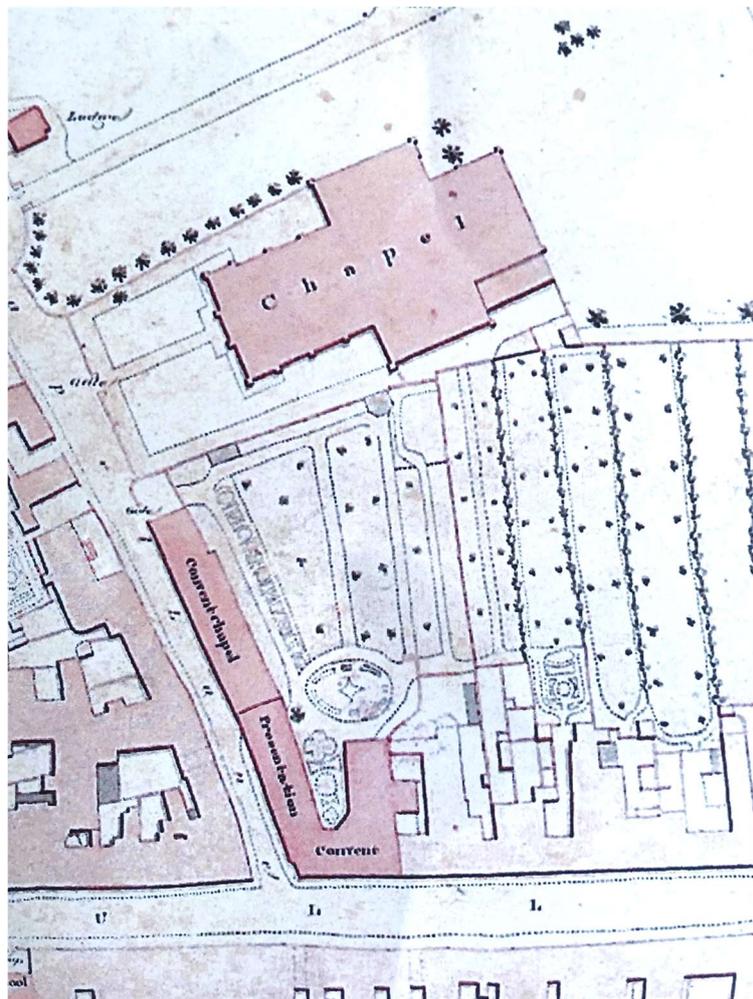
Fig.4: Extract of OS Map of Town of Carlow, 1:1,056, Sheet 3, Surveyed 1839, (Copy TCD, Original in National Archives of Ireland OS/140/Carlow/1839)

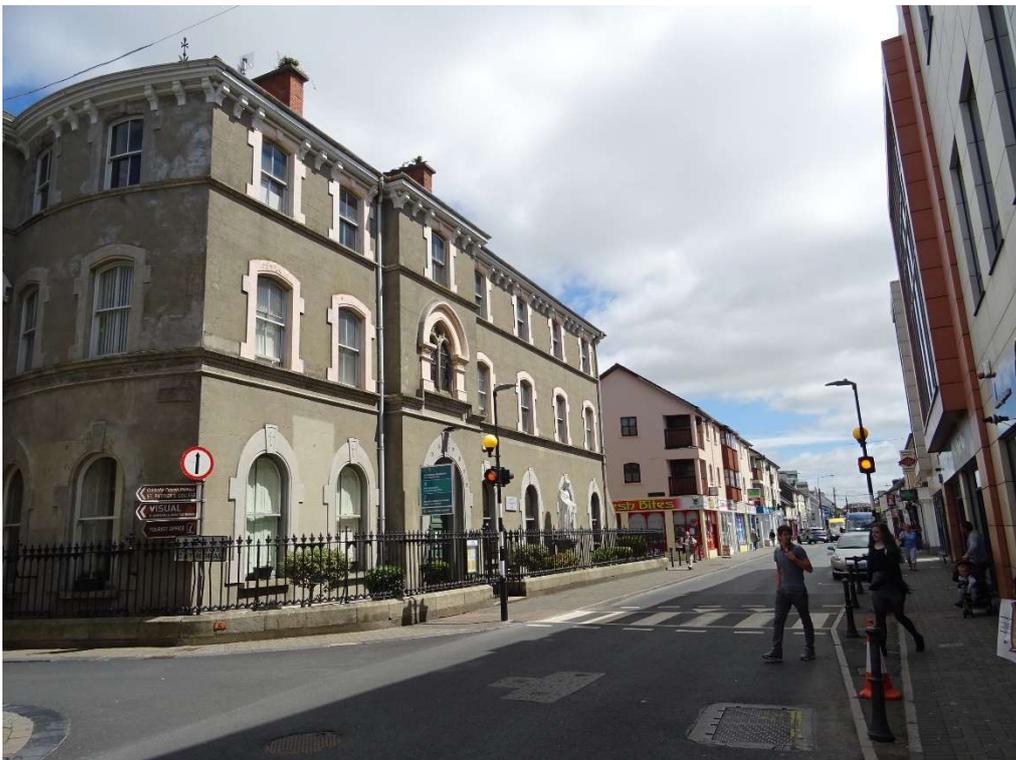
Fig.16: A streetscape view of Tullow Street, looking east. The former Presentation Convent is a landmark building on the northern side of the street.

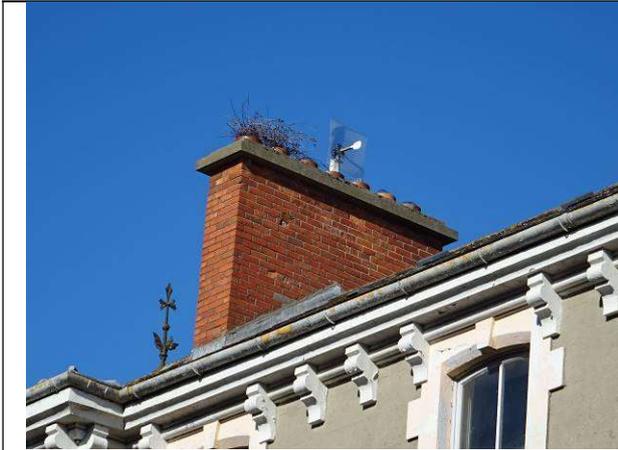
Fig.17: Rebuilt chimneystack with nest material to pots. Spalled brickwork. Cement pointing with cement patch repairs. Flaking paintwork to replacement half-round gutter. Flaking paint to corbels at cornice.

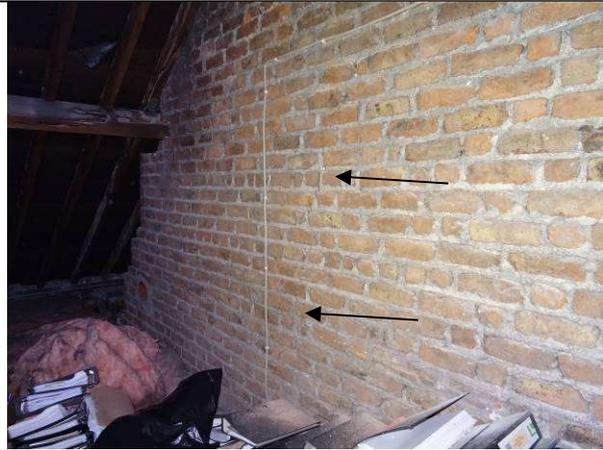
Fig.18: Narrow vertical crack to joints of eastern face of eastern chimneybreast.

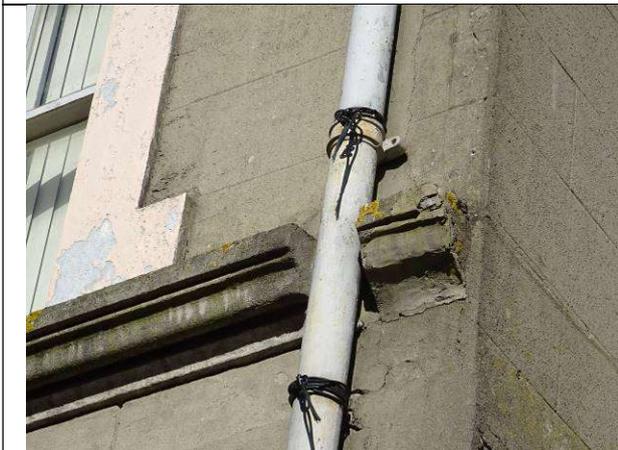
Fig.19: Replacement circular downpipe installed to east end of front elevation. Stringcourse was broken to accommodate the insertion.

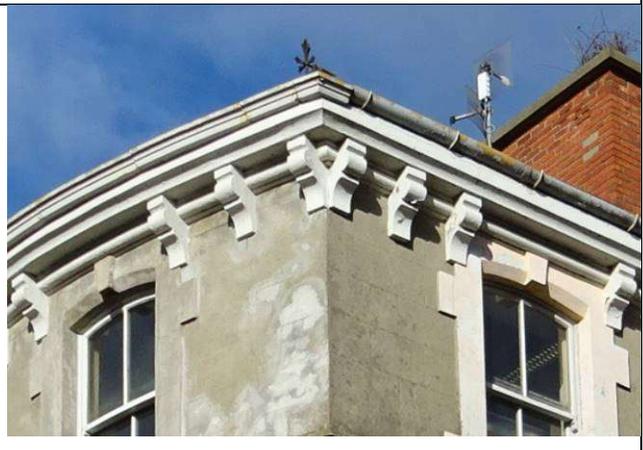
Fig.20: Original flat-bottomed gutter to the bowed west end with a replacement round-bottomed gutter to the façade.

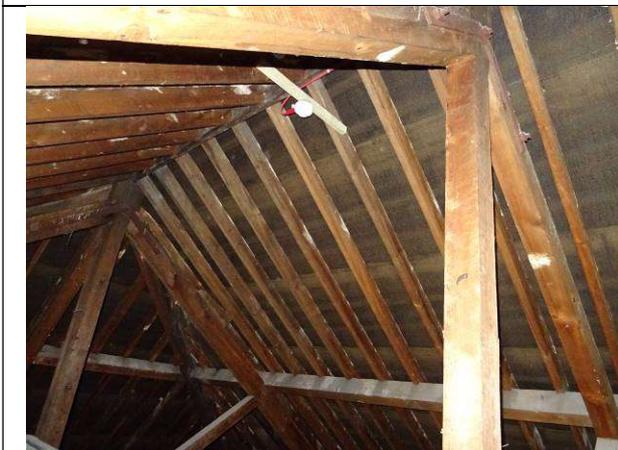
Fig.21: White mould present to timbers below impervious felt.

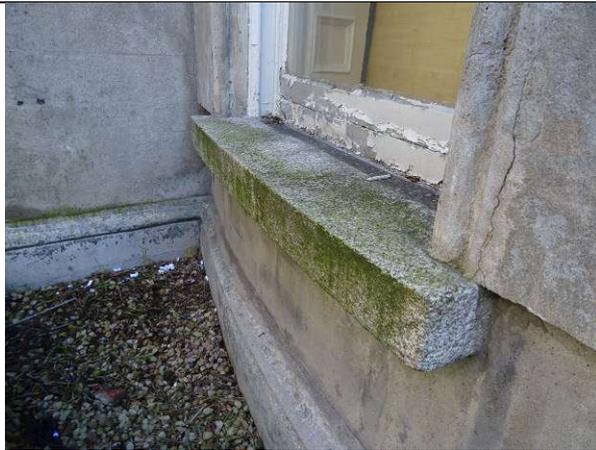
Fig.23: Green staining to the granite sill. Flaking paint of the sash window's timberwork.

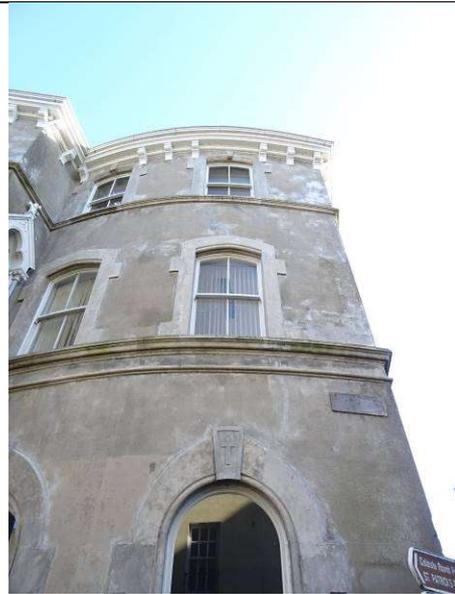
Fig.24: Localised patch repairs to the render at the southwest corner.

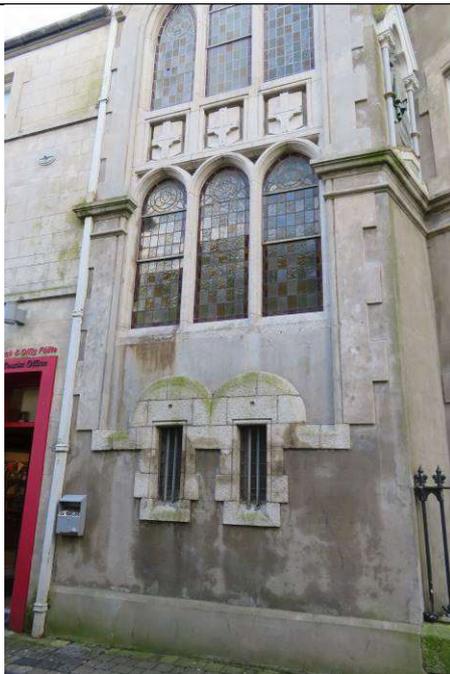
Fig.25: West end with stairs window with saturated render, green and rust staining.

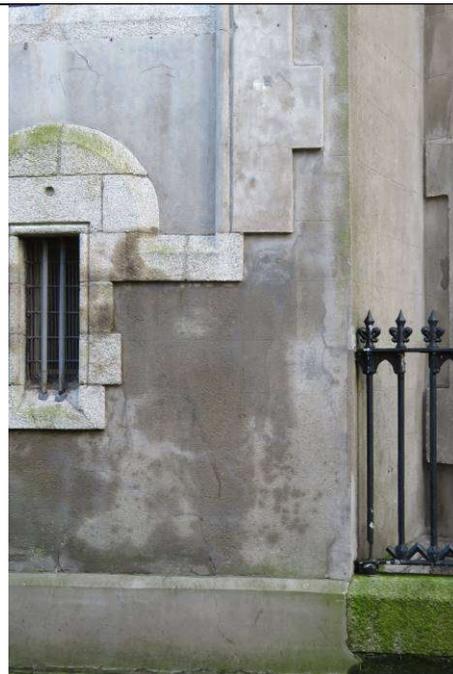
Fig.26: Darker render indicates moisture penetration to render. Any cracks allow moisture to travel inwards resulting in damp penetration.

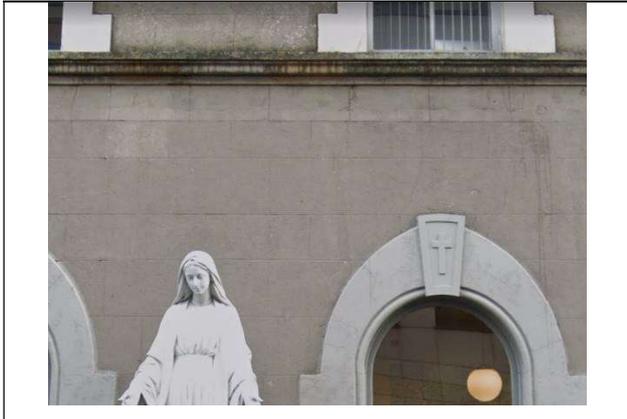
Fig.27: A band of render below the first-floor sill course looks as if it has been renewed. The moulded underside of the sill is very stained by atmospheric pollution. A series of fine cracks can be seen to the render below the upper window.

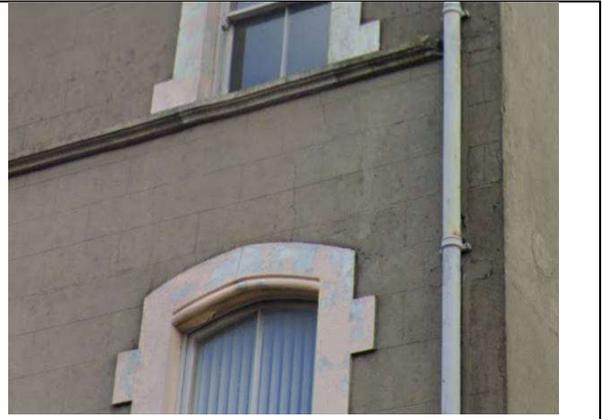
Fig.28: Fine vertical cracks seen in the exterior render of the building. The render has cracked with the slightest of movement because it is so rigid. When rainwater penetrates such cracks, it will not freely evaporate due to the cement render.

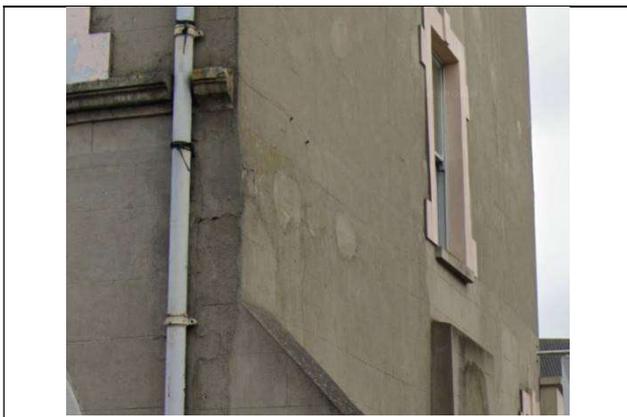
Fig.29: Cracking to render and patch repairs at the southeast corner.

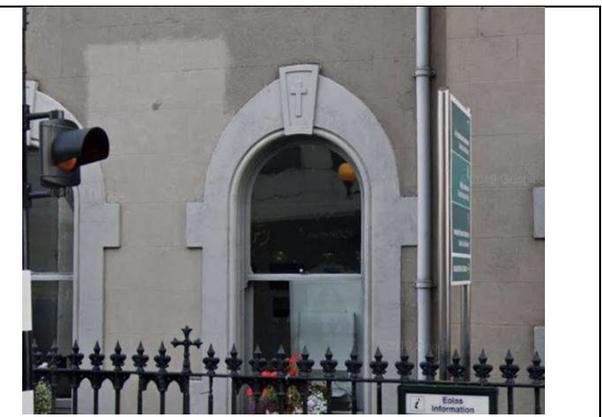
Fig.30: A wash applied to render between windows at west end of ground floor on front elevation.

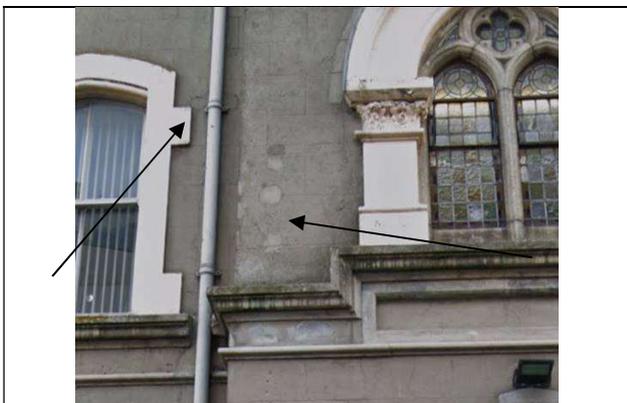
Fig.31: Replacement downpipe with scars of old brackets. Further patch repairs to breakfront render.

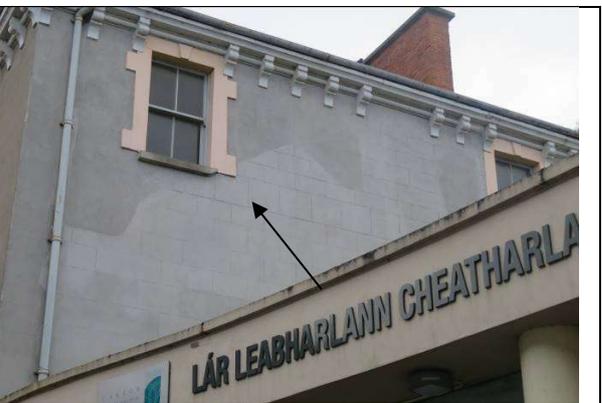
Fig.32: Render applied to the scar of the demolished rear extension. The upper floor windowsill was chamfered to accommodate the roof pitch.

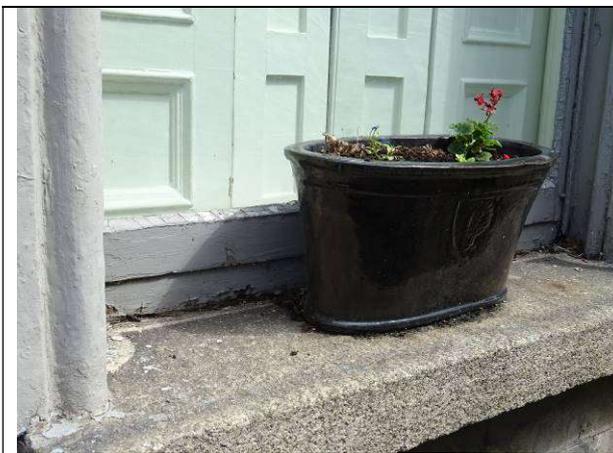
Fig.35: Flaking paintwork to sash with cracked window putty.

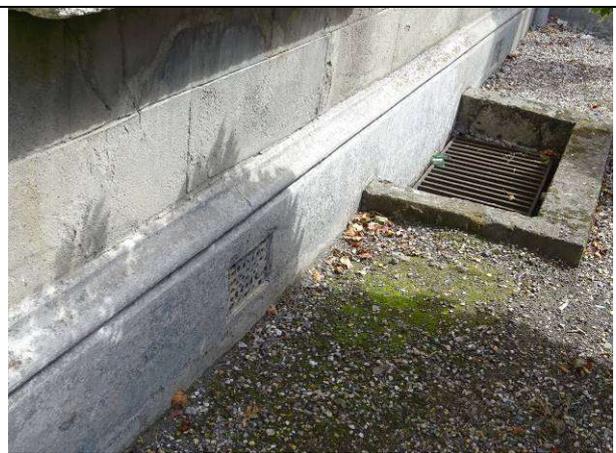
Fig.36: Flaking paint to plinth course to front elevation with flaking paint to air vent.

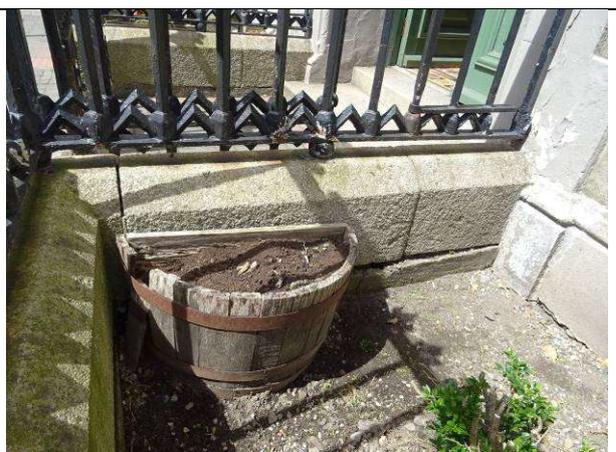
Fig.38: Open joints to stonework and localised corrosion of ironwork to railings.

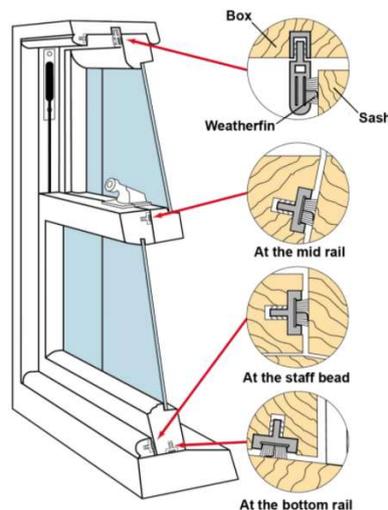
Fig.39: Image draught-proofing system (Ventrolla) to be employed

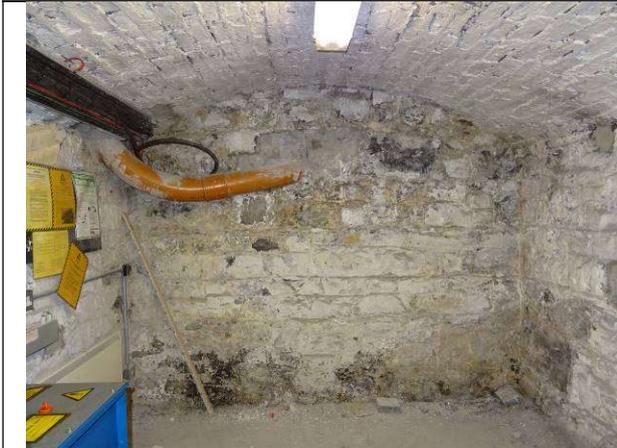
Fig.40: Vaulted basement room below the entrance hall. The rubble wall at the end of the chamber retains the soil behind and has the potential to allow water to ingress.

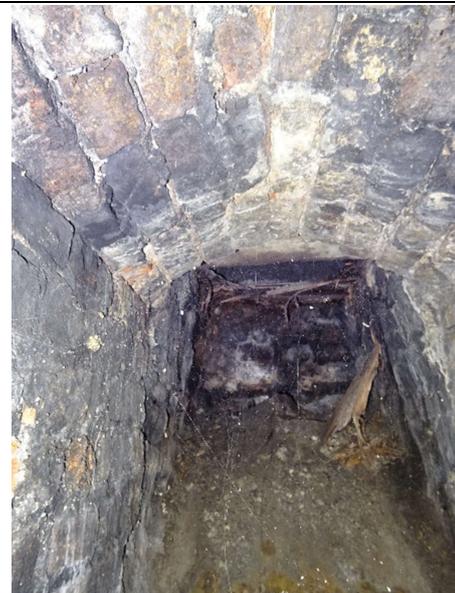
Fig.43: A view up the coal chute towards the inadequately covered opening.

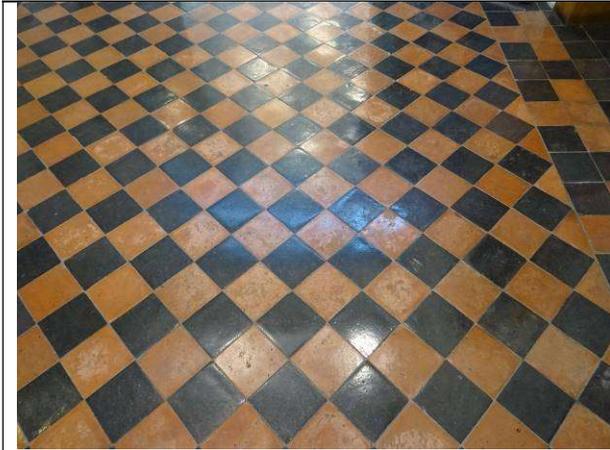
Fig.44: Shellac-coated quarry tiles to stairhall floor.

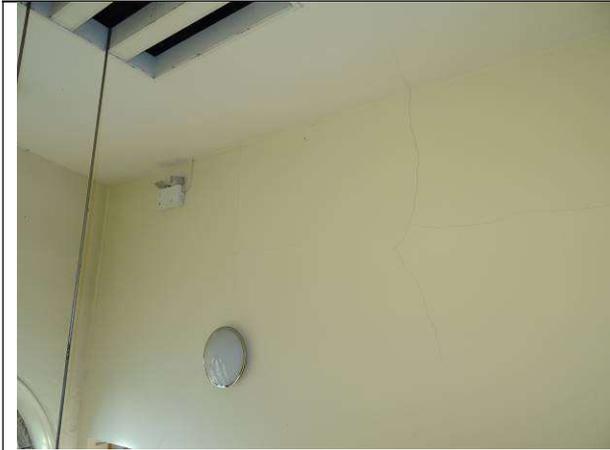
Fig.50: Cracked plasterwork to stairwell. Plasterwork was replaced during renovations.

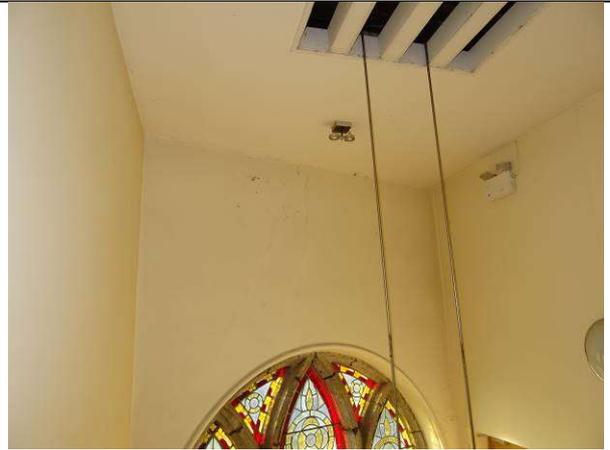
Fig.51: Cracked plasterwork to stairwell. Plasterwork was replaced during renovations.

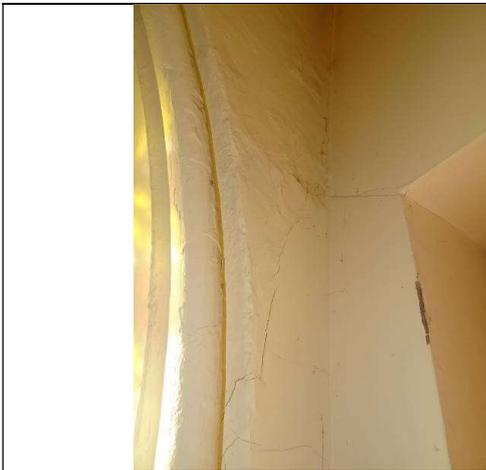
Fig.52: Cracking to early and replacement plasterwork at the stairs.

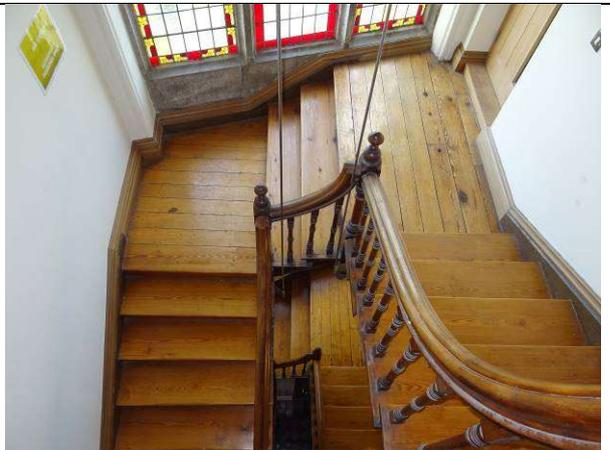
Fig.53: The timberwork of the stairs is by-and-large in good condition. This image shows how the suspension rods support the second half-landing.

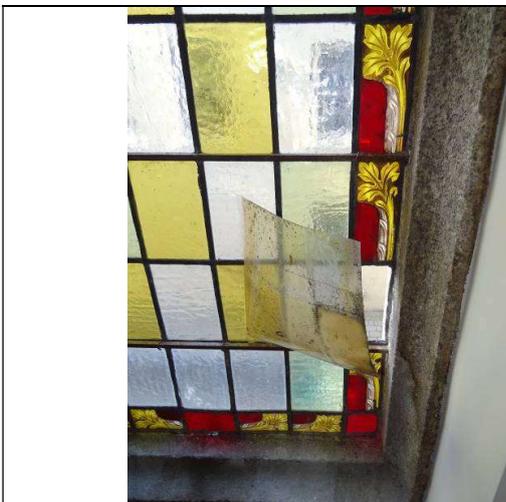
Fig.54: Missing pane to window

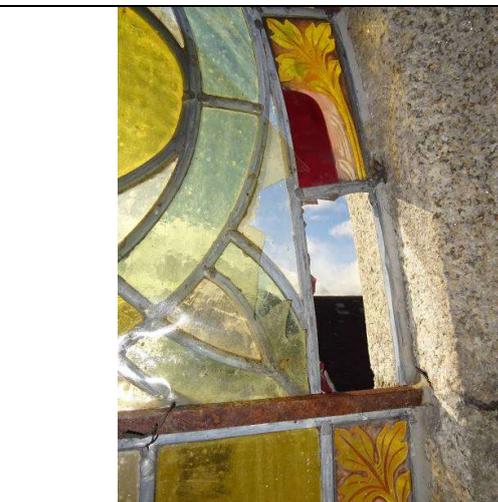
Fig.55: Broken panes

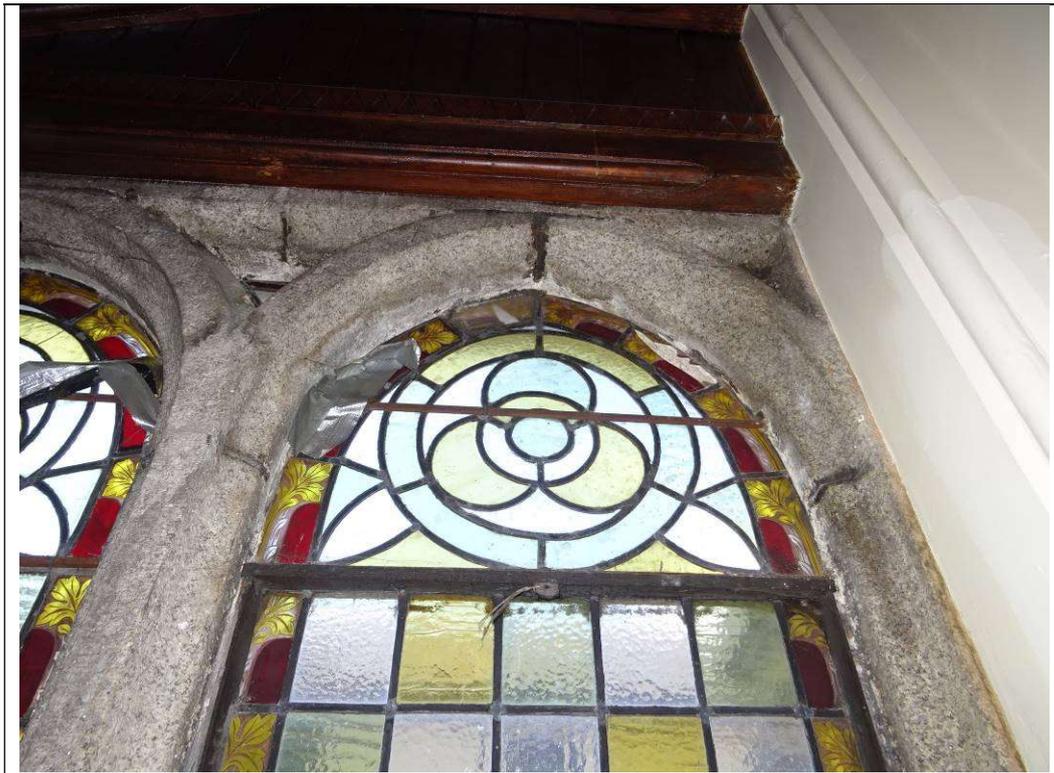
Fig.56: Tape used to secure iron bar. Broken margin panes above.

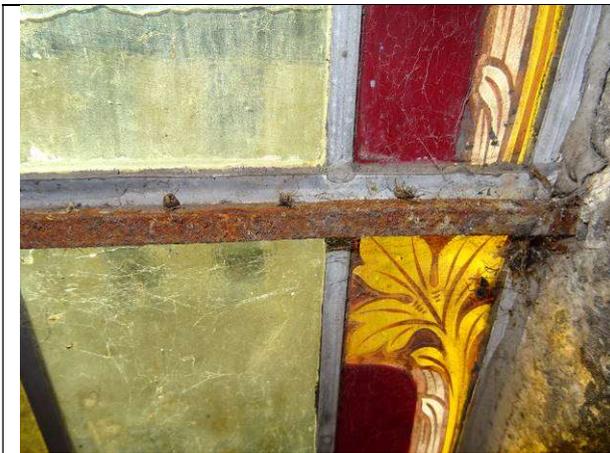
Fig.57: Corroded surface of horizontal iron bar.

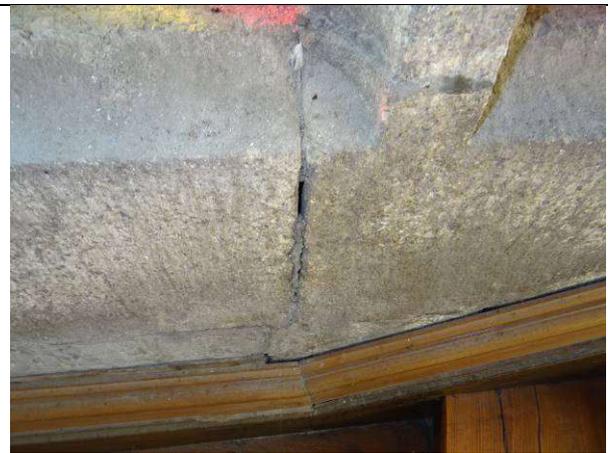
Fig.58: Open joint to ashlar joint of cut-stone granite.

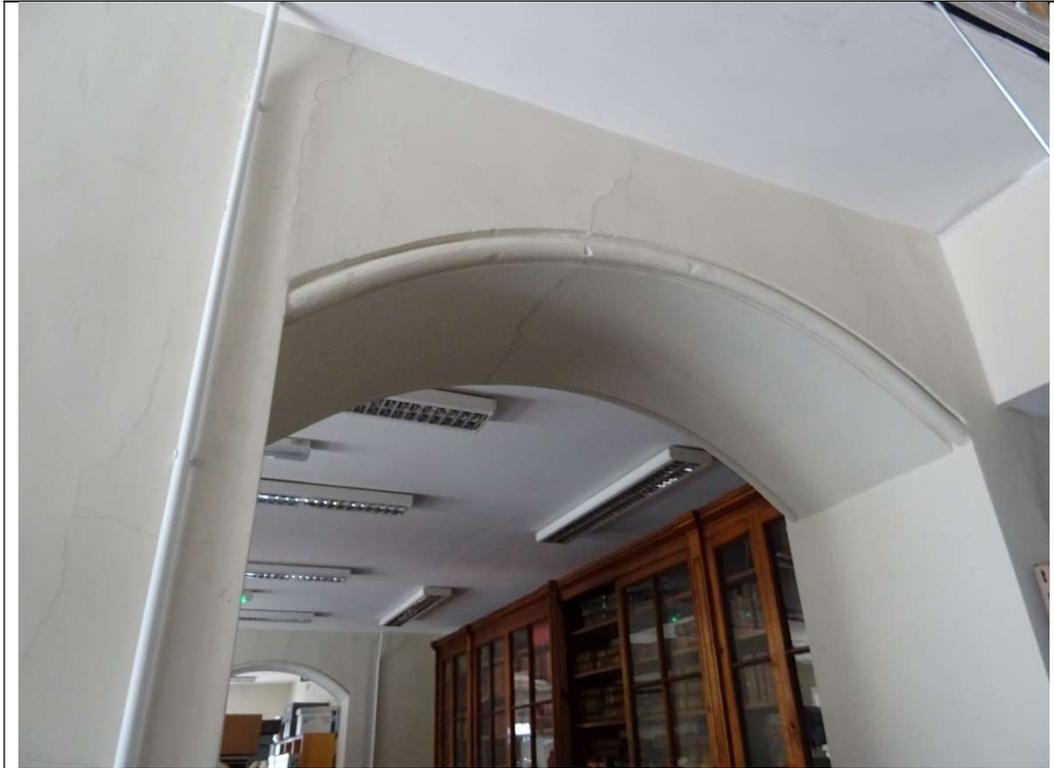
Fig.59: Structural cracking to archway at second floor archive.

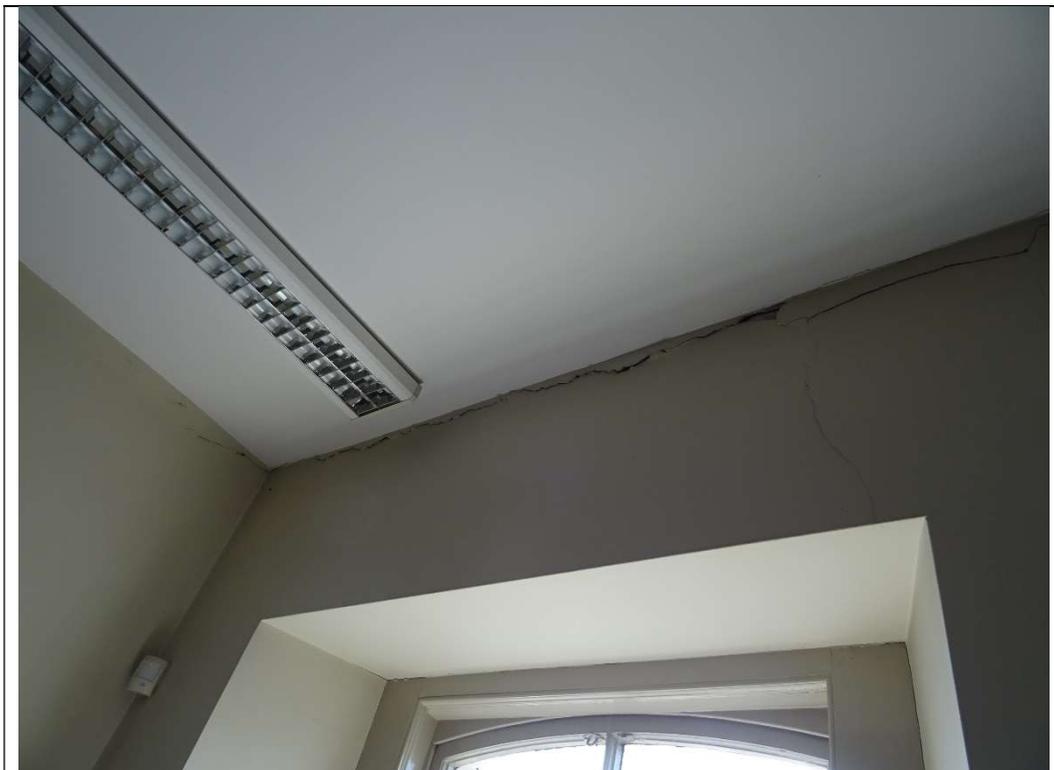
Fig.60: Horizontal cracking to top of front elevation at second floor.

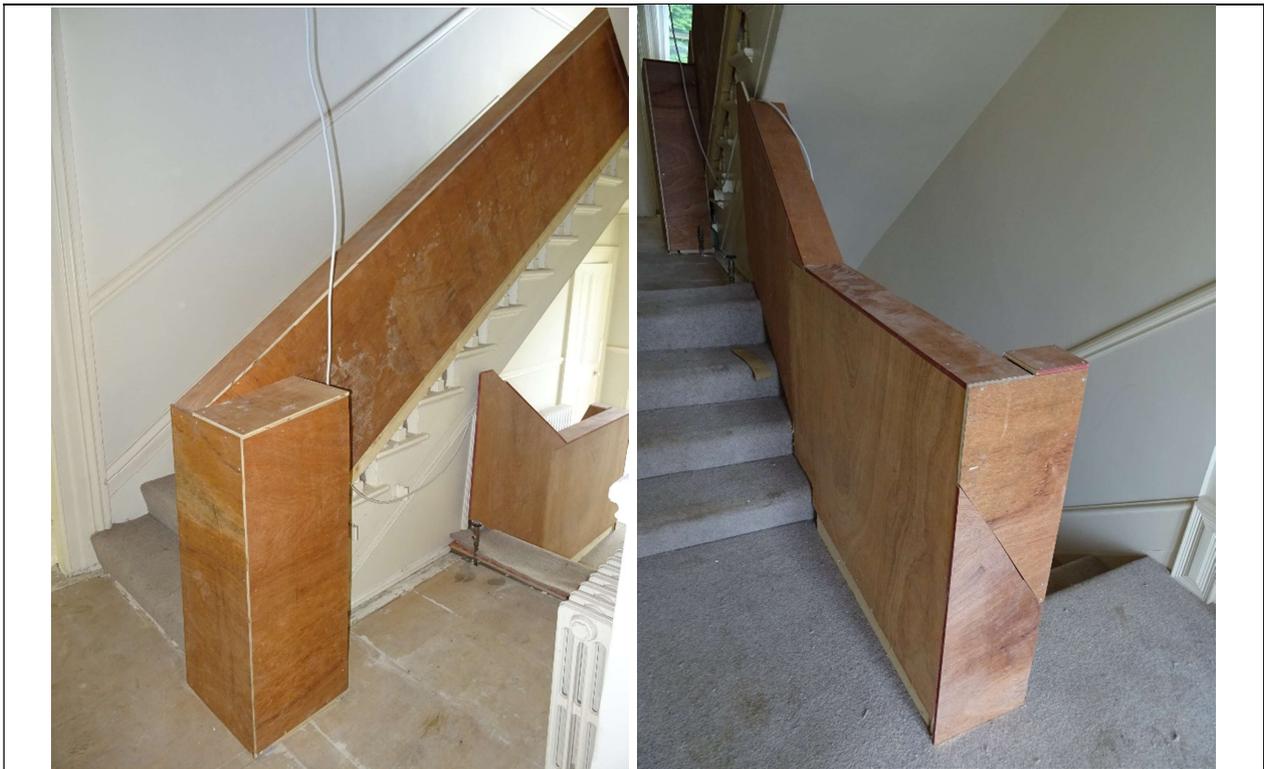
Fig.62: Images of staircase protected by means of plywood sheeting during works.

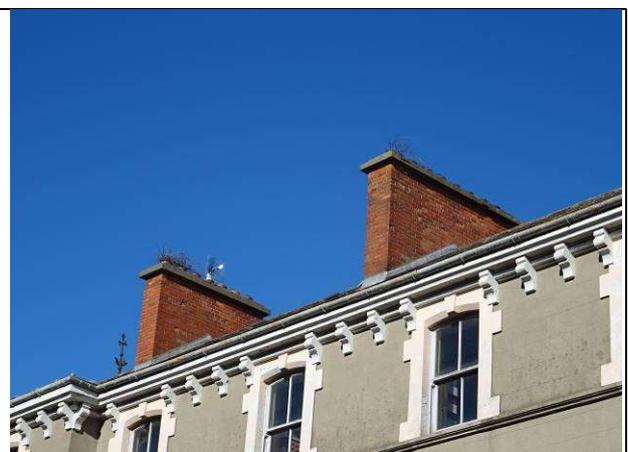
Fig.70: Replacement chimneys to centre of building

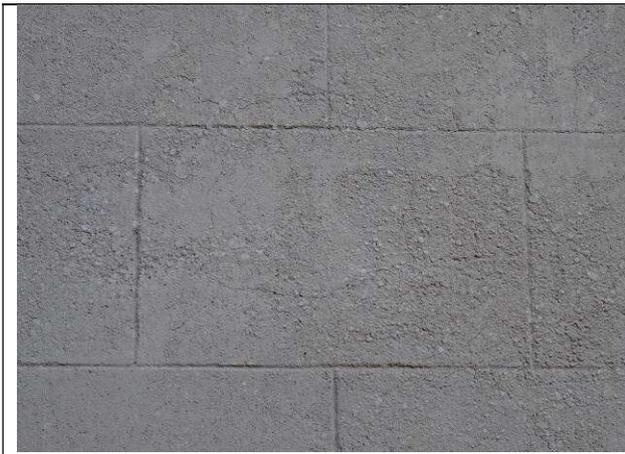
Fig.71: Detail of ruled-and-lined render
