Commercial Shopfront Structures
Shamrock Square
Carlow Town
County Carlow

Heritage Assessment Report

September 2021

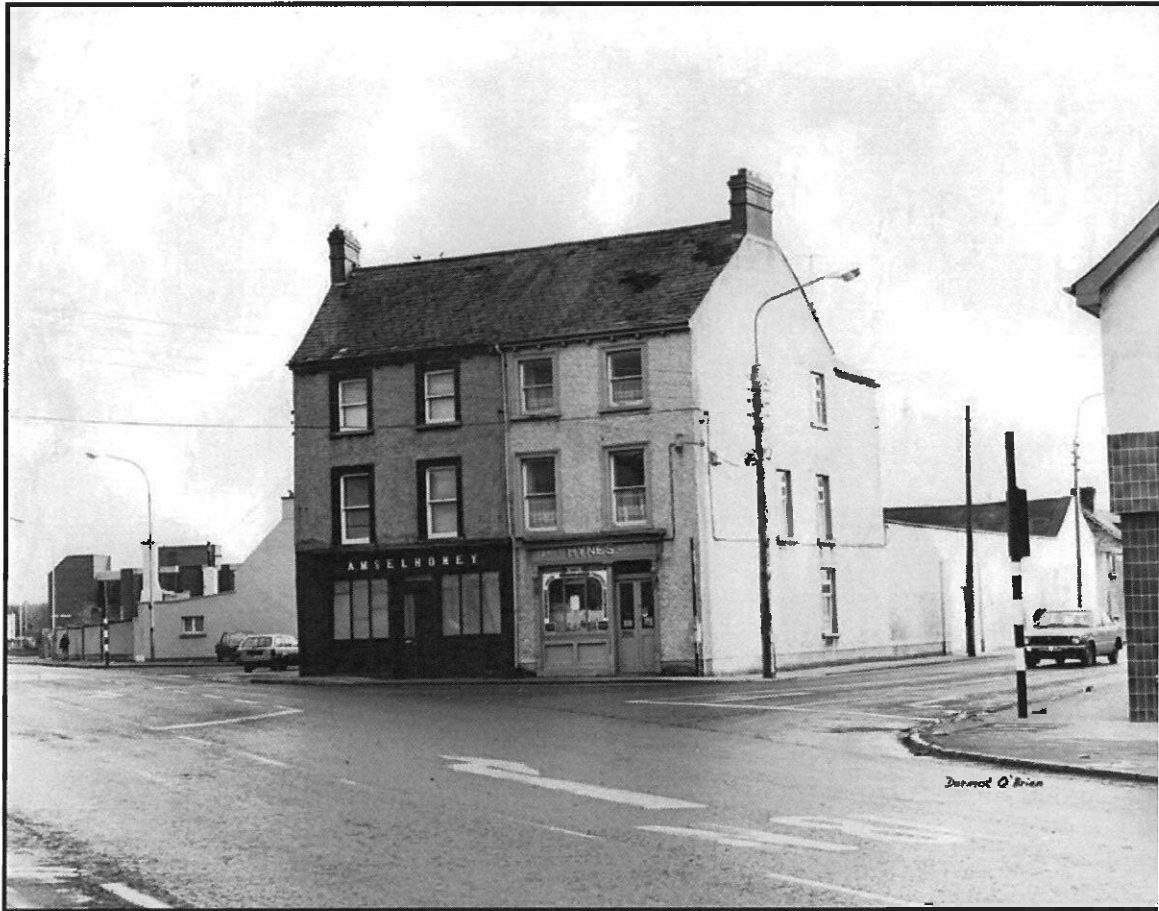
Photo No. 1. General photo looking east, showing the west front elevations of the two shop front buildings around 1990. The late 19th century shopfronts remain intact in this view, and show that the buildings are otherwise quite ordinary and modest examples of commercial buildings with living accommodation above, dating from the first half of the 19th century.

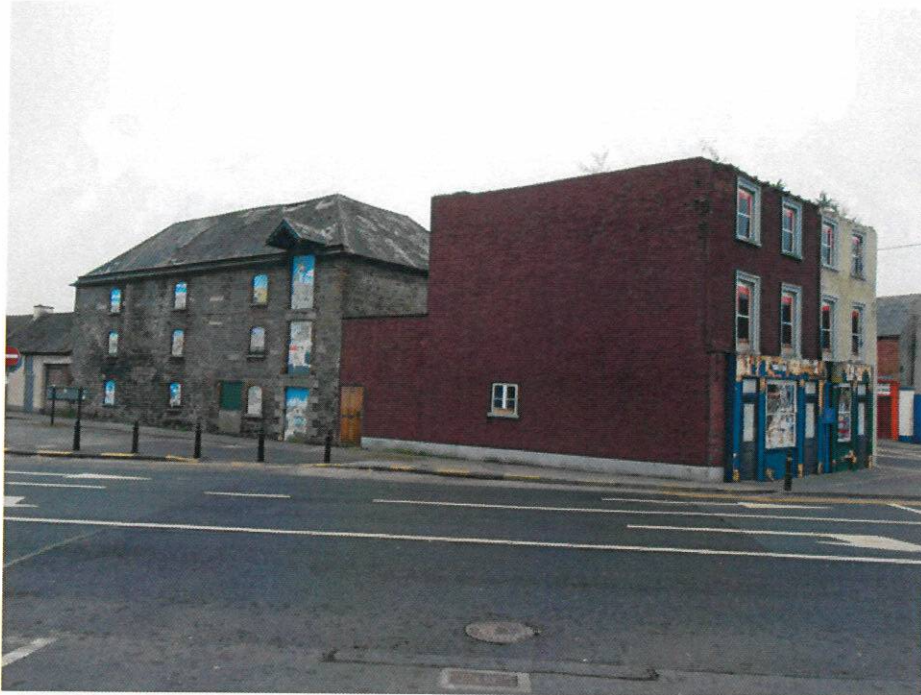
Photo No. 3. General view looking south showing the former brewery on the left, and the pair of commercial buildings looking out onto Shamrock Square on the right.

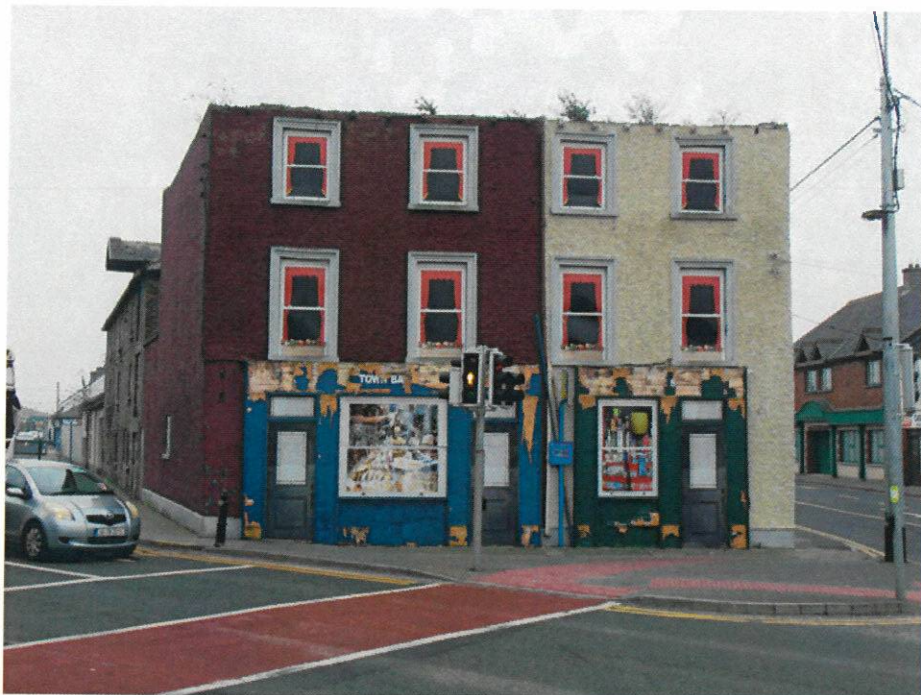
Photo No. 4. General view looking east, showing the west facing front elevations of the shop buildings. The fire damaged roof has totally collapsed into the building. The windows and shopfronts were covered with plywood.

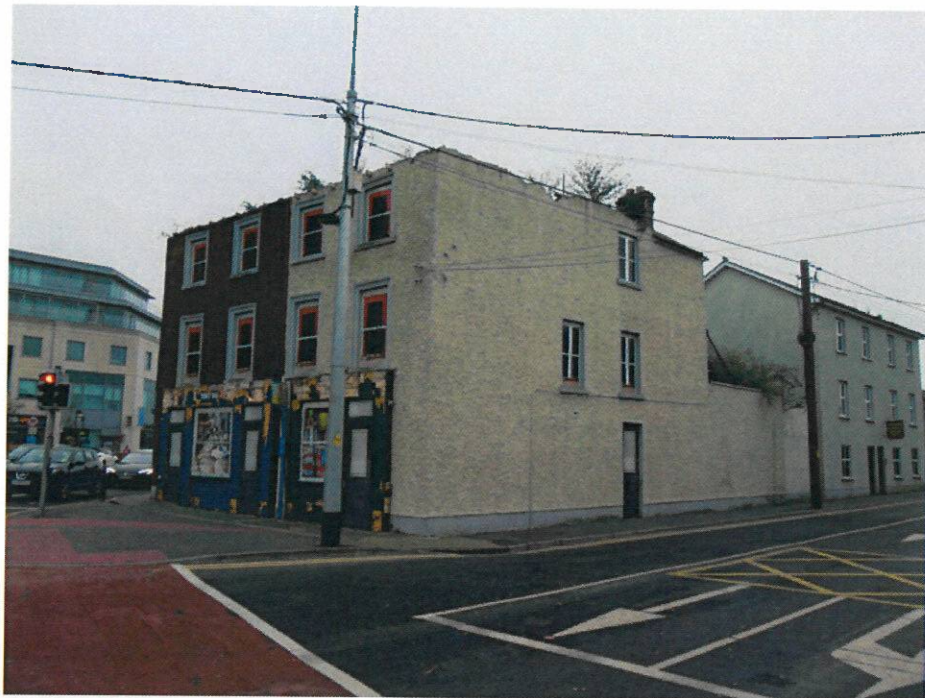
Photo No. 5. General view looking north-east, showing the current condition of the two commercial buildings. Note the vegetation growing on the wall heads.

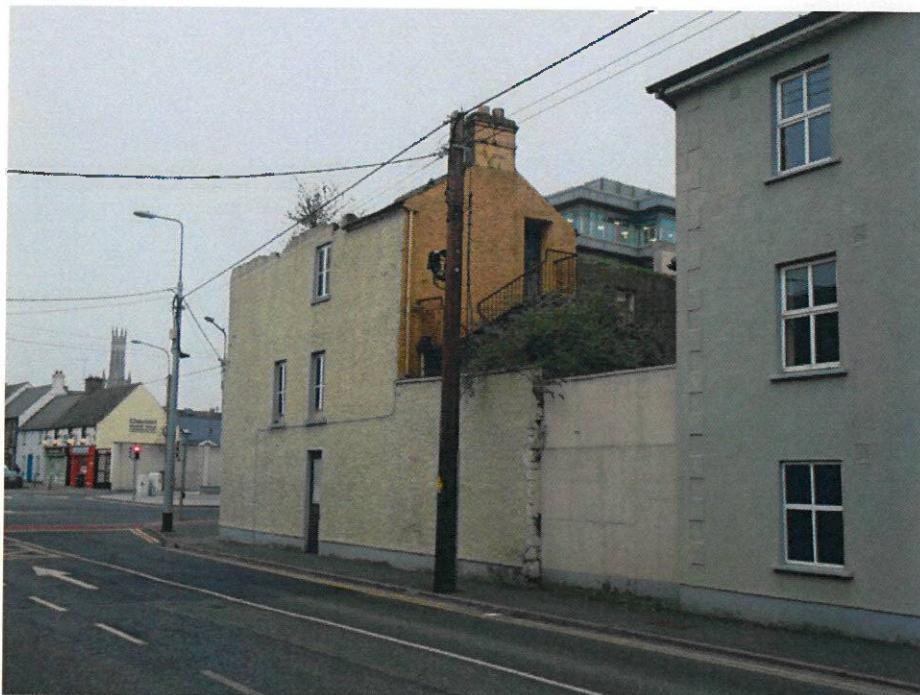
Photo No. 6. View looking north-west showing the south elevation of the commercial buildings that face onto Shamrock Square.

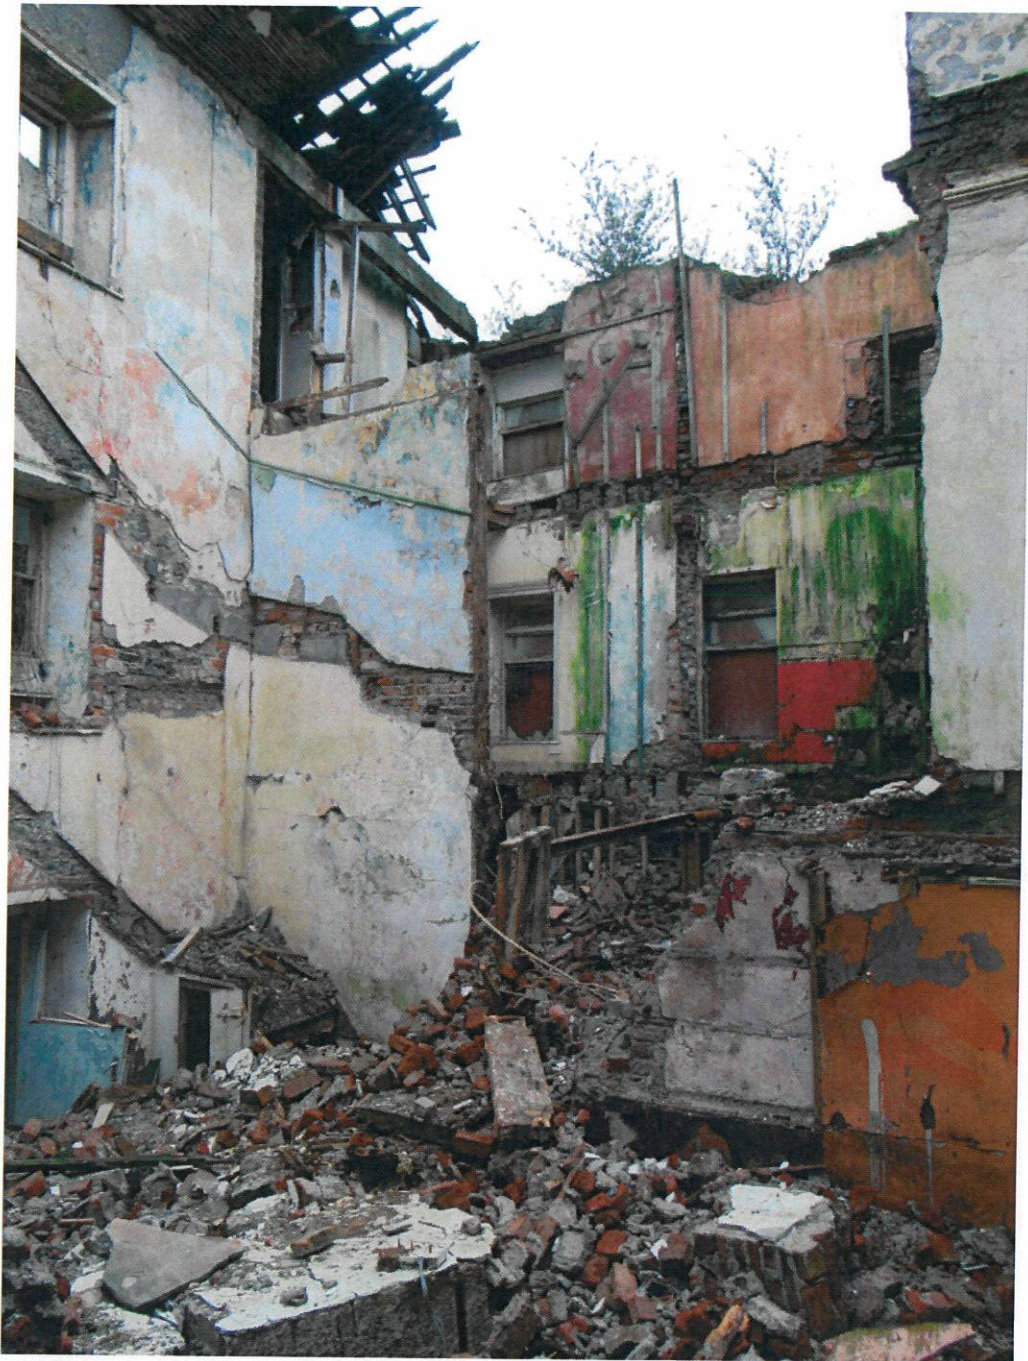
Photo No. 7. Detail view looking south inside the Shamrock Square buildings. Note the advanced decay to the internal structure, and the loose materials at the top of the wall heads. These buildings would require substantial resources to reinstate, and very little of the original decorative fabric would be retained.

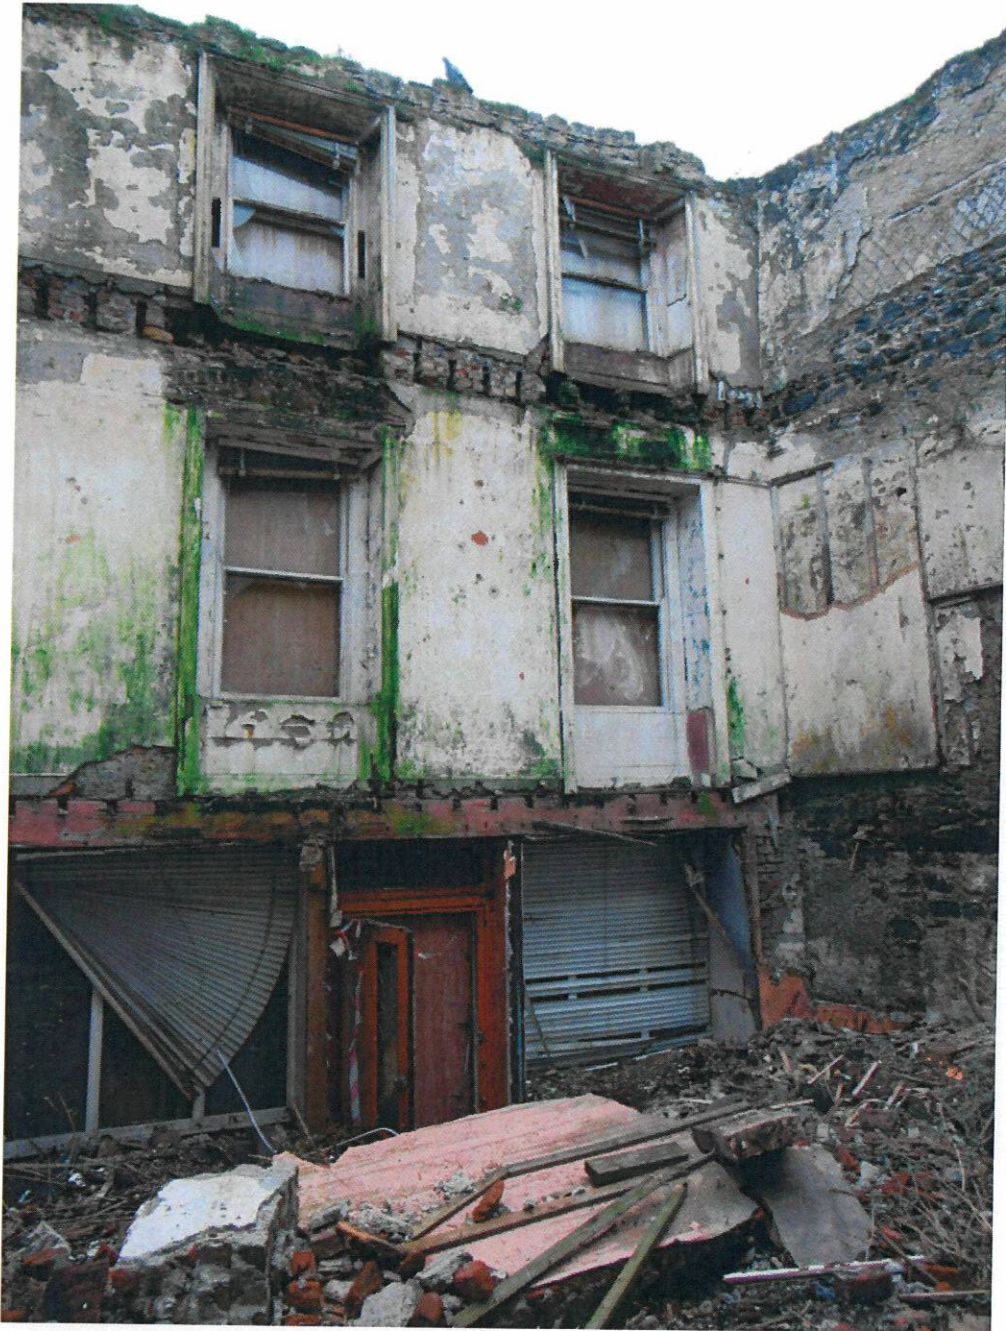
Photo No. 8. Detail view looking west inside the Shamrock Square buildings. The shopfront to the northern building is shown here, including its badly rotted timber lintel. That large timber beam has rotted due to being exposed to the weather over the last decade, and will shortly be unable to support the two floors of masonry above it.
