FORMER BANK OF IRELAND PREMISES
Court Place, Carlow

ARCHITECTURAL HERITAGE IMPACT ASSESSMENT

January 2026

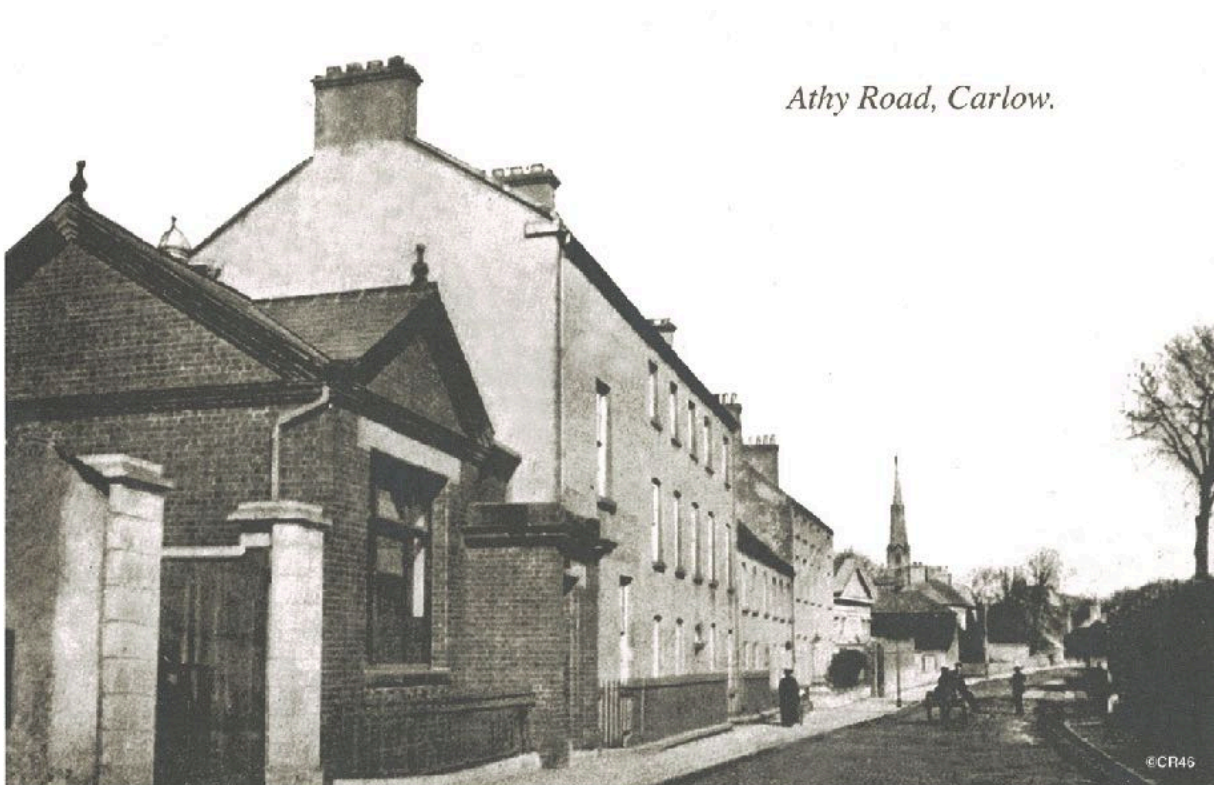
Historic image, date unknown

Formal ashlar gate piers and roof finials have since been removed

Note: Ridge tiles are plain (not crested as at present), Ventilator has survived in place.

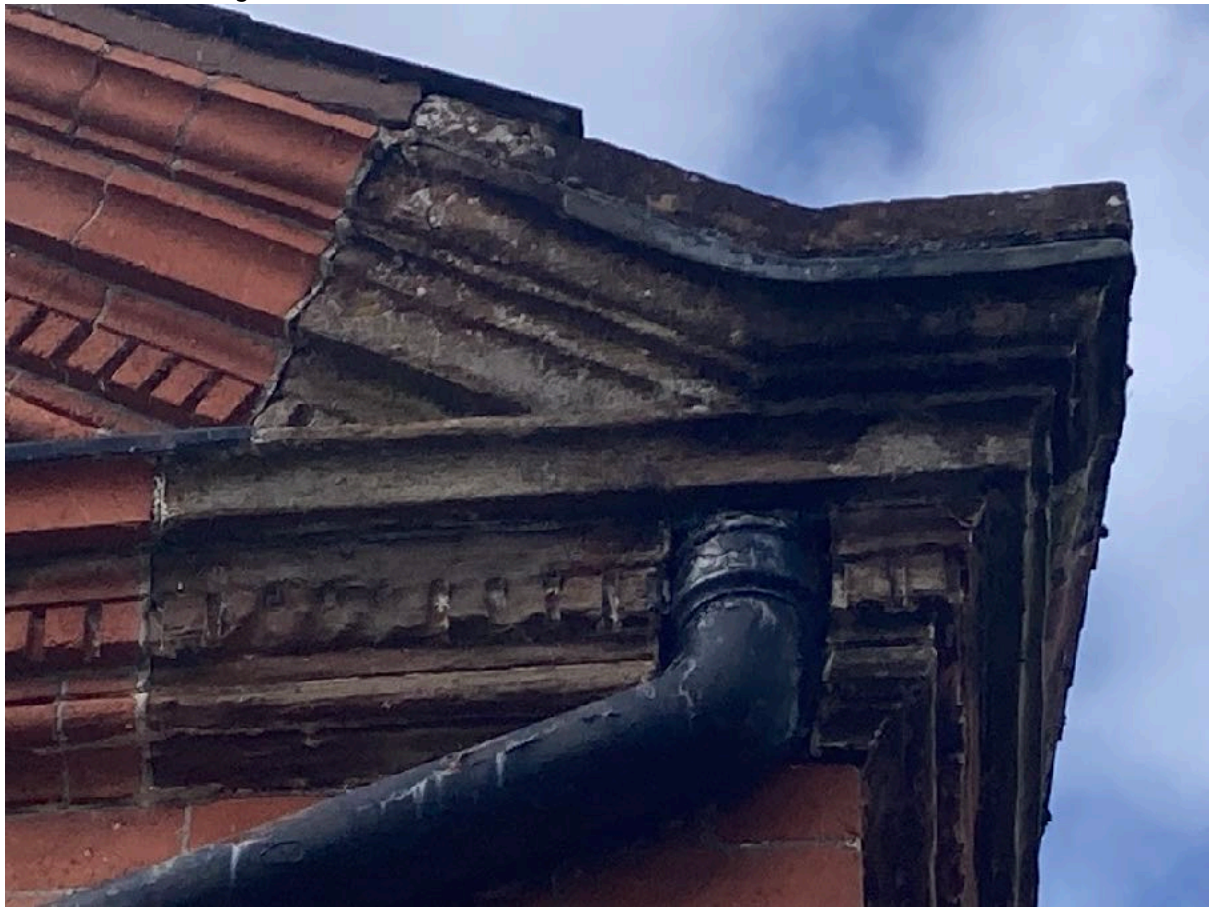
Eaves pieces (granite or reconstituted stone) formed to match profile of brick barge

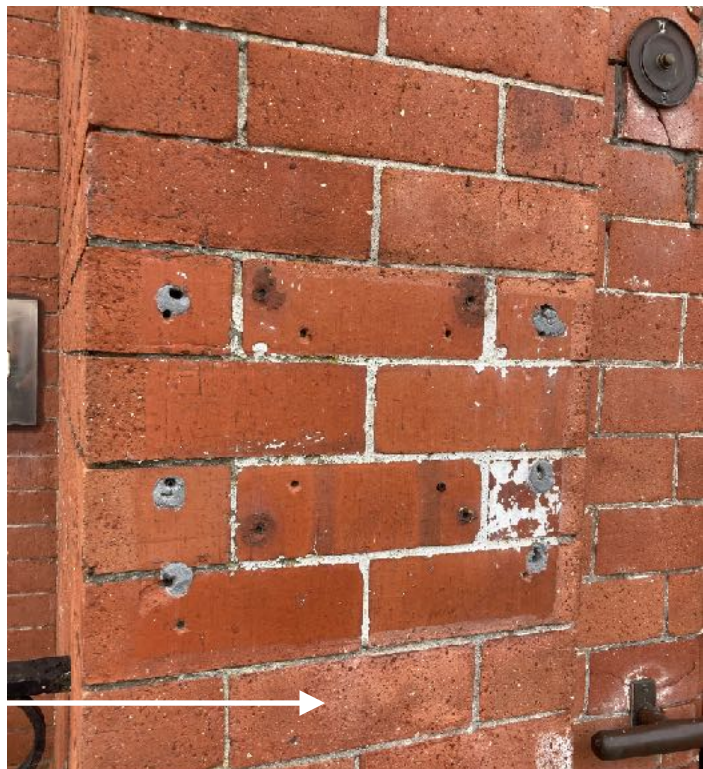
Pier at porch where nameplate had been attached, protecting the brick from the abrasive cleaning. Note line under where the protective skin has been removed from bricks by an inappropriate cleaning method

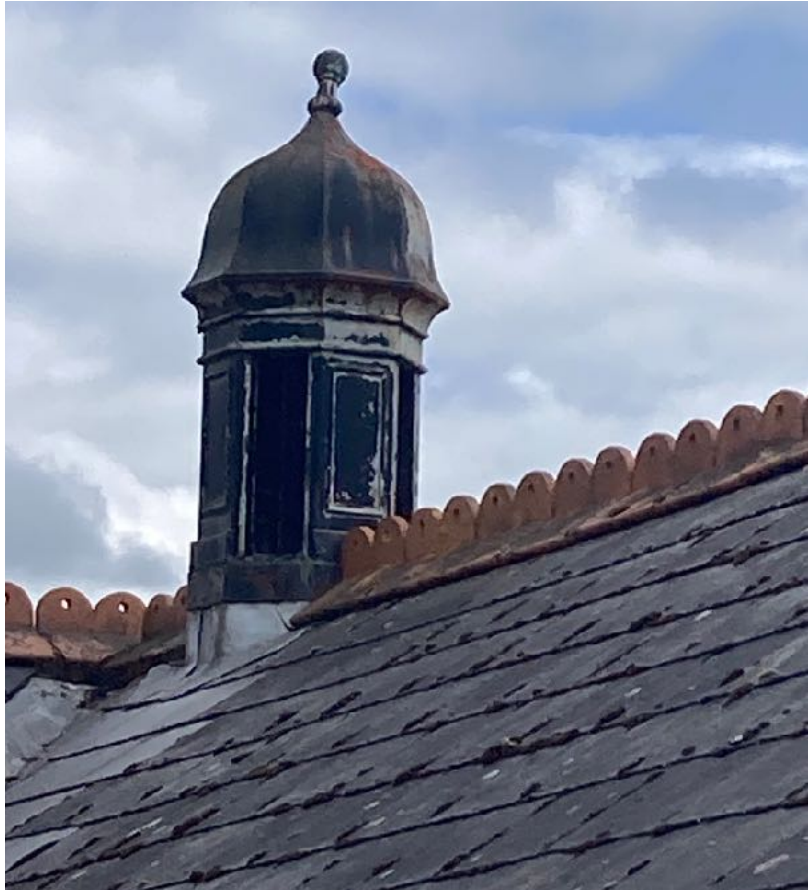
Octagonal ventilator feature on roof, to be retained

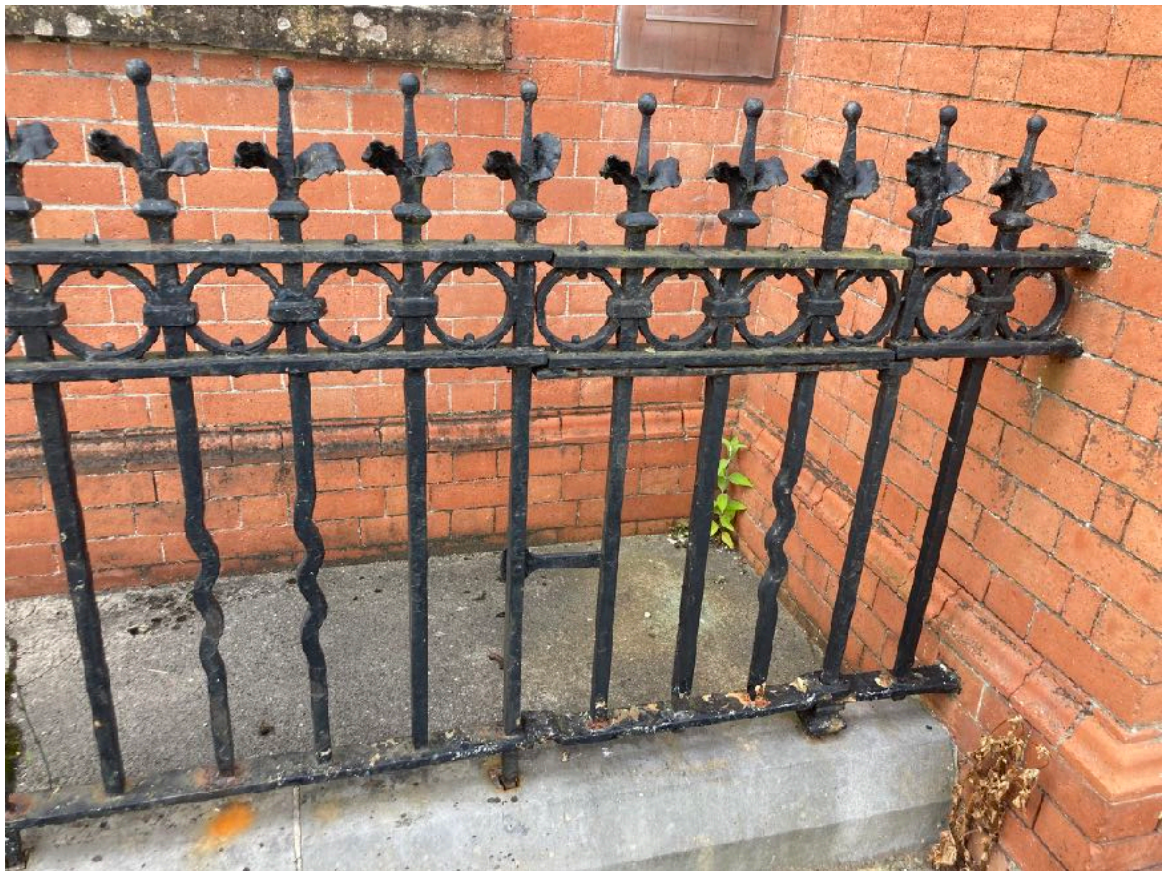
Front railings to banking hall - probably wrought and cast iron

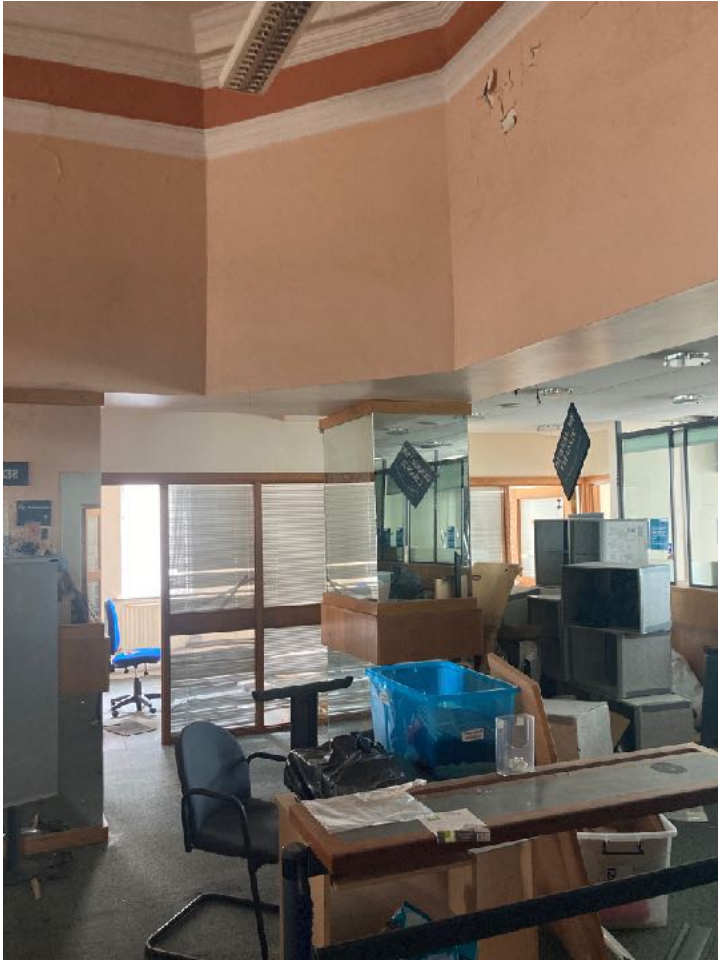
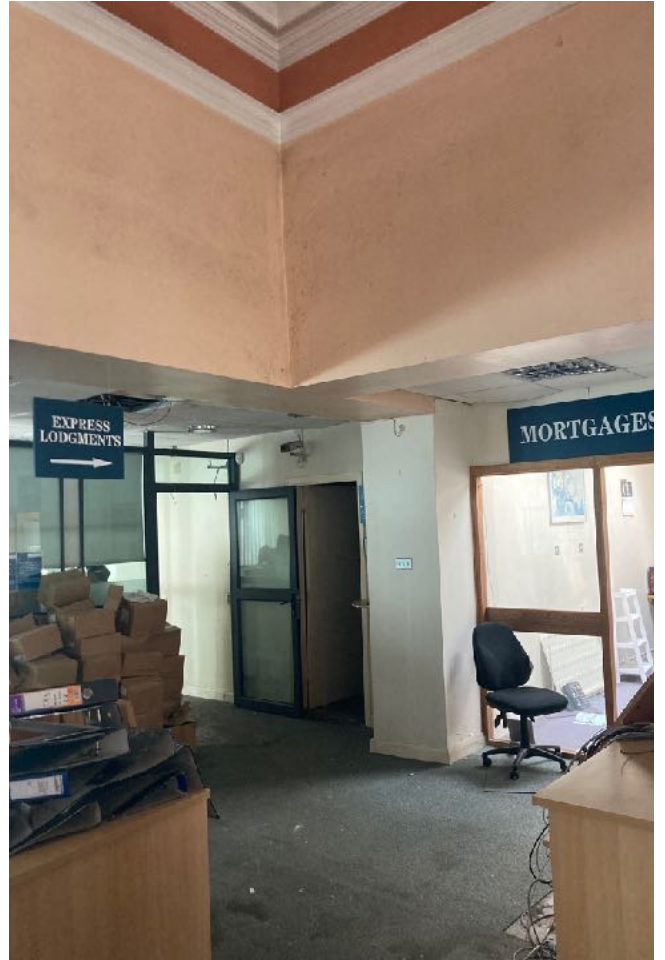
Internally, the original banking hall was the principal and formal space within the building. It had a decorative ceiling with cornice and stucco-work on corbelled supports to beams. This has survived, while some of the supporting walls have been removed with later beams inserted. These inappropriate interventions have rendered the main space incoherent. The other feature of note is the decorative mosaic on part of the floor, designed with B and I (Bank of Ireland?) lettering as a centrepiece with surrounding patterned border and corner features.

Rear corners of banking hall where original walls have been removed and beams inserted. It is proposed to reinstate the partitions/walls in this space to reinstate the original enclosure

Internally, the high-ceilinged banking hall, architecturally the most important element, has had its integrity diminished by structural alterations. This will be fully addressed in the proposals which will reinstate the character of the hall by re-establishing the original enclosure under the surviving ceiling.

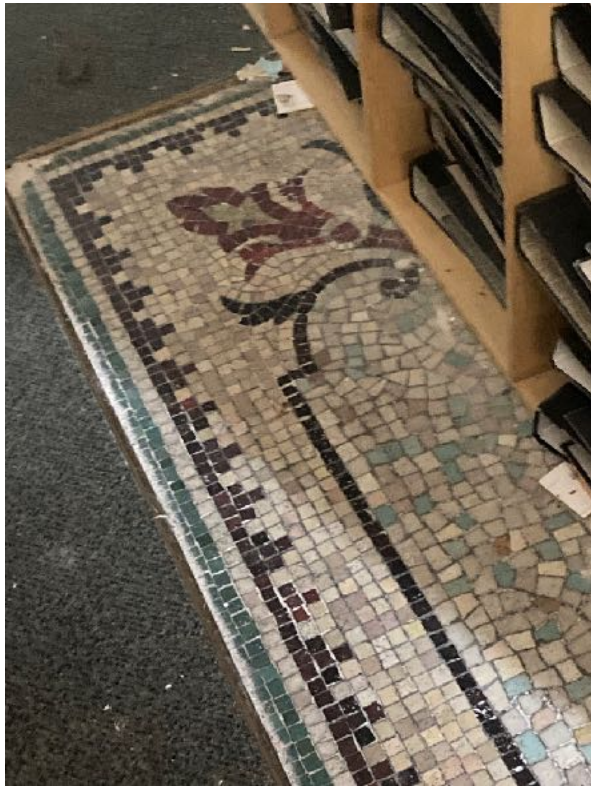
Detail of mosaic (to be retained) in banking hall

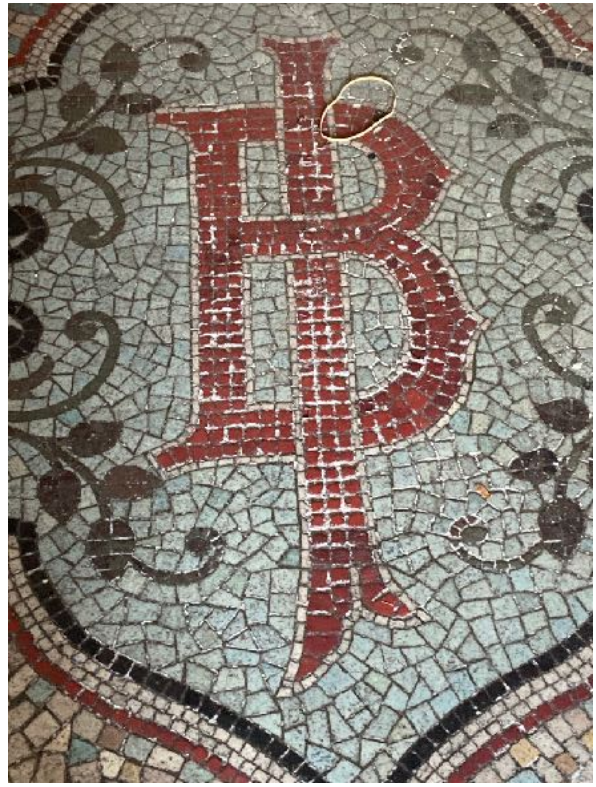
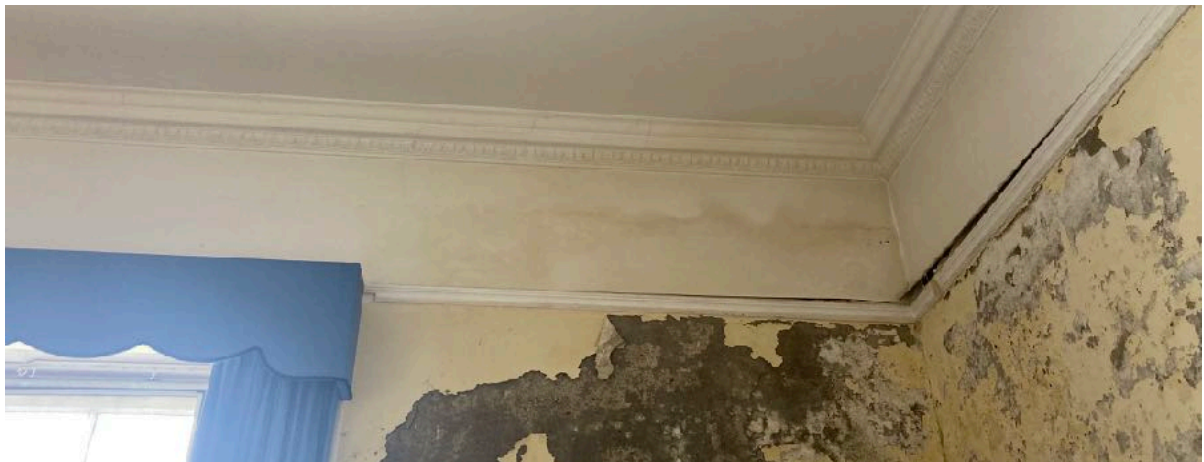
Features of adjoining Georgian building - windows, egg-and-dart cornice, picture rail - to be repaired and retained

<p>Interior of Georgian building Retain, repair/conservate plaster, cornices, mosaic and joinery.</p>	<p>Retain what survives of features and finishes. The staircase balustrade is not original</p>	<p>Positive impact</p>

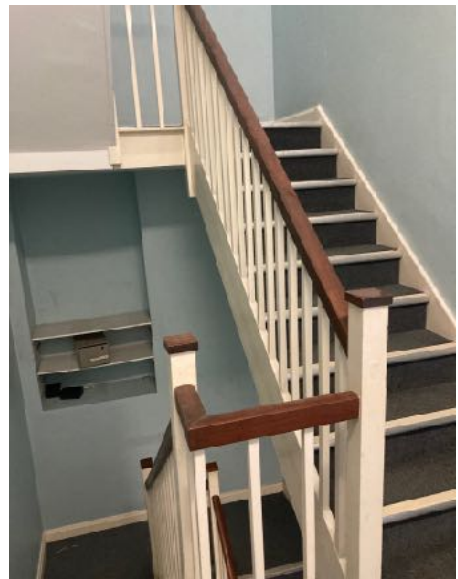
in the older section, the stair balustrade, and perhaps the staircase, has been replaced. Cornices, picture rails and windows survive.

Stair balustrade - which is of no architectural significance
