Carlow Library Extension

Civil Structural Part 8 Planning Report

February 2021

Document Number 191284-D003-R0

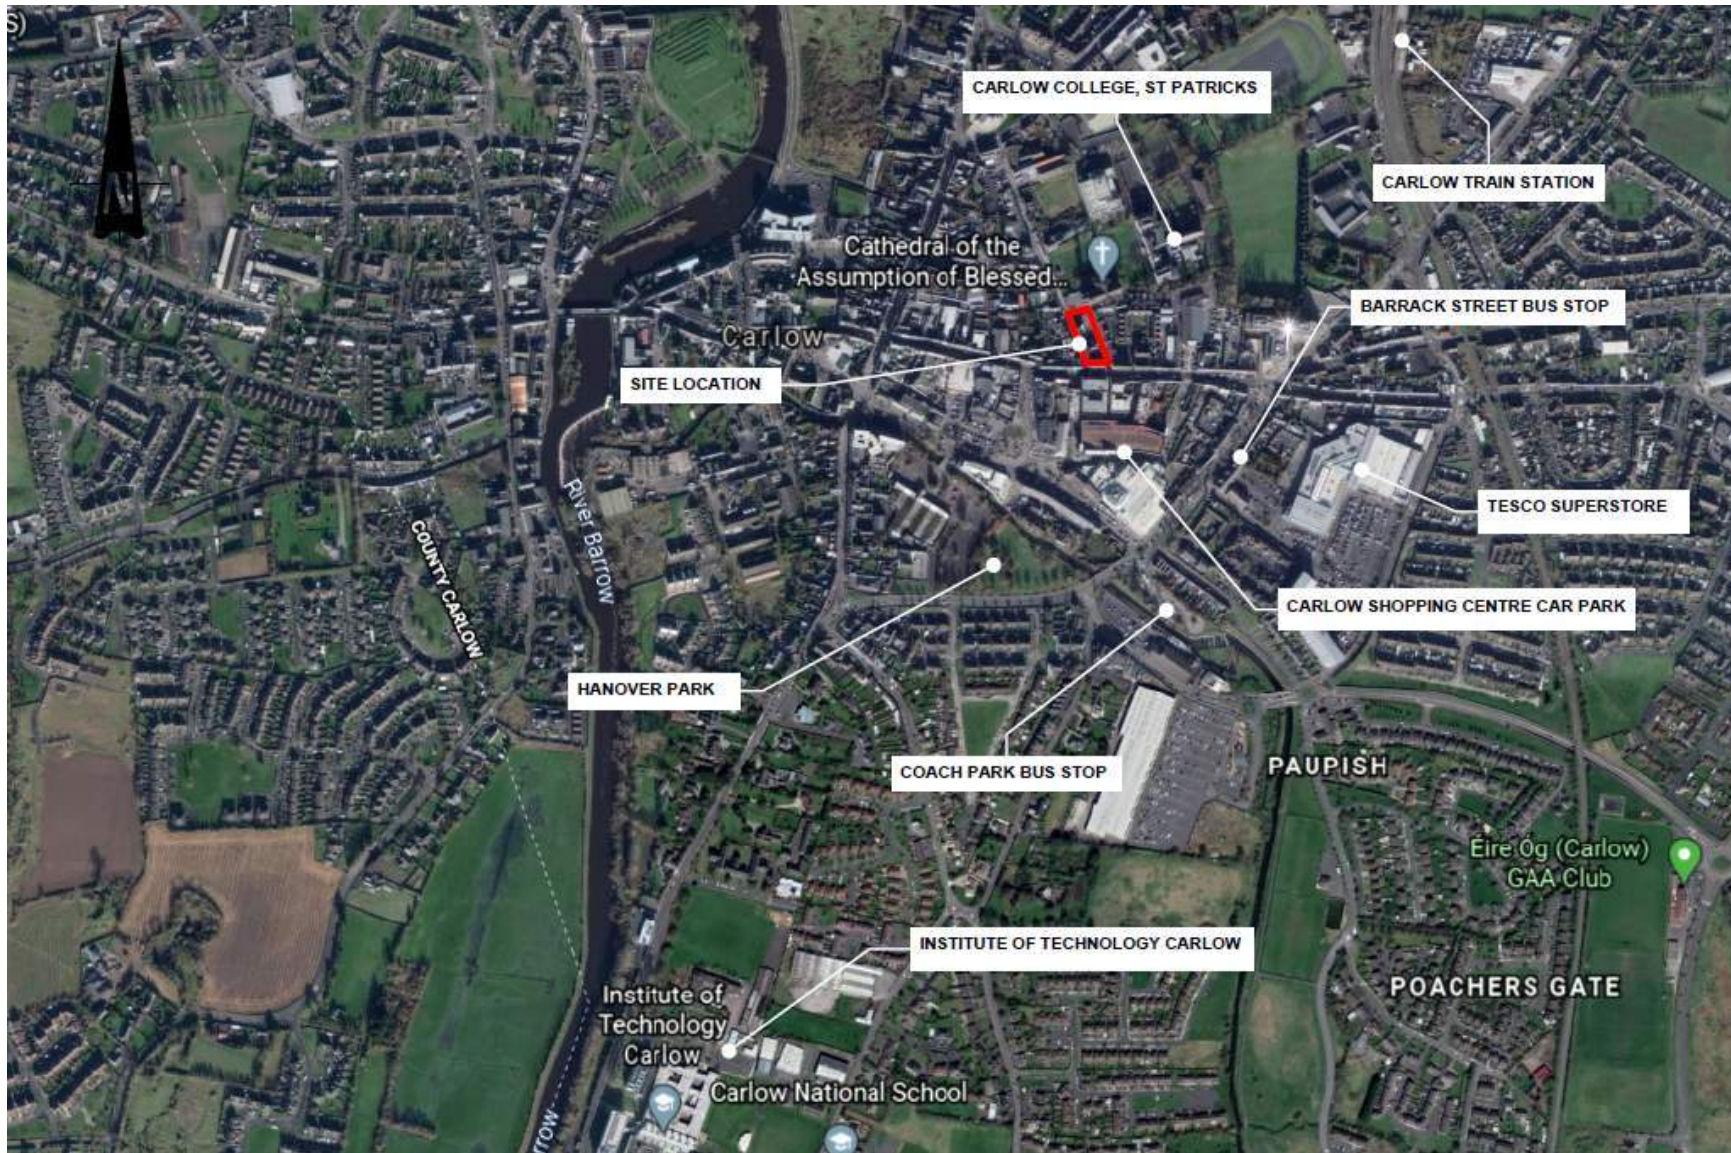
Figure 2-2: Site Development-Adjacent Developments.

Table 2-1 below describes describes the approximate transport times from the proposed development site to various transport hubs and significant areas. Please note for bus and train journeys these times include walking, connections etc. Traffic conditions will vary, and the times may be different for car and bus times shown. The locations of the significant existing Transport Features are shown in Figure 2-2 below.
