Carlow Library

Rear Elevation

External Condition Drawings

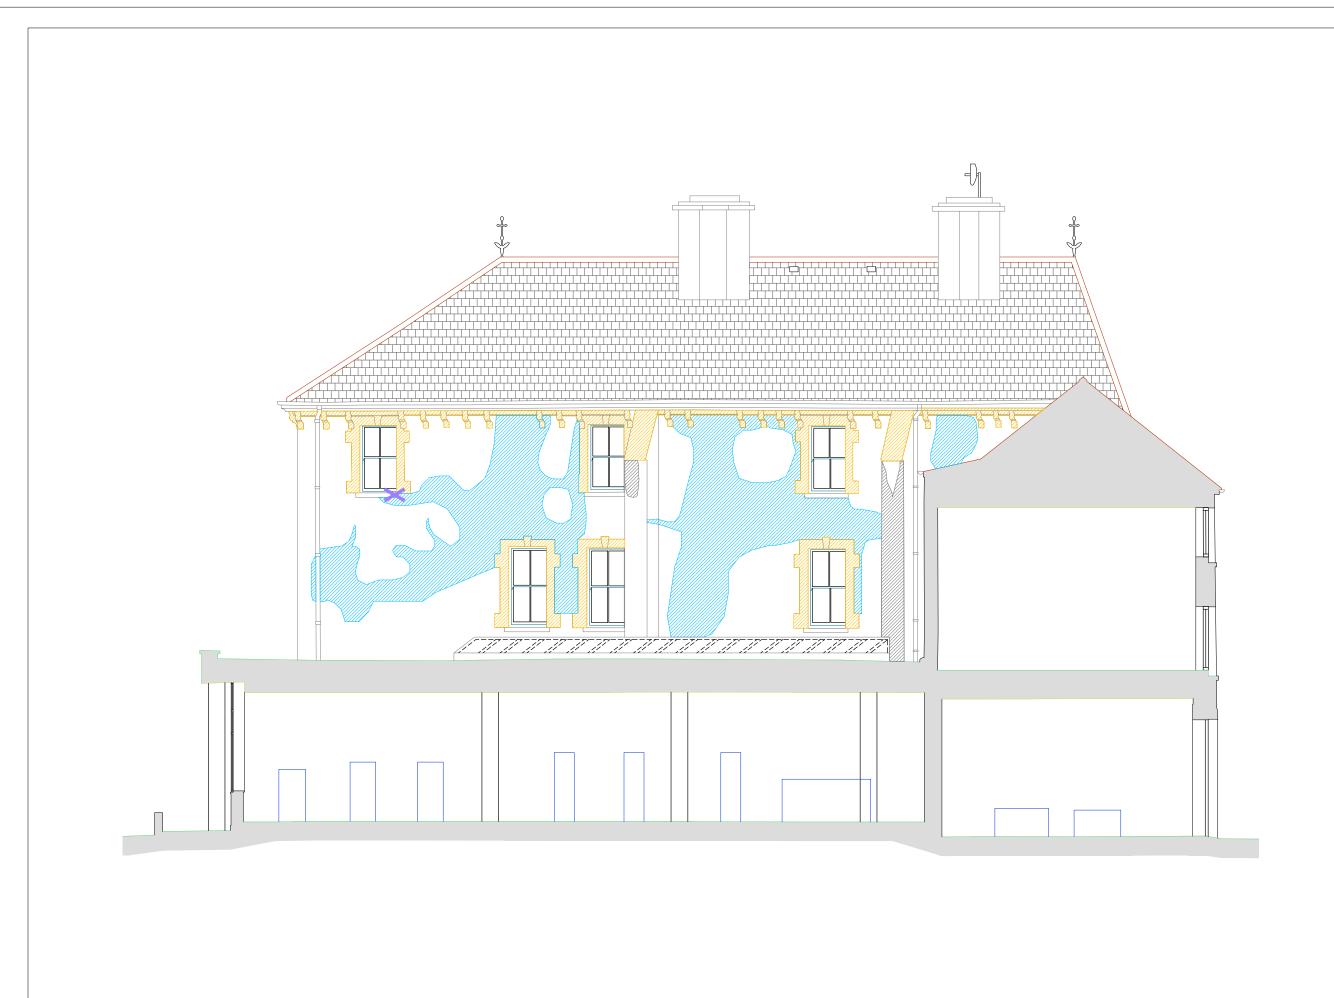
RENDER PATCH REPAIR

ATMOSPHERIC STAINING

CHANFERED BOTTOM CORNER OF SILL TO ACCOMODATE FORMER PITCH OF ROOF

FLAKING PAINTWORK TO RENDER
