FORMER BANK OF IRELAND PREMISES
Court Place, Carlow

ARCHITECTURAL HERITAGE IMPACT ASSESSMENT

January 2026

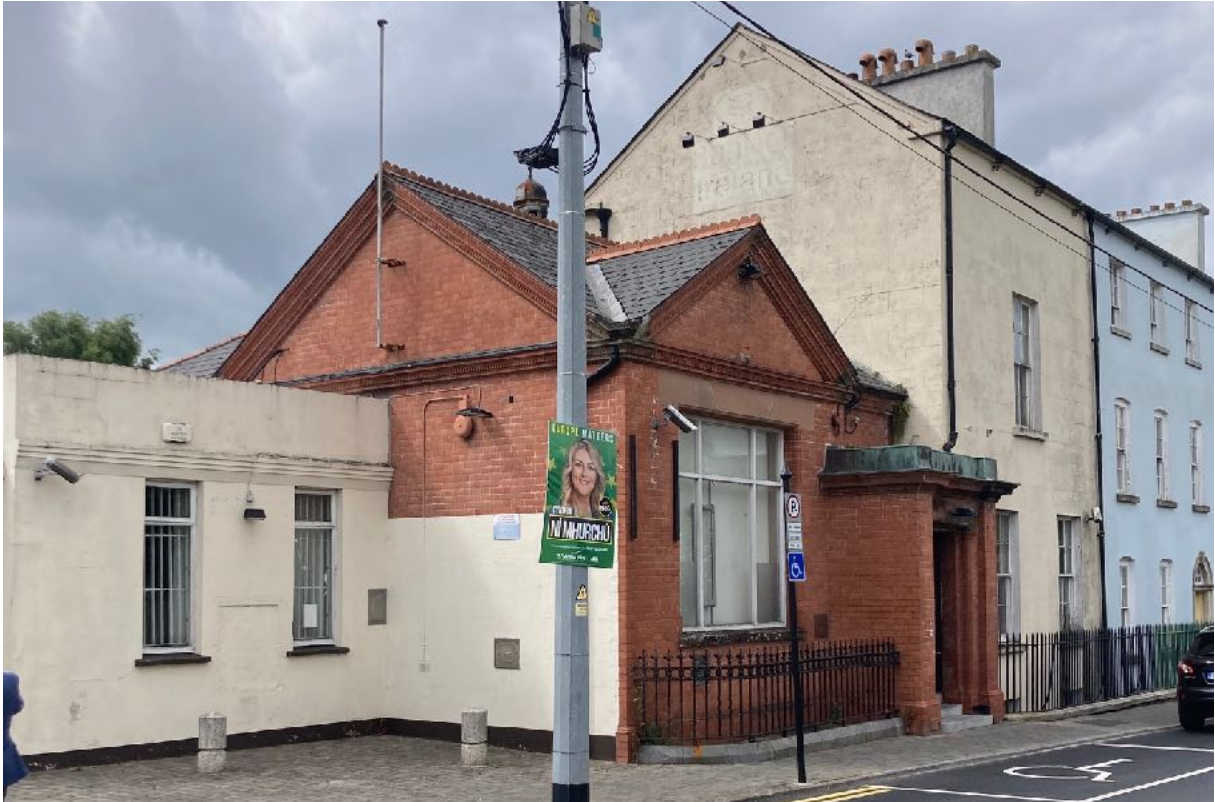
The banking hall is of smooth-faced red-brick with a gable to the front and side. The elevations have brick detailing with heavily moulded and dentilled brickwork to barges and string-courses. The ridge and eaves pieces match the profile of the moulded brick courses (standard profiles from the brickworks) but appear to be of granite -probably specially carved to match the roof pitch- or reconstituted stone. Exposed lintols appear to be of a precast material similar to coade stone to match the brick. The roof is of slate with terracotta hip and ridge tiles. The ridge tiles are ornamental crested type - not original - as evidenced in a historic photograph showing plain ridges. It also shows finials on the ridge of each gable, no longer in existence. There is a central lantern-type feature, probably part of a ventilation system for the banking hall. The porch has a flat roof finished in copper over a moulded brick eaves. The front window appears to be a replacement.

The older section to the north has an unusual fenestration pattern for a street frontage. The windows are placed to suit a stairwell, normally located to the rear of such a building. The windows do not align with those in the adjoining building, which appears contemporary. Finish is of lined render. Windows are traditional vertical sliding 6/6 sashes.

Existing street frontage

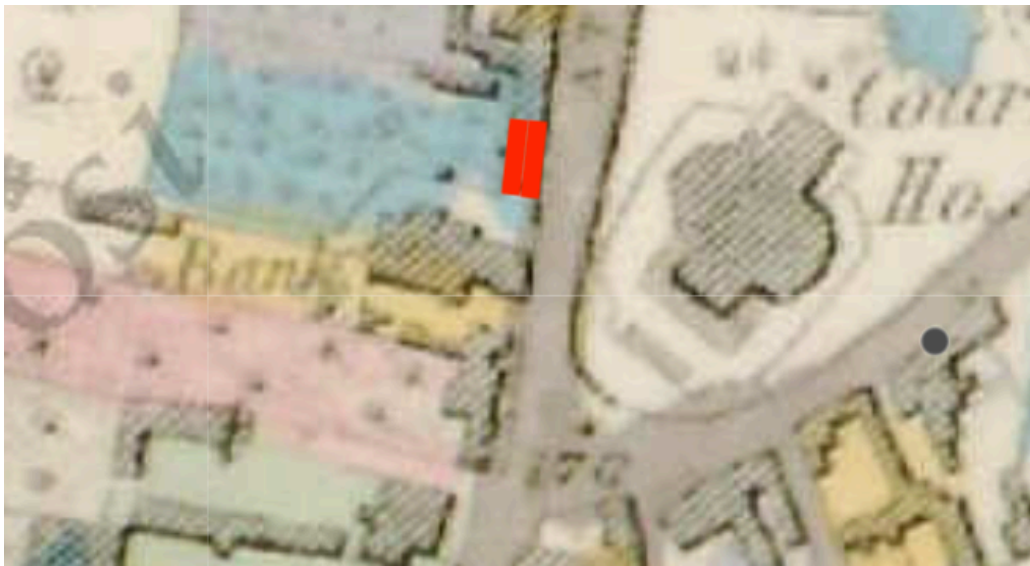
1st Ed OS map c 1840

The first edition OS 6" map (c 1840) shows the two-bay building in existence but not the redbrick addition in its present form. However, the building to the south, adjoining the site in question is identified as a 'Bank'. The second edition OS (c 1900) shows the older components of the present complex - the banking hall and the two-bay building. The single storey extension to the banking hall is of 20c date.

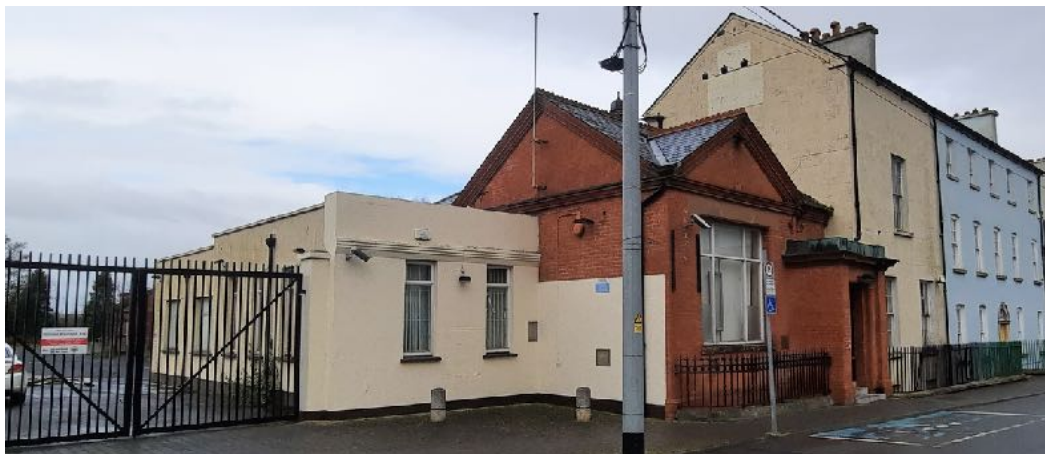
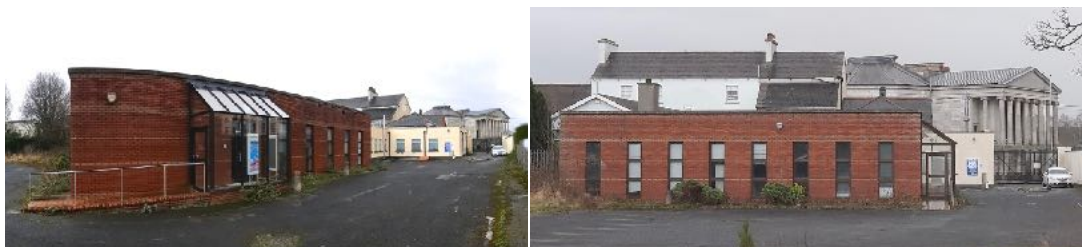
The single-storey extension to the south is of little architectural or historical merit or significance. However, the relocation and redesign of the entrance creates an opportunity to improve the streetscape, forming the approach to the building as well as to the riverside walk along the Barrow.

Modern single-storey extension - front, side and rear elevations

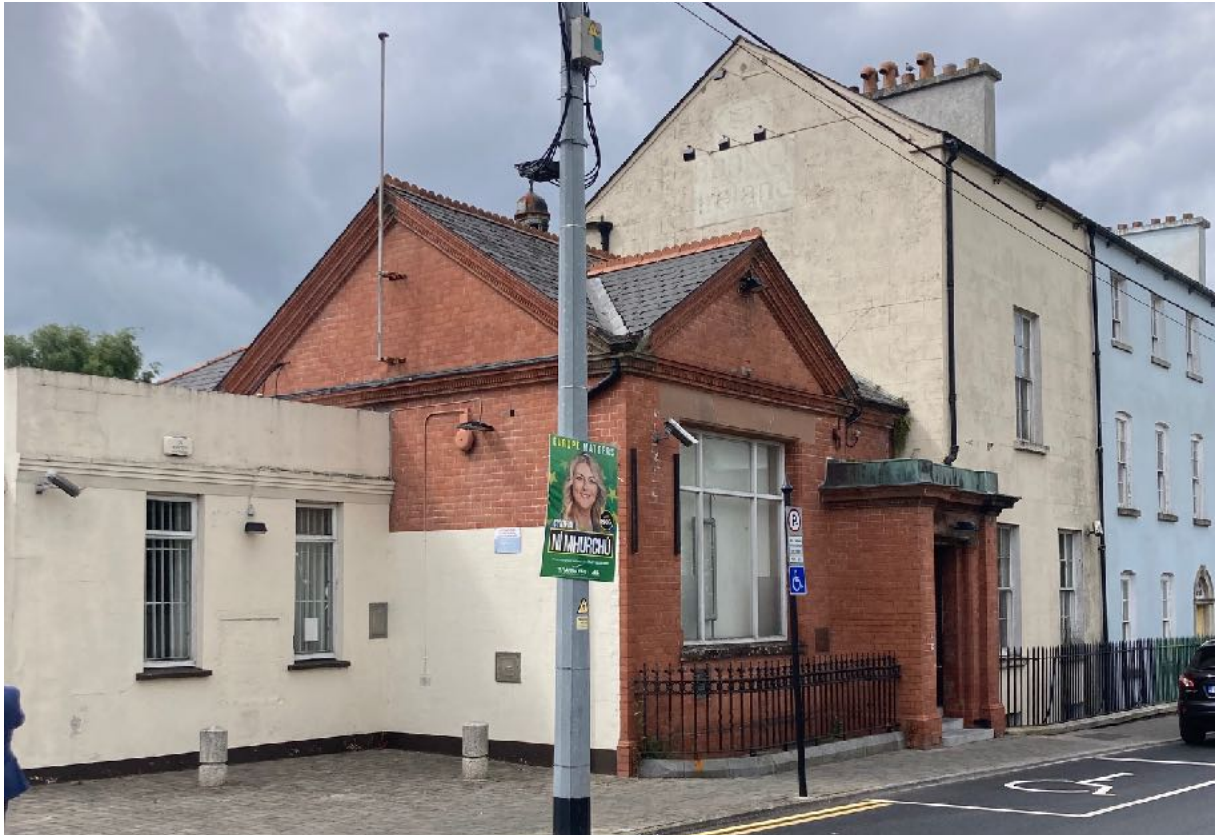
Street view of frontage

PROPOSAL	JUSTIFICATION	IMPACT
<p>Exterior Conservation of the exterior including treatment of the brickwork and stone eaves pieces by a specialist contractor. Removal of all attachments - flag pole, alarms etc</p> <p>Repair/restoration</p> <ul style="list-style-type: none"> • of external joinery • of cast/wrought iron railing • of octagonal ventilator by specialist 	<p>To improve the appearance and maintain the character of the original structure. The brickwork appears to have been sand-blasted in the past damaging its surface and leaving it vulnerable to weathering. Special care needed.</p>	<p>Positive impact for the protected structure and the streetscape</p>
<p>Redesign of extension including new metal cladding Retention of the existing single storey extension</p>	<p>The existing 20c building has a negative visual impact on the protected structure</p>	<p>Positive impact The proposed new cladding will have a positive impact. The pre-patinated copper effect will act as a foil to the brickwork of the old bank frontage</p>

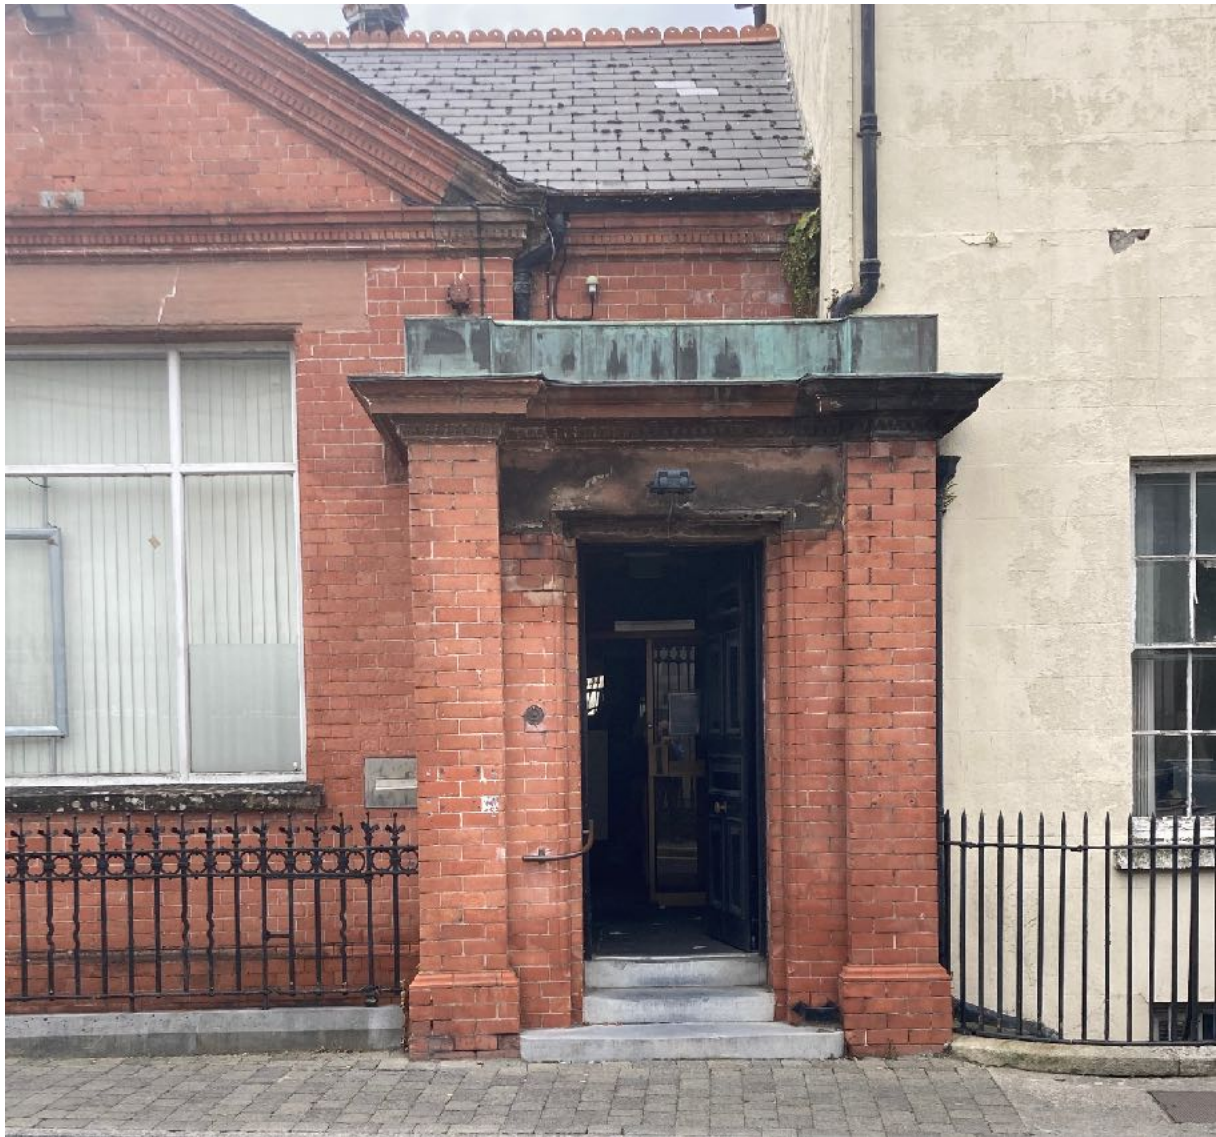
Original entrance porch

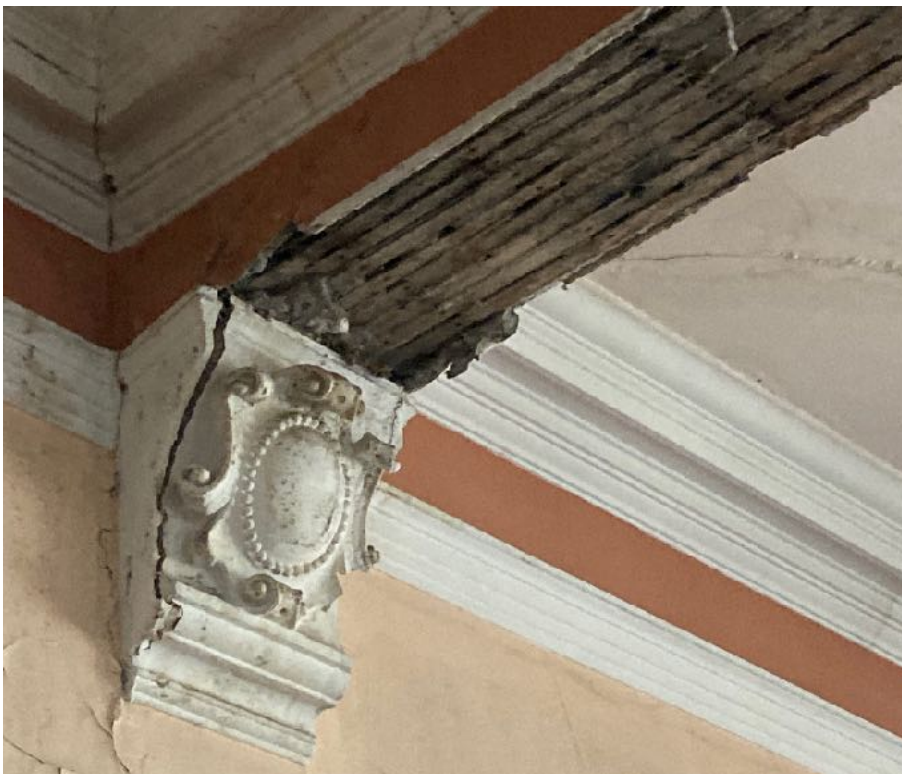
Internally, the original banking hall was the principal and formal space within the building. It had a decorative ceiling with cornice and stucco-work on corbelled supports to beams. This has survived, while some of the supporting walls have been removed with later beams inserted. These inappropriate interventions have rendered the main space incoherent. The other feature of note is the decorative mosaic on part of the floor, designed with B and I (Bank of Ireland?) lettering as a centrepiece with surrounding patterned border and corner features.

Detail of banking hall ceiling
