PROPOSED FLOOR PLANS

job: REFURBISHMENT OF EXISTING FIRE STATION
 site: MUINE BHEAG, CO. CARLOW
 client: CARLOW COUNTY FIRE AND RESCUE SERVICE
 drawing: PROPOSED FLOOR PLANS

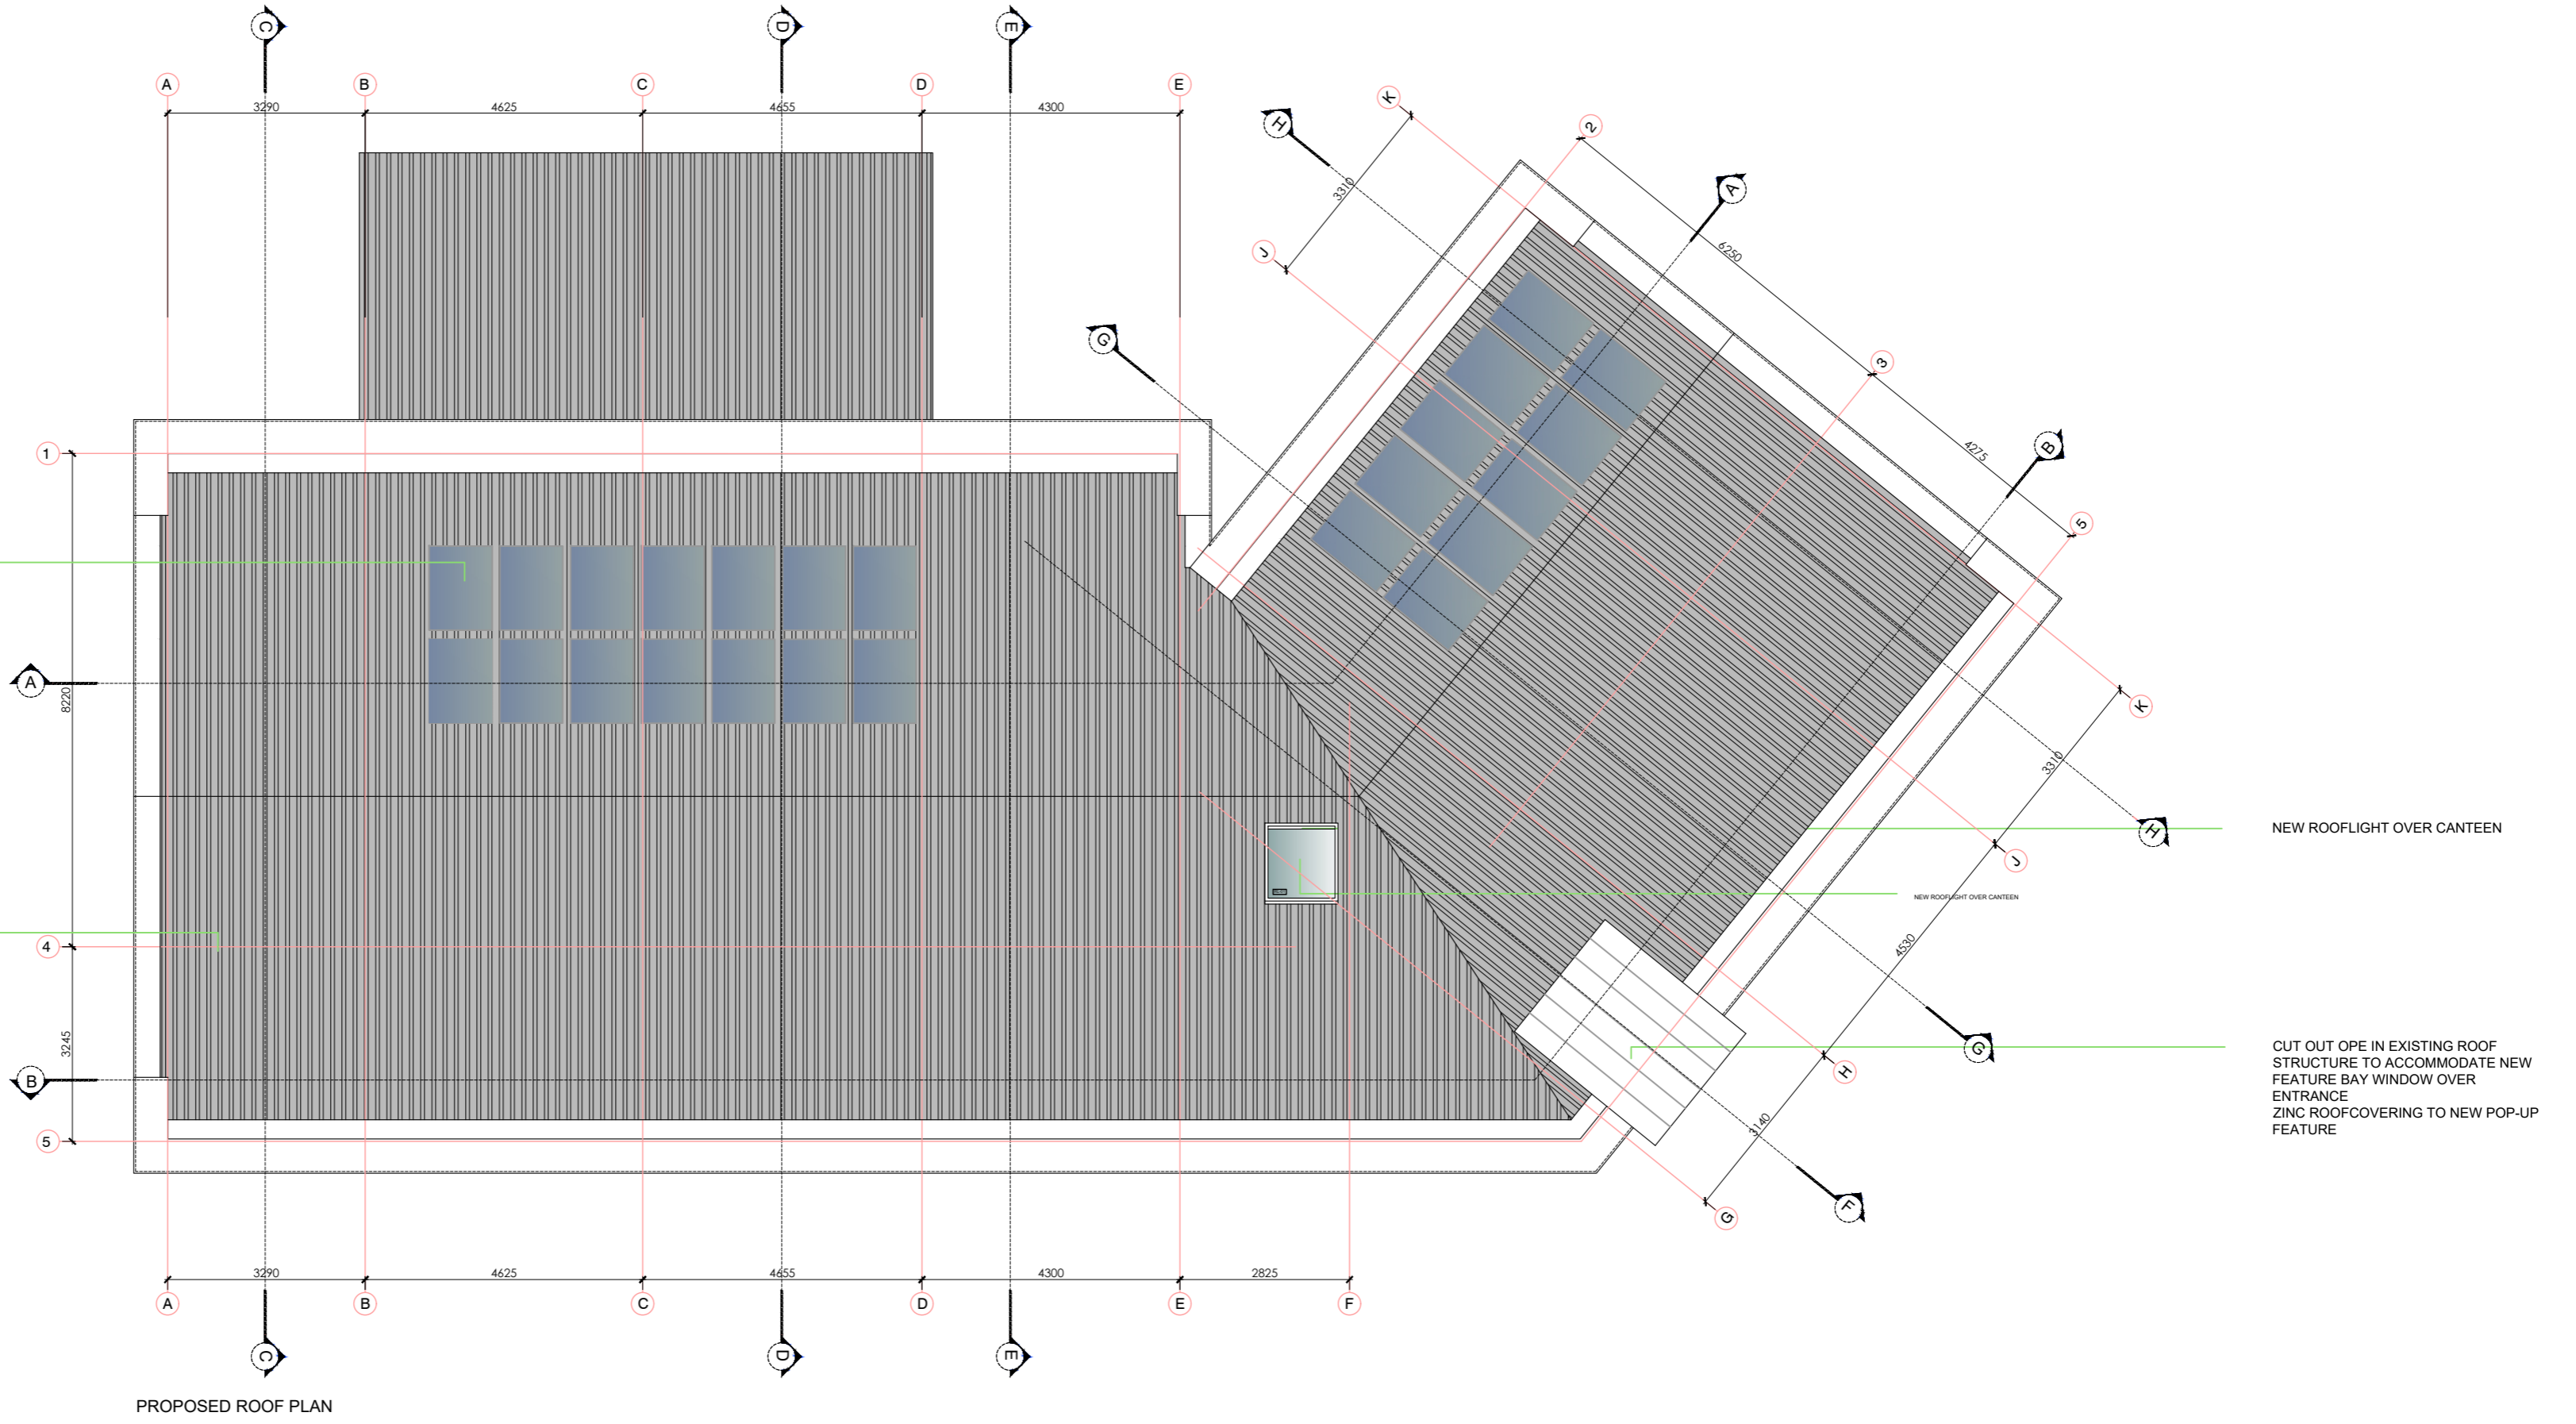
2 BANKS OF SOLAR PANELS TO M&E ENGINEER'S SPECIFICATION

NEW KINGSPAN QUADCORE METAL DECK ROOF IN SELECTED COLOUR

NEW ROOFLIGHT OVER CANTEEN

CUT OUT OPE IN EXISTING ROOF STRUCTURE TO ACCOMMODATE NEW FEATURE BAY WINDOW OVER ENTRANCE ZINC ROOF COVERING TO NEW POP-UP FEATURE

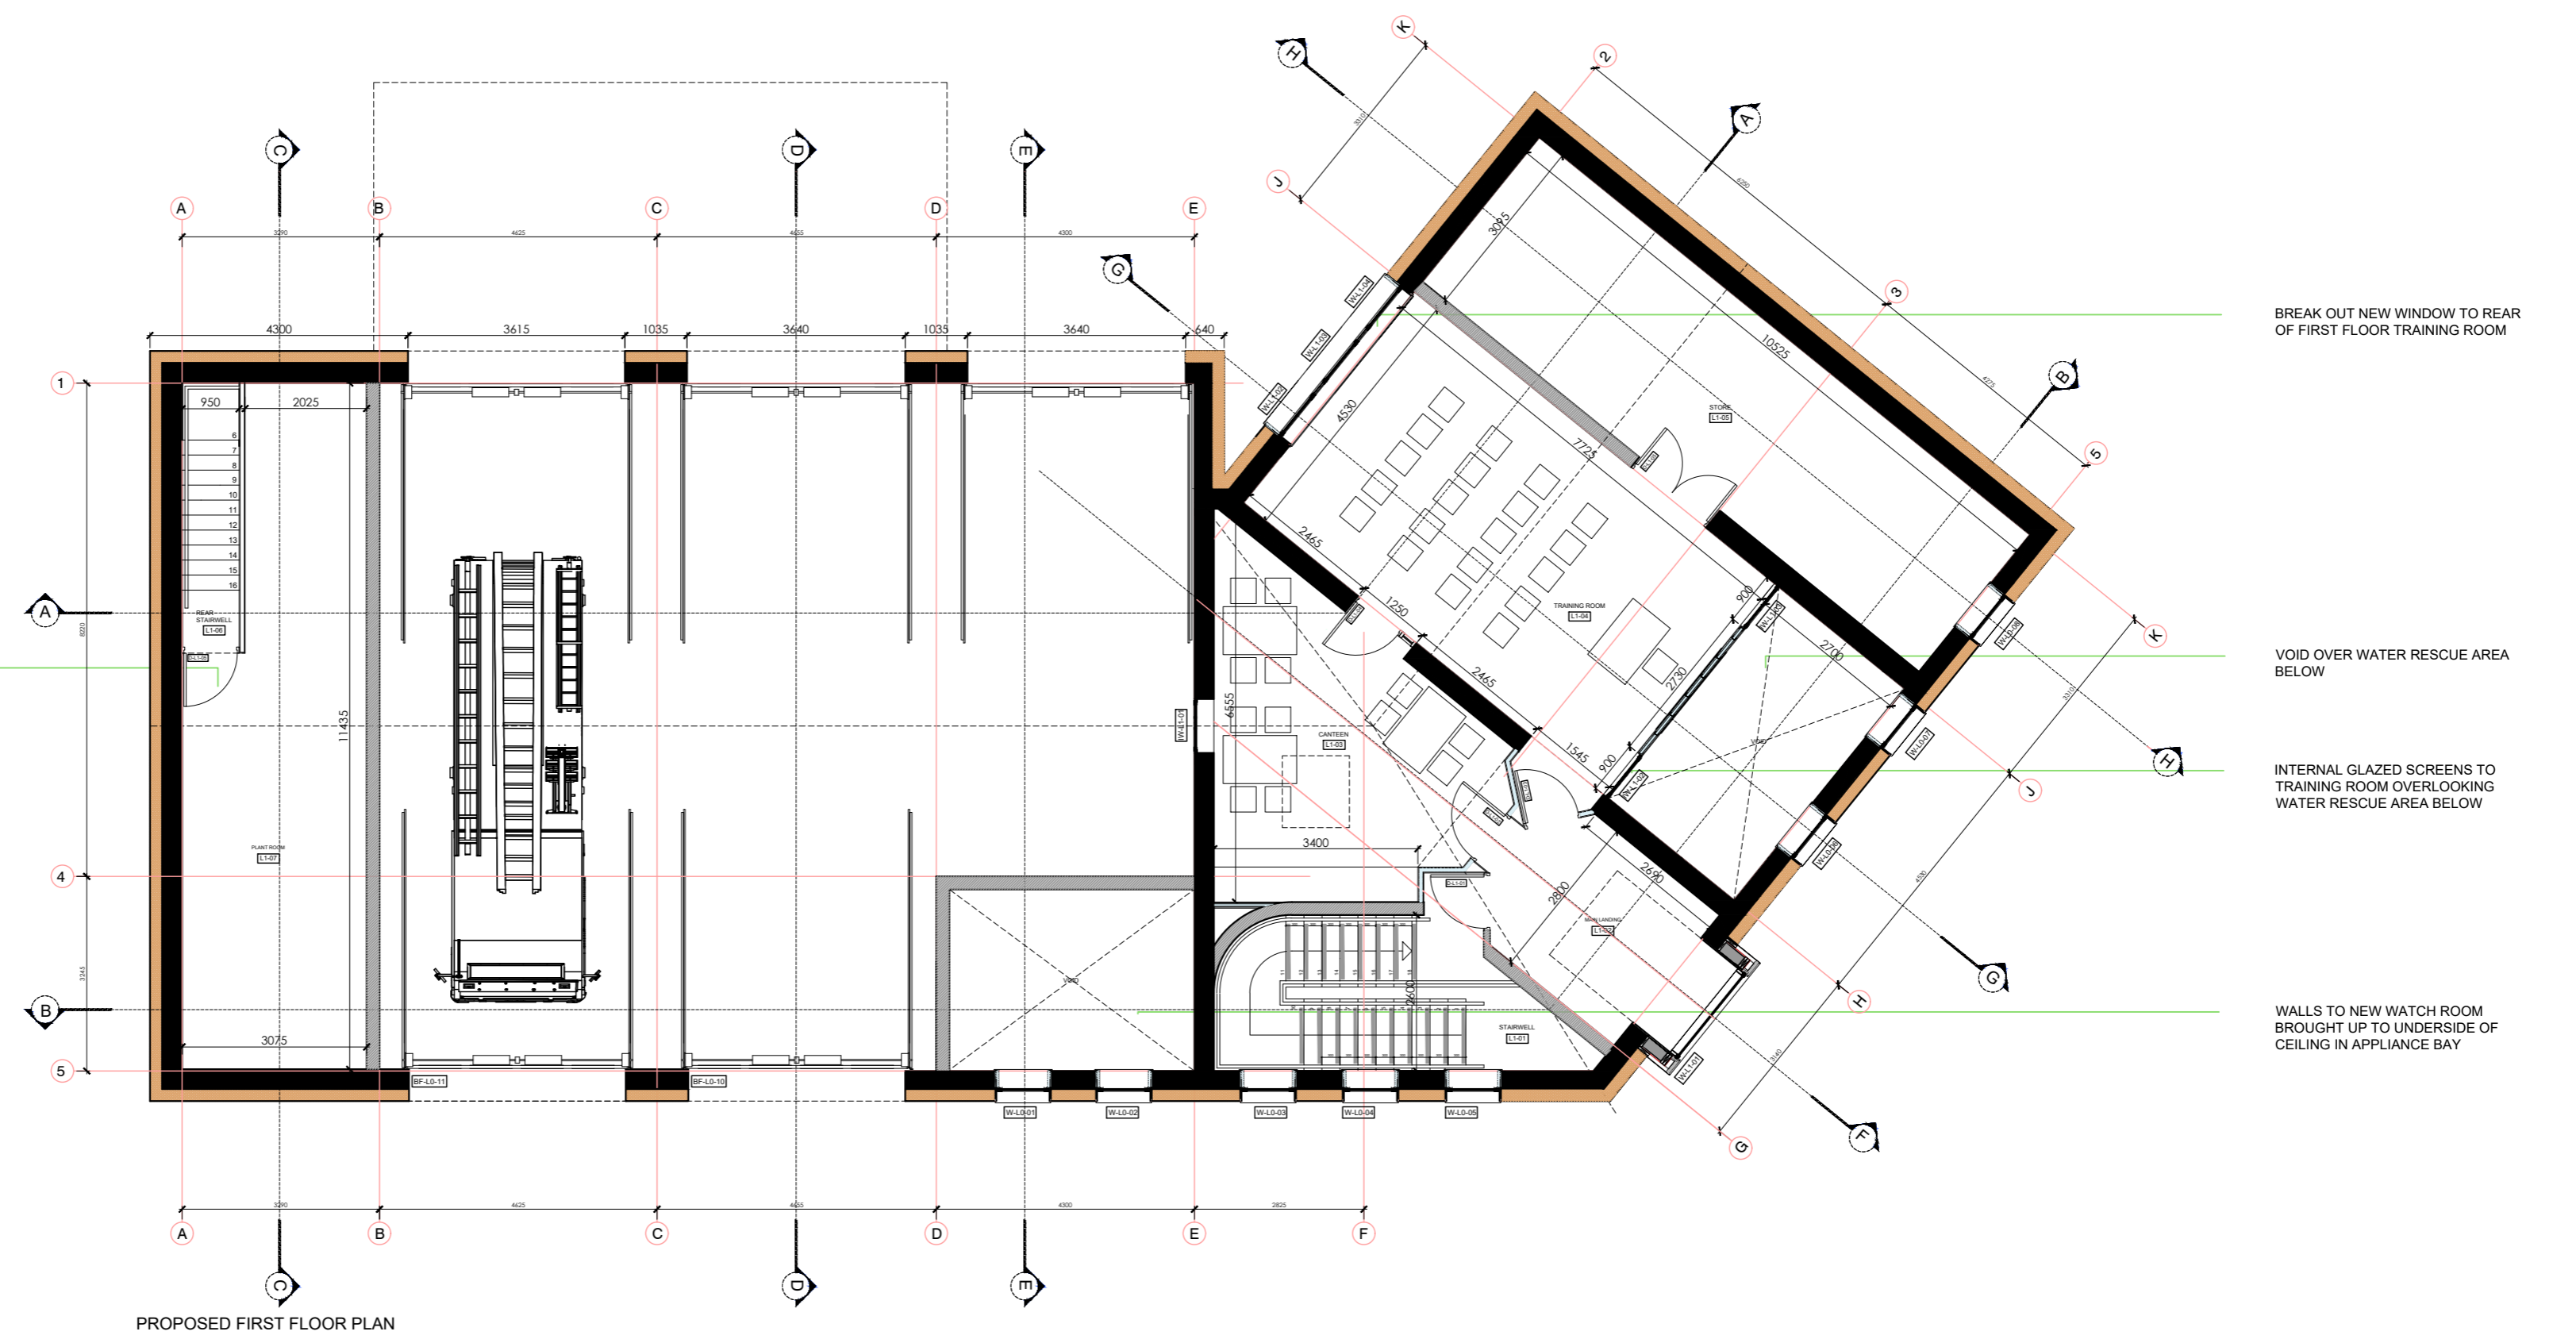
REMOVE EXISTING CEILING JOISTS AND INSTALL NEW FLOOR OVER GROUND FLOOR ROOMS TO ACCOMMODATE NEW PLANT AND EQUIPMENT

BREAK OUT NEW WINDOW TO REAR OF FIRST FLOOR TRAINING ROOM

VOID OVER WATER RESCUE AREA BELOW

INTERNAL GLAZED SCREENS TO TRAINING ROOM OVERLOOKING WATER RESCUE AREA BELOW

WALLS TO NEW WATCH ROOM BROUGHT UP TO UNDERSIDE OF CEILING IN APPLIANCE BAY

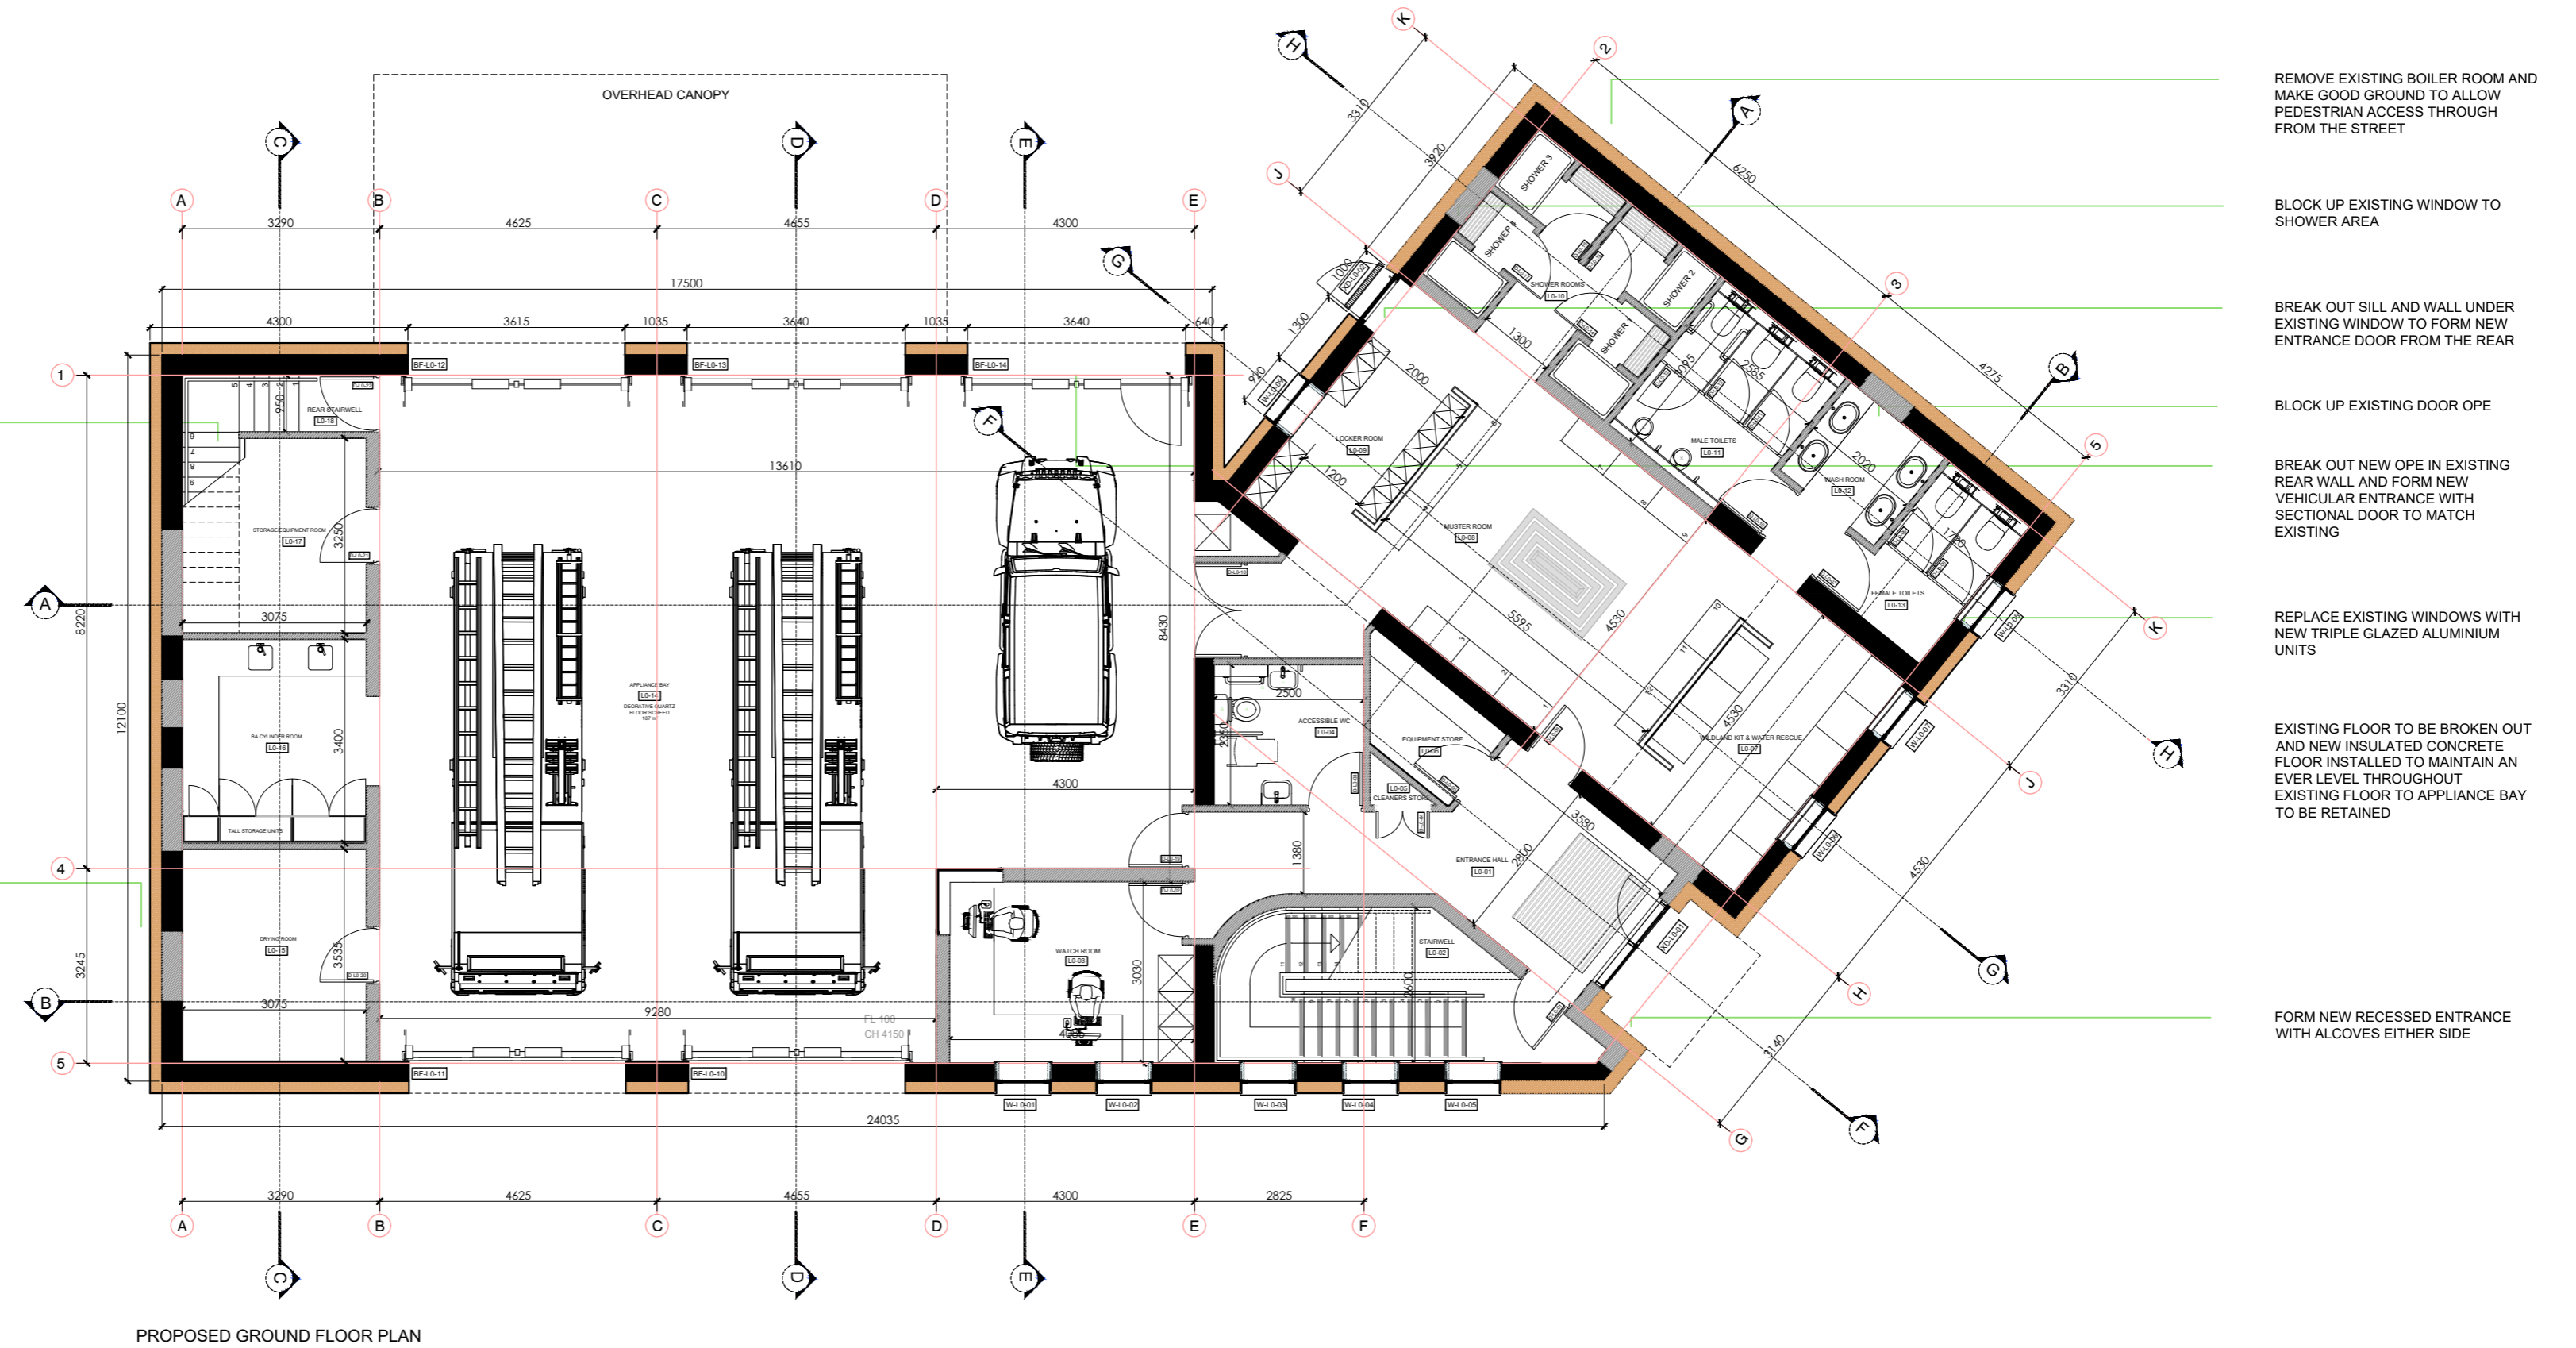
REMOVE EXISTING STAIRS TO STORAGE AREA OVER AND FORM NEW SWITCHBACK STAIRS TO PLANT ROOM

ALL OPENS ON SOUTHERN GABLE WALL TO BE BLOCKED UP

REMOVE EXISTING BOILER ROOM AND MAKE GOOD GROUND TO ALLOW PEDESTRIAN ACCESS THROUGH FROM THE STREET

BLOCK UP EXISTING WINDOW TO SHOWER AREA

BREAK OUT SILL AND WALL UNDER EXISTING WINDOW TO FORM NEW ENTRANCE DOOR FROM THE REAR

BLOCK UP EXISTING DOOR OPE

BREAK OUT NEW OPE IN EXISTING REAR WALL AND FORM NEW VEHICULAR ENTRANCE WITH SECTIONAL DOOR TO MATCH EXISTING

REPLACE EXISTING WINDOWS WITH NEW TRIPLE GLAZED ALUMINIUM UNITS

EXISTING FLOOR TO BE BROKEN OUT AND NEW INSULATED CONCRETE FLOOR INSTALLED TO MAINTAIN AN EVER LEVEL THROUGHOUT EXISTING FLOOR TO APPLIANCE BAY TO BE RETAINED

FORM NEW RECESSED ENTRANCE WITH ALCOVES EITHER SIDE
