PROJECT TITLE
 Carlow Library

DRAWING TITLE
 Front Elevation

DRAWING STATUS
 External Condition Drawings

DRAWN PT	DATE 24.07.2020	BY SH	SCALE 1:100@A3	PASS	REVISION NO. R00
PROJECT NUMBER 020024	DRAWING NUMBER C03

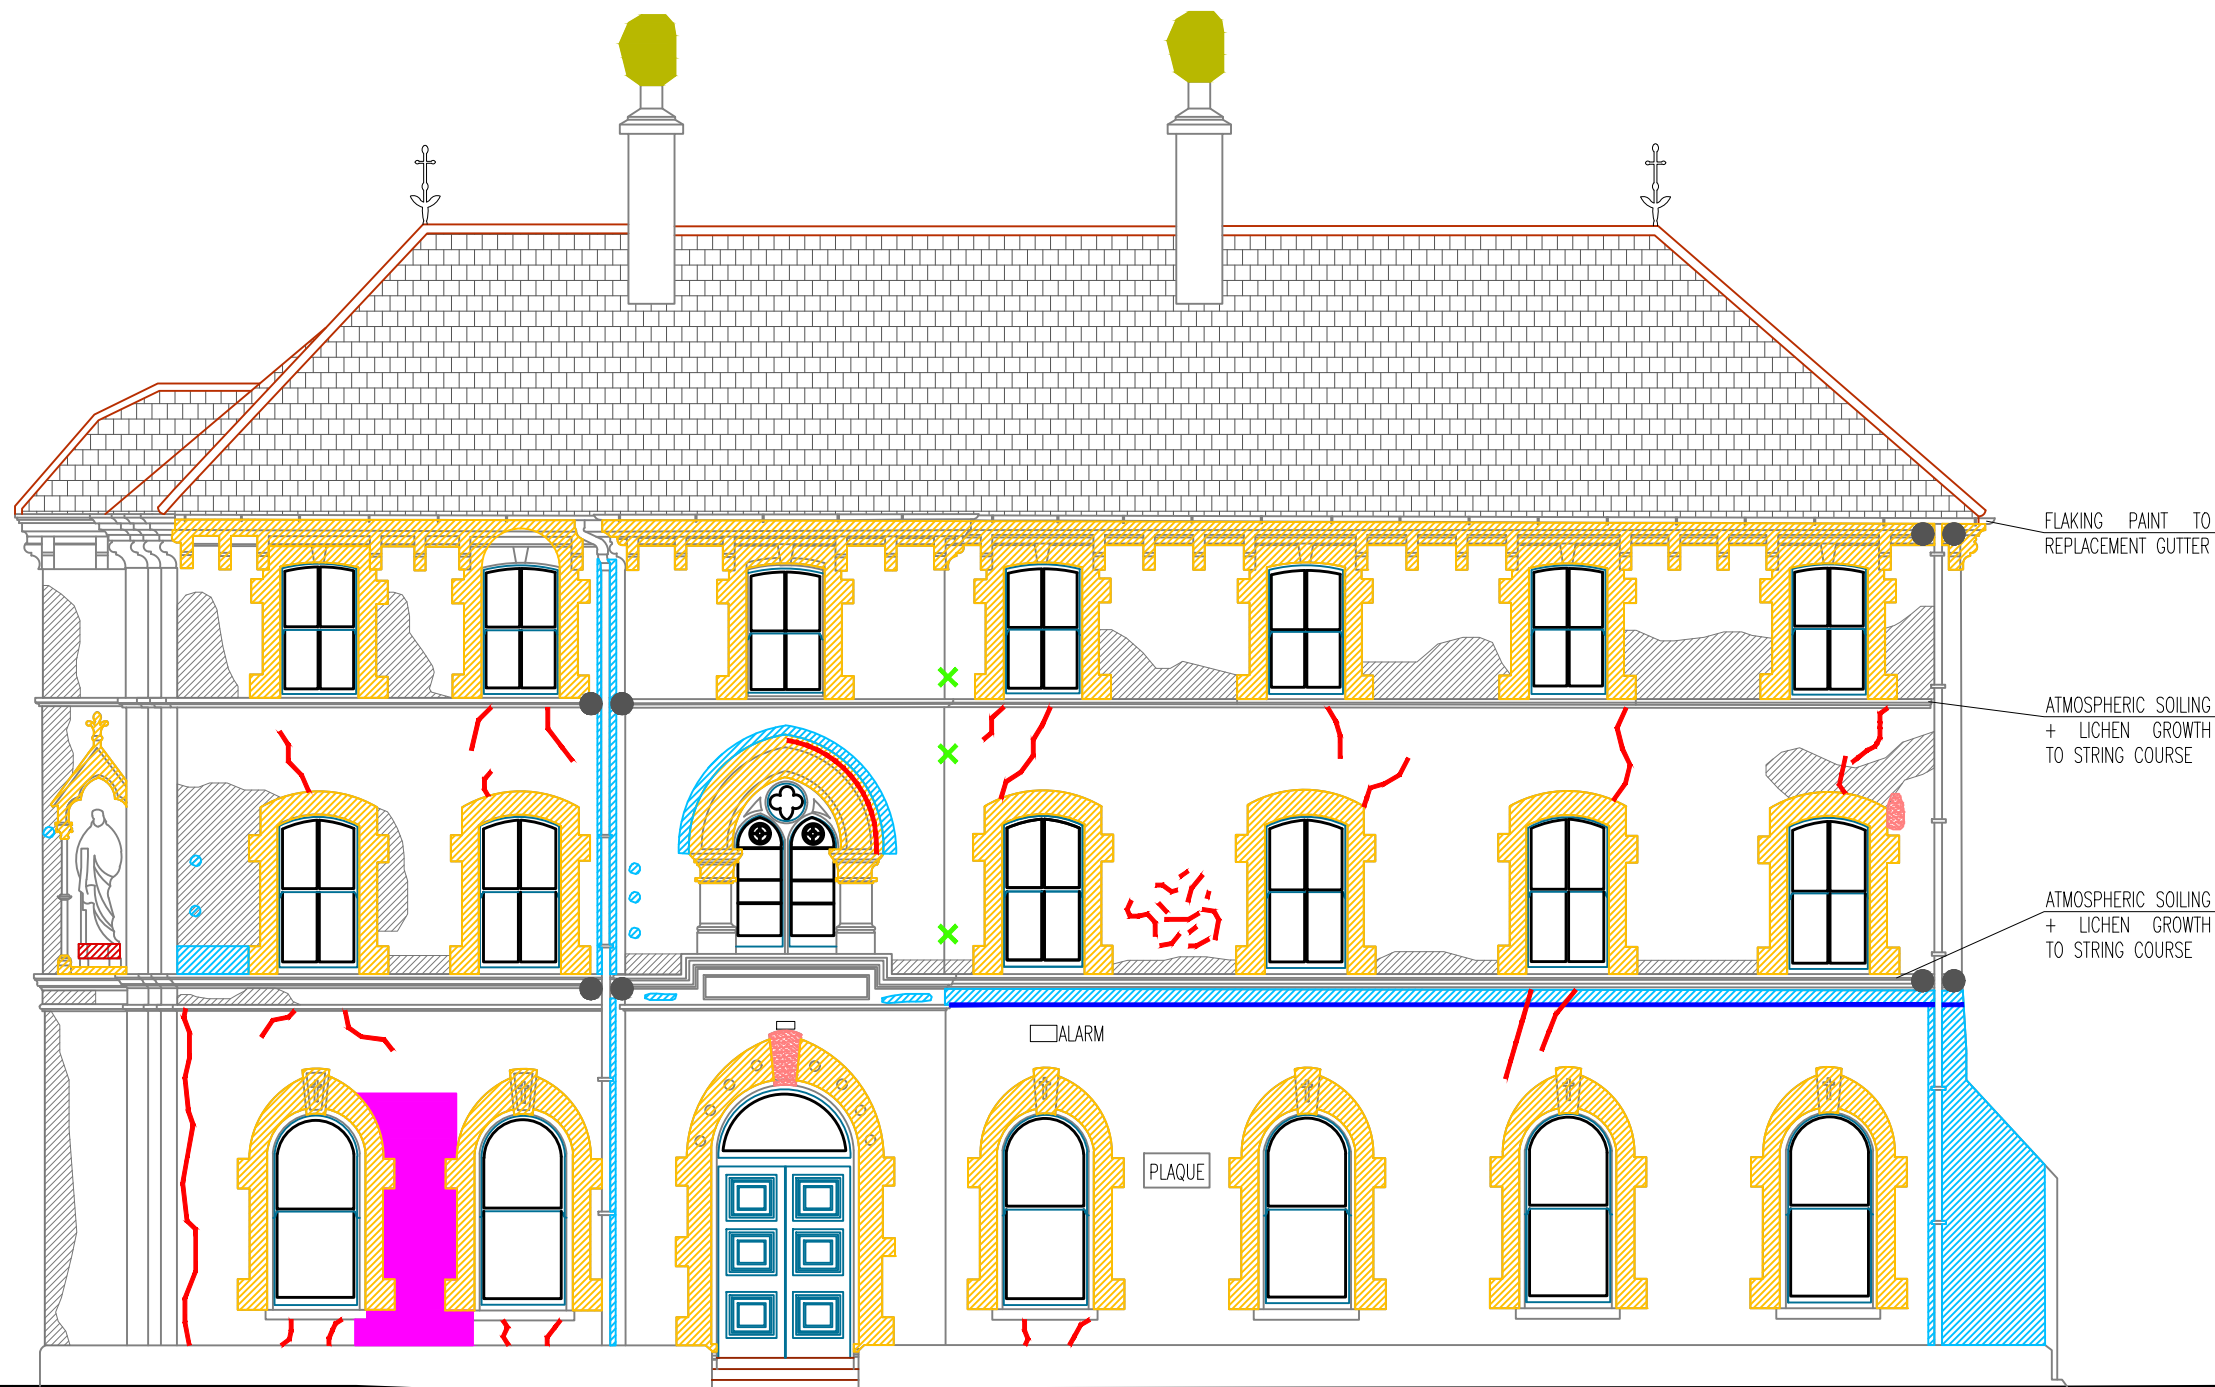
FRONT ELEVATION, 1:100

- KEY
- WASH COLOUR APPLIED OVER RENDER
 - RENDER PATCH REPAIR
 - CRACKS
 - RUST STAIN
 - ATMOSPHERIC STAINING
 - ORGANIC GREEN STAINING
 - FLAKING PAINTWORK TO RENDER
 - MISSING COURSE
 - BROKEN STRING COURSE TO ACCOMMODATE REPLACEMENT DOWNPIPE
 - VEGETATION TO CHIMNEY
 - FLAKING RENDER

FLAKING PAINT TO REPLACEMENT GUTTER

ATMOSPHERIC SOILING + LICHEN GROWTH TO STRING COURSE

GENERAL NOTES:
 FLAKING AND WORN PAINTWORK TO ALL SASHES.
 FLAKING PAINT TO TIMBER DOORS.
