External Recommendations Drawings
Max OF OF MAG Metrodoxia Image: 16.02.2021 State: 11.100@A3 R01
020024 R02

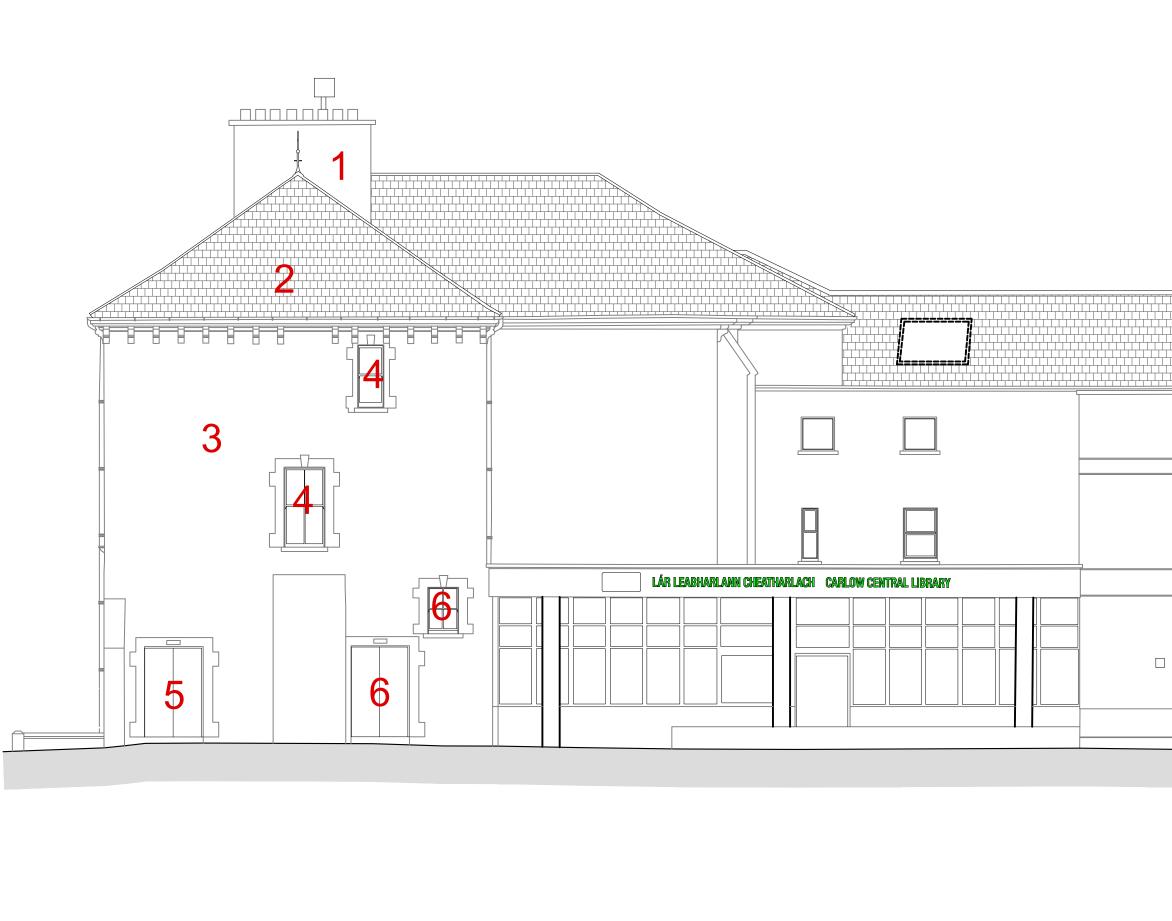
KEY
1 Rake brick joints and flush repoint in NHL3.5 lime & sand mortar. Lithomex repairs to localised spalled brick. Remove vegetation from chimneypots. Provide galvanised cowls. Repair any cracks to concrete coping. New mortar flaunching. Survey lead flashing, repair or renew with Code 4 lead sheet.
2 Strip, clean and store ridge & hip tiles. Strip slates and check if sound. Remove exiting felt and provide breathable membrane on new treated battens. Re-slate with sound existing slates to east hip. Provide new natural slate to make up deficit. Use copper nails. Provide slate vents to rear. Re-bed ridge and hip tiles in lime mortar. Localised timber repairs if necessary. Refurbish historic RWG to west. Replace non-original RWG at front, east and rear with cast-iron units to match profile of original RWG
3 Remove cementitious render but leave decorative string-courses, opening surrounds and eaves corbels in situ. Provide lime render (Otterbein) to a ruled-and-lined finish. Scored lines to be refined. Make good any damaged string-courses or other decorative render elements. Like-for-like repairs to decorative render. Repaint surrounds.

4 Repair any cracking to cement-rendered surrounds. Renew surrounds where boast. Retain and refurbish timber sash windows. Retain glass. Provide new sash cords if required.
5 For alterations, please refer to Architect's drawings.
6 Opening to be blocked as per Architect's drawings.
NOTES: ALL DIMENSIONS TO BE CHECKED ON SITE. DO NOT SCALE FROM DRAWING. DISCREPANCIES AND OMISSIONS TO BE REPORTED IMMEDIATELY TO CARRIG CONSERVATION INTERNATIONAL. THIS DRAWING IS COPYRIGHT AND IS ISSUED ON THE CONDITION THAT IT IS NOT COPIED EITHER WHOLLY OR IN PART WITHOUT THE CONSENT IN WRITING OF CARRIG CONSERVATION INTERNATIONAL
C A R R I G
Second Floor - Atlantis Building South Cumberland Street phone: 00 353 1552980
e-mail info@crrigie www.carrigie BRAWIG (DEYRGHT - CARRE (DISERVATOR HITEMATIONAL CONT CONT CONT CONT CONT CONT CONT CONT
Carr Cotter & Naessens Architects mean mar Carlow Library
Beame True East Elevation
