ARCHITECTURAL HERITAGE IMPACT ASSESSMENT

TWO SHOP/HOUSES, MAIN STREET, BORRIS

'E. BREEN'

MARGARET QUINLAN ARCHITECTS

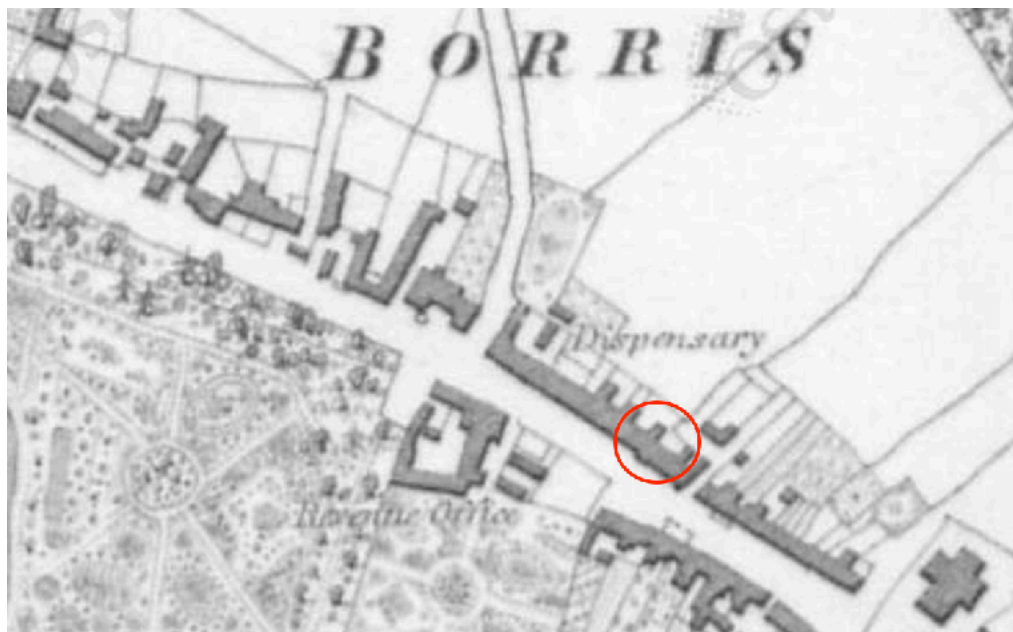
1st edition OS map c. 1840,

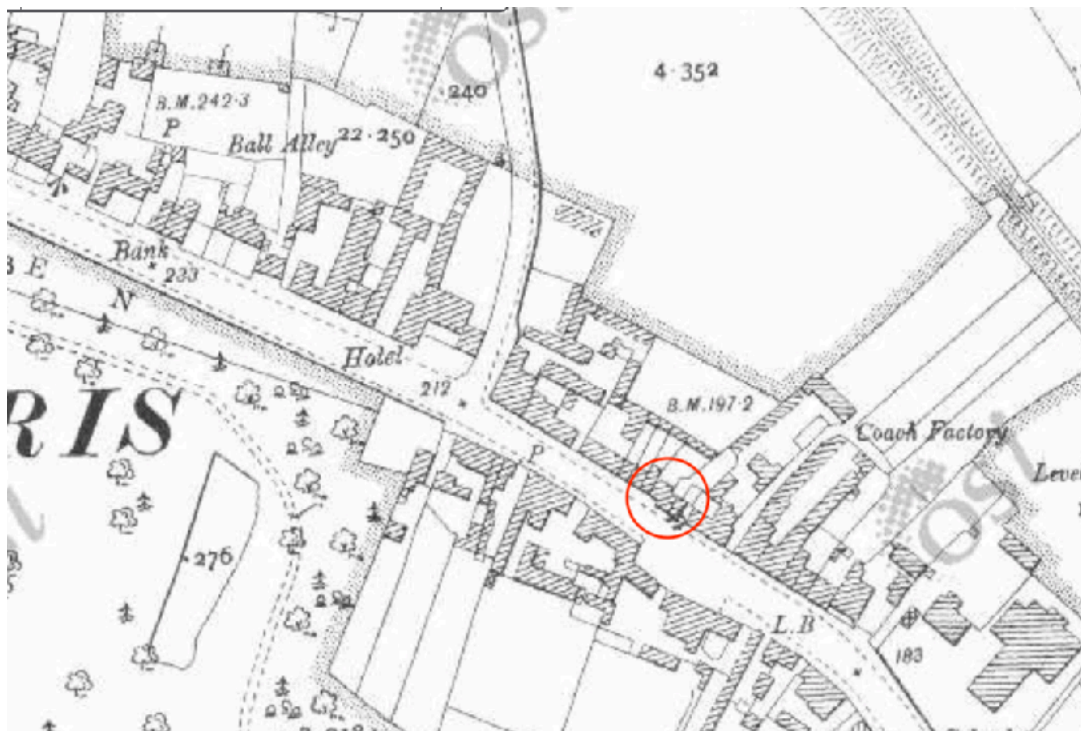
2nd edition OS map c. 1900. Note division of rear garden and railway track to the rear

Proposal	Justification	Impact
SETTING		
New boundary between two buildings	Provide garden division between two units	Positive impact. Reinstate original boundary - see 2nd edition OS
Remove leylandii from rear garden	Leylandii are overgrown and deprive the rear of light	Positive visual impact. The deciduous trees are further back, will not block light and will be retained
Replace gate to side entrance, inward opening with 2 no. unequal leaves.	Gate in poor condition and in one large leaf.	Positive impact. Two leaves will enable easier access for the less able-bodied. Character will be retained by cladding the new gate/s in corrugated metal sheeting to match existing

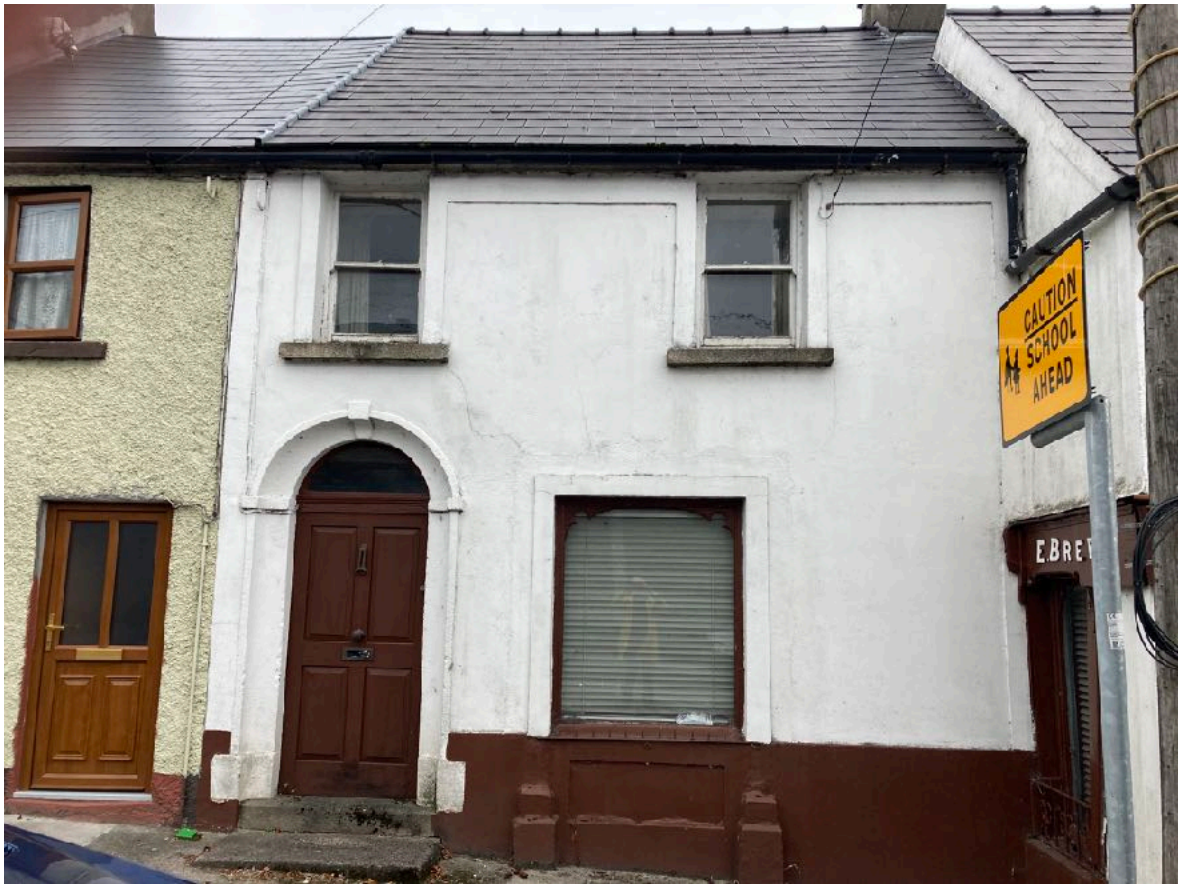
There is attractive detailing of elements in the frontage - Unit B contains a fine granite doorcase and the shop windows have cusped foils on the corners and other vernacular details on the joinery, all of which add interest.

Above
Round-headed door case, probably granite

Proposal	Justification	Impact
EXISTING BUILDING/S		
Exterior Retain all existing door and window openings	Retain character	Positive impact
Carry out test clean on painted round-headed door case and on plinths including pilasters . Clean back to granite if feasible	To establish if the painted elevational details are granite and if the paint can be removed successfully	Possible positive impact in restoring original character. Any cleaning will be by specialist
Replace rainwater goods with full half-round and downpipes	To increase capacity and deal with levels	Positive impact
Record detail of shopfront (including windows) by photograph.and sketch, numbering all decorative components Careful removal by specialist joiner, retaining all components Careful removal of any historic glass.	To make a proper record of the fabric to be conserved to inform the reinstatement.	Positive impact
Repair all joinery where possible in doors and windows. Replace to match existing where decay is extensive, reinstating all decorative components in windows, shopfront fascia and pilasters. Where no historic glass survives, double/triple-glazed units may be used. Where it survives , use secondary units internally. The ground floor window beside the side entrance may be divided into 3 no. vertical lights	To conserve character while making fit for purpose To conserve energy To adjust proportions of the modern unit. The division based on those of the Nolan and Dalton shop windows	Minimal impact. Loss of fabric only where timber is no longer viable

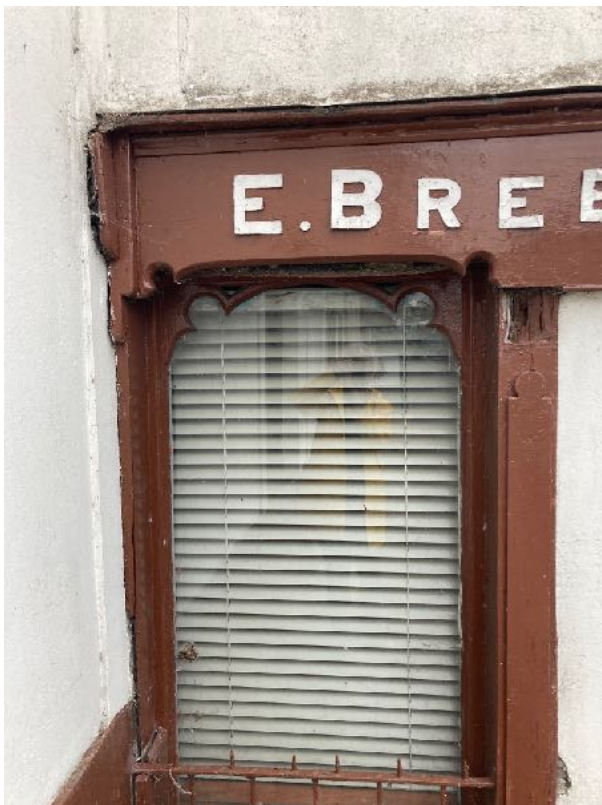
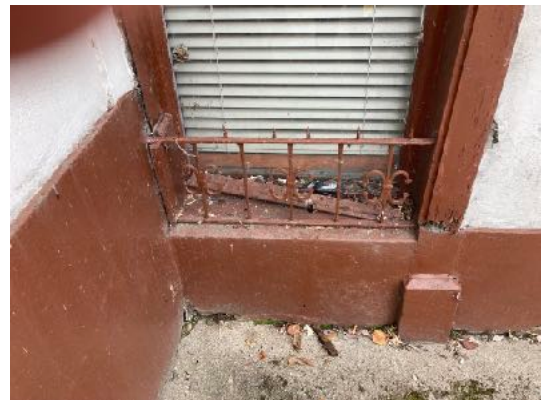
The projection into the pavement incorporates a side shop-window which faces the pedestrian walking down the street.

Left and below
Window on projecting corner with metal fitting

On upper floor sliding sash windows will be draught-stripped. Secondary glazing may be used internally but not to affect elevation externally.	To conserve energy Secondary glazing, if used, will be such as not to affect elevation externally.	Positive impact
Remove metalwork from window cill, grit-blast, treat with cold-gale, Paint and reinstate	To conserve feature	Positive impact
Remove rear extensions	Building of poor quality and not usable	Positive impact
Repair existing render where necessary in lime mortar, paint	Signs of hairline cracks. Check for hollow spots	Positive impact

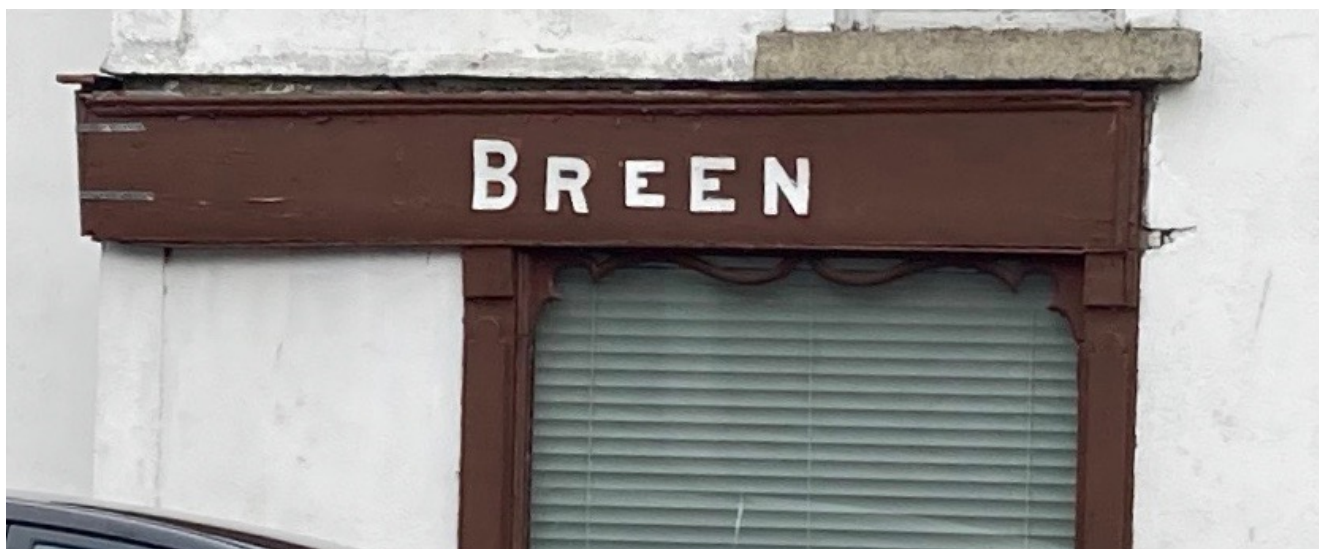
The street frontage is of interest. It is one of a number of attractive 19c shopfronts. It benefits from the buildings being offset. The shop windows have a cusped foil detail on the corners and the largest window has a scroll detail along the head. There are granite dressings to one doorcase. Sliding sash windows to first floor.

Cusped foils in corners and scrollwork detail along head
